“BEING MORE THAN A COLLECTION OF INDIVIDUALS, SUNY POTSDAM IS A COMMUNITY DEDICATED TO THE PURSUIT OF COMMON GOALS.”

- SUNY POTSDAM PLEDGE

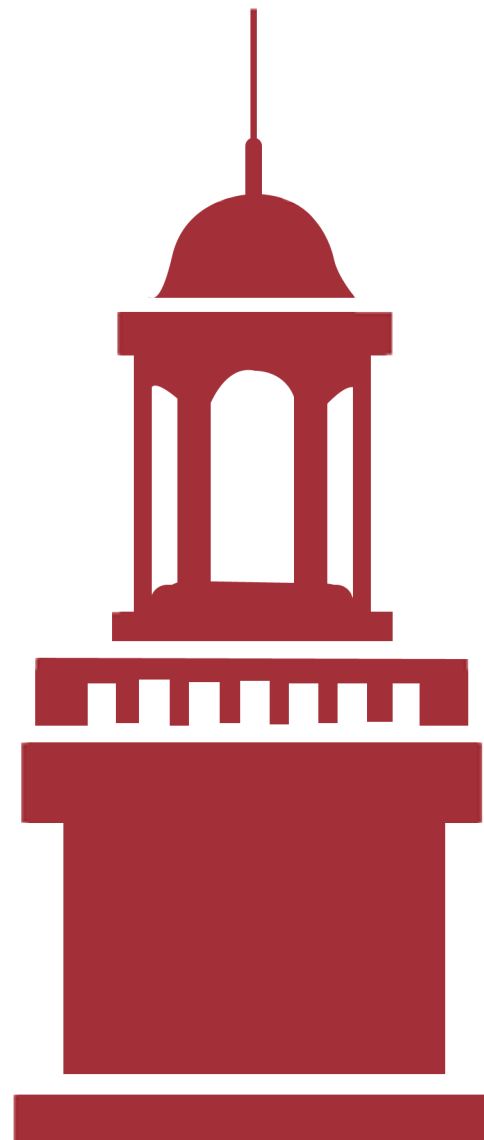
# FACILITIES MASTER PLAN PHASE II ASSESSMENT OF CONDITIONS

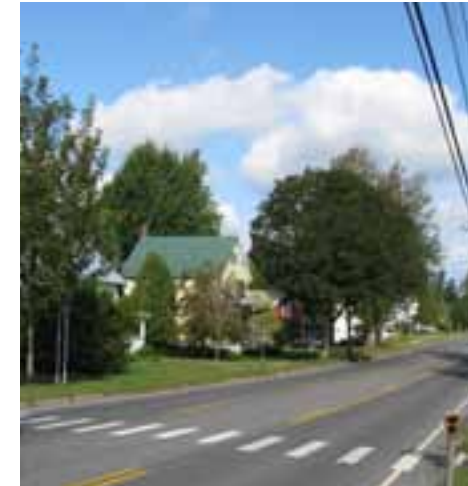
ADJACENT RESIDENTIAL NEIGHBORHOOD

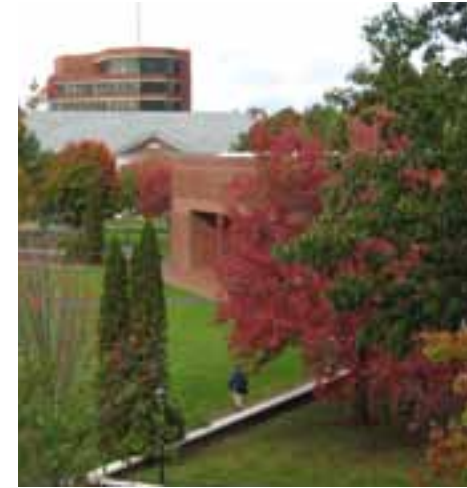
- Install trees in and around surface parking lots to provide buffer and to reduce parking lot heat island effect.
- Rehabilitate and increase the bridges that span the causeway.
- Lehman Park offers an ideal opportunity for campus development.

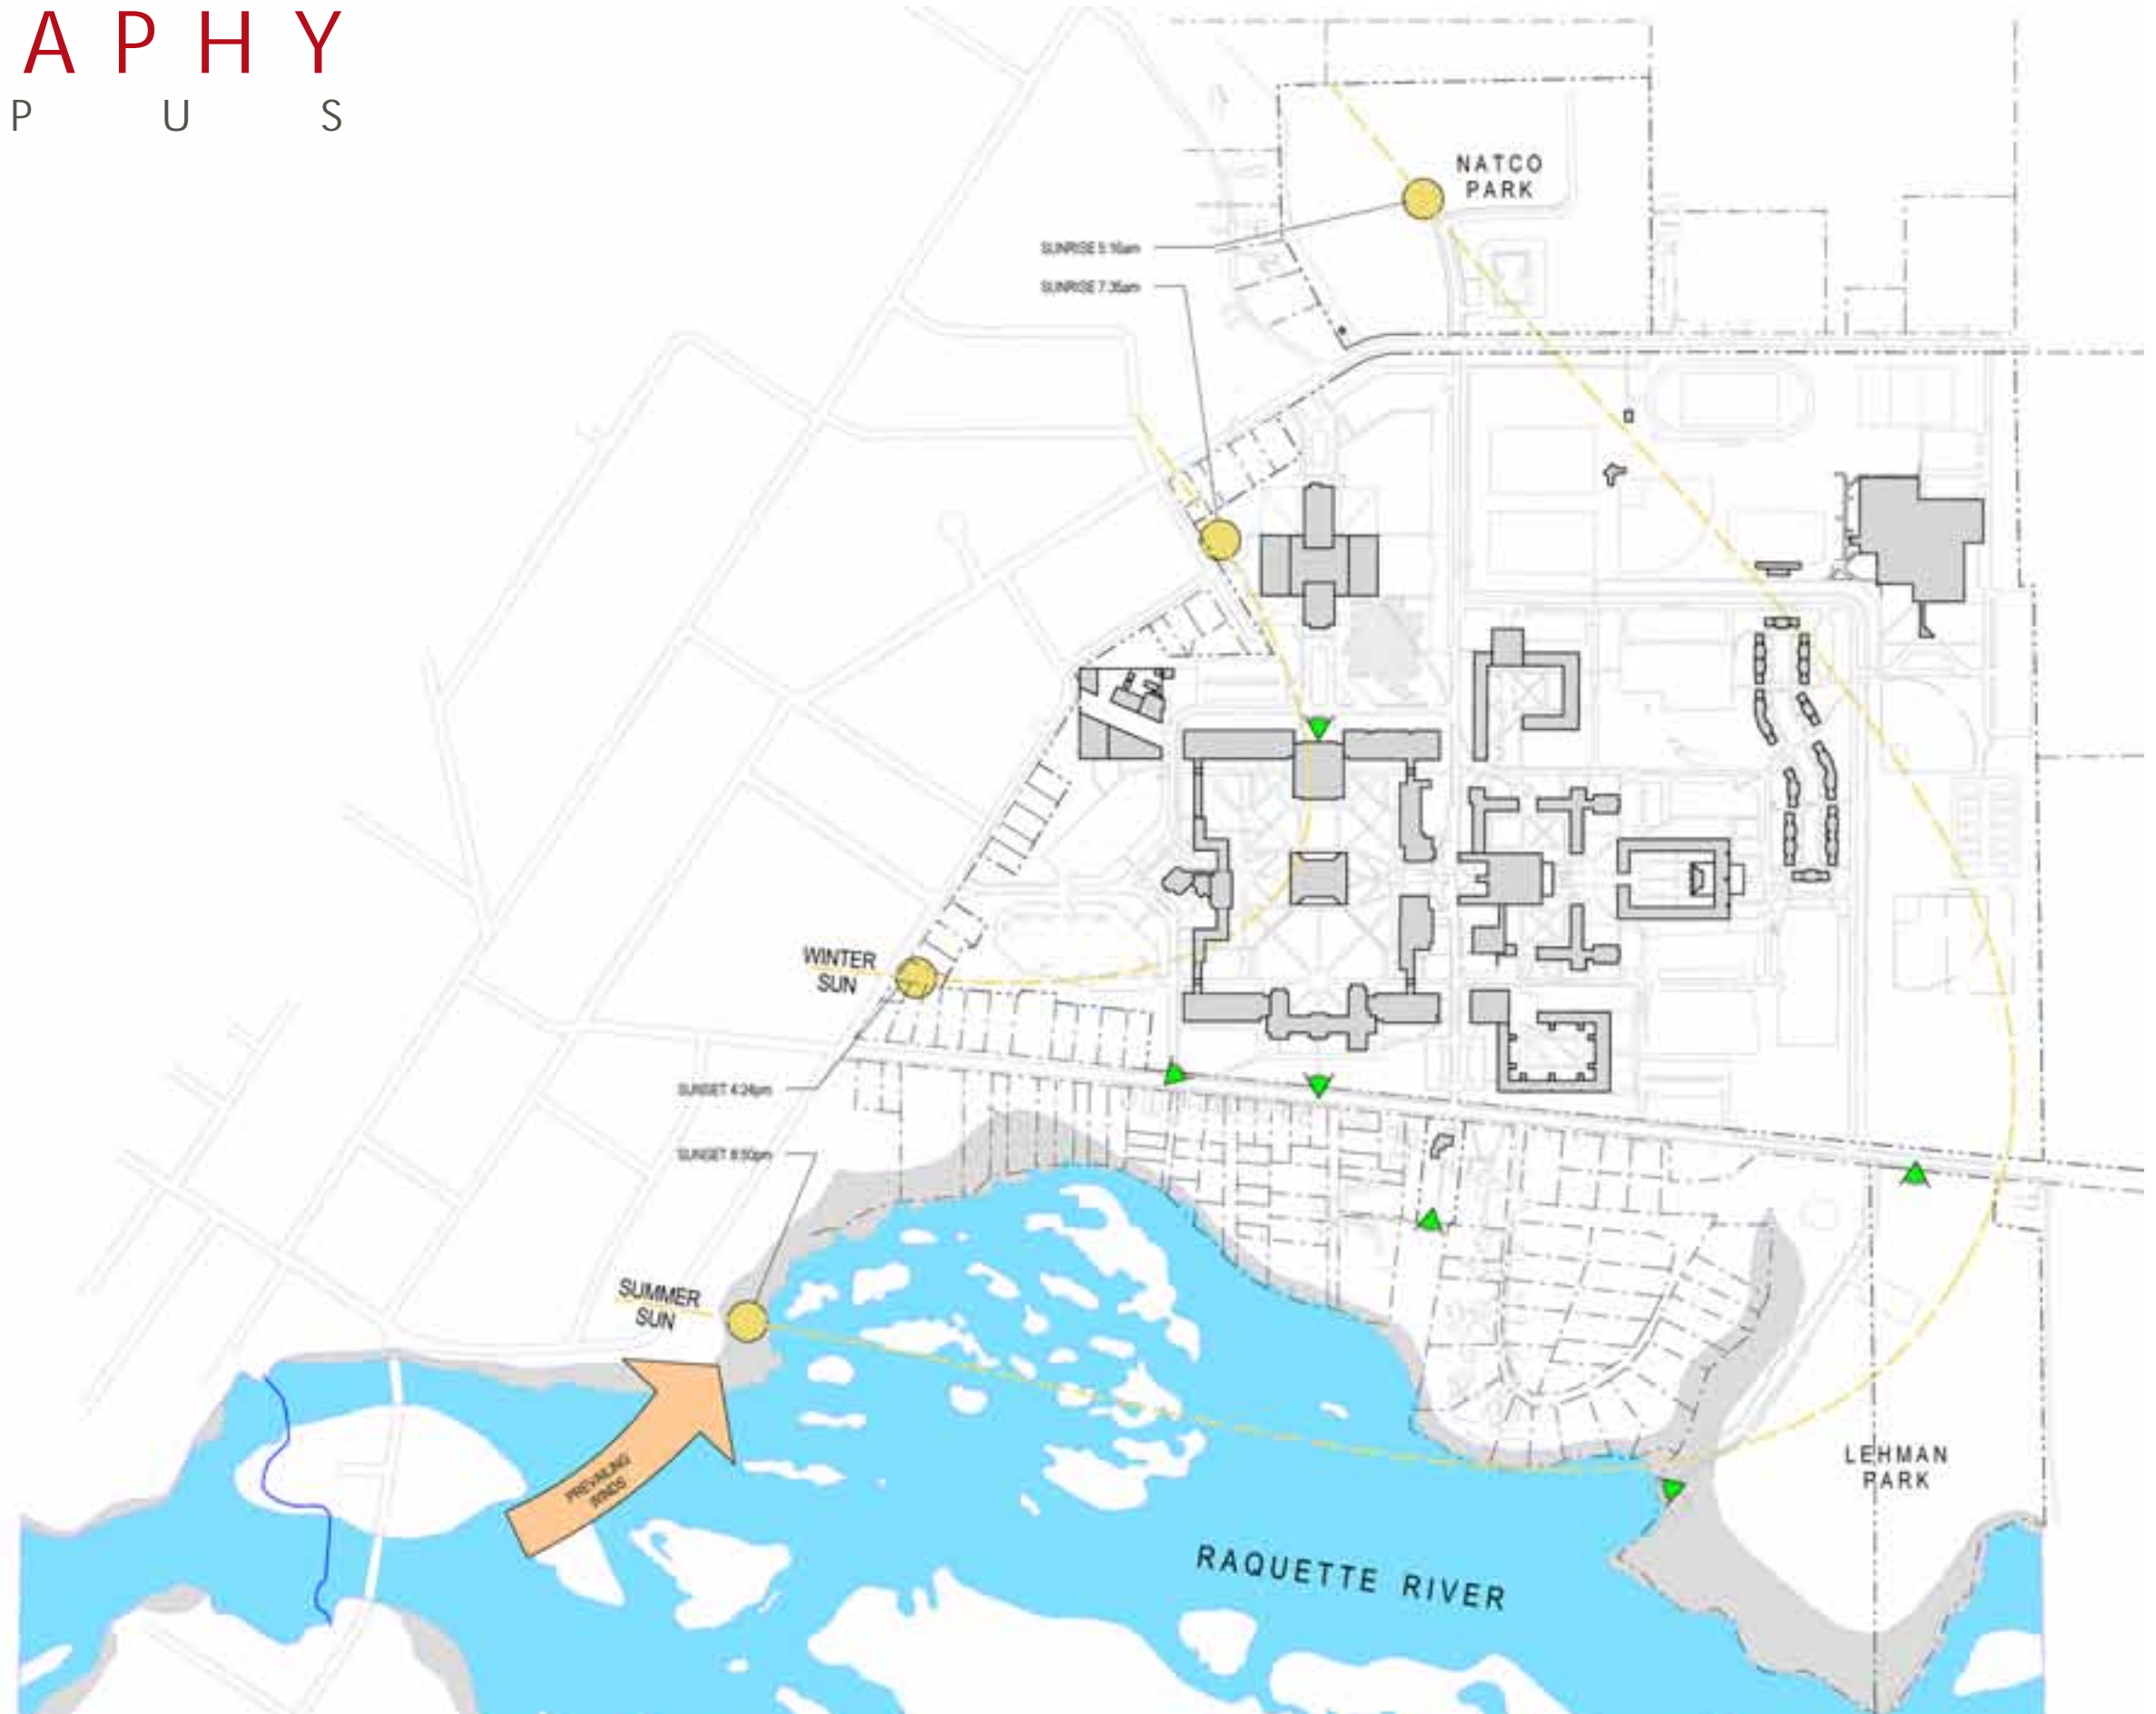
# PHYSICAL CONDITIONS

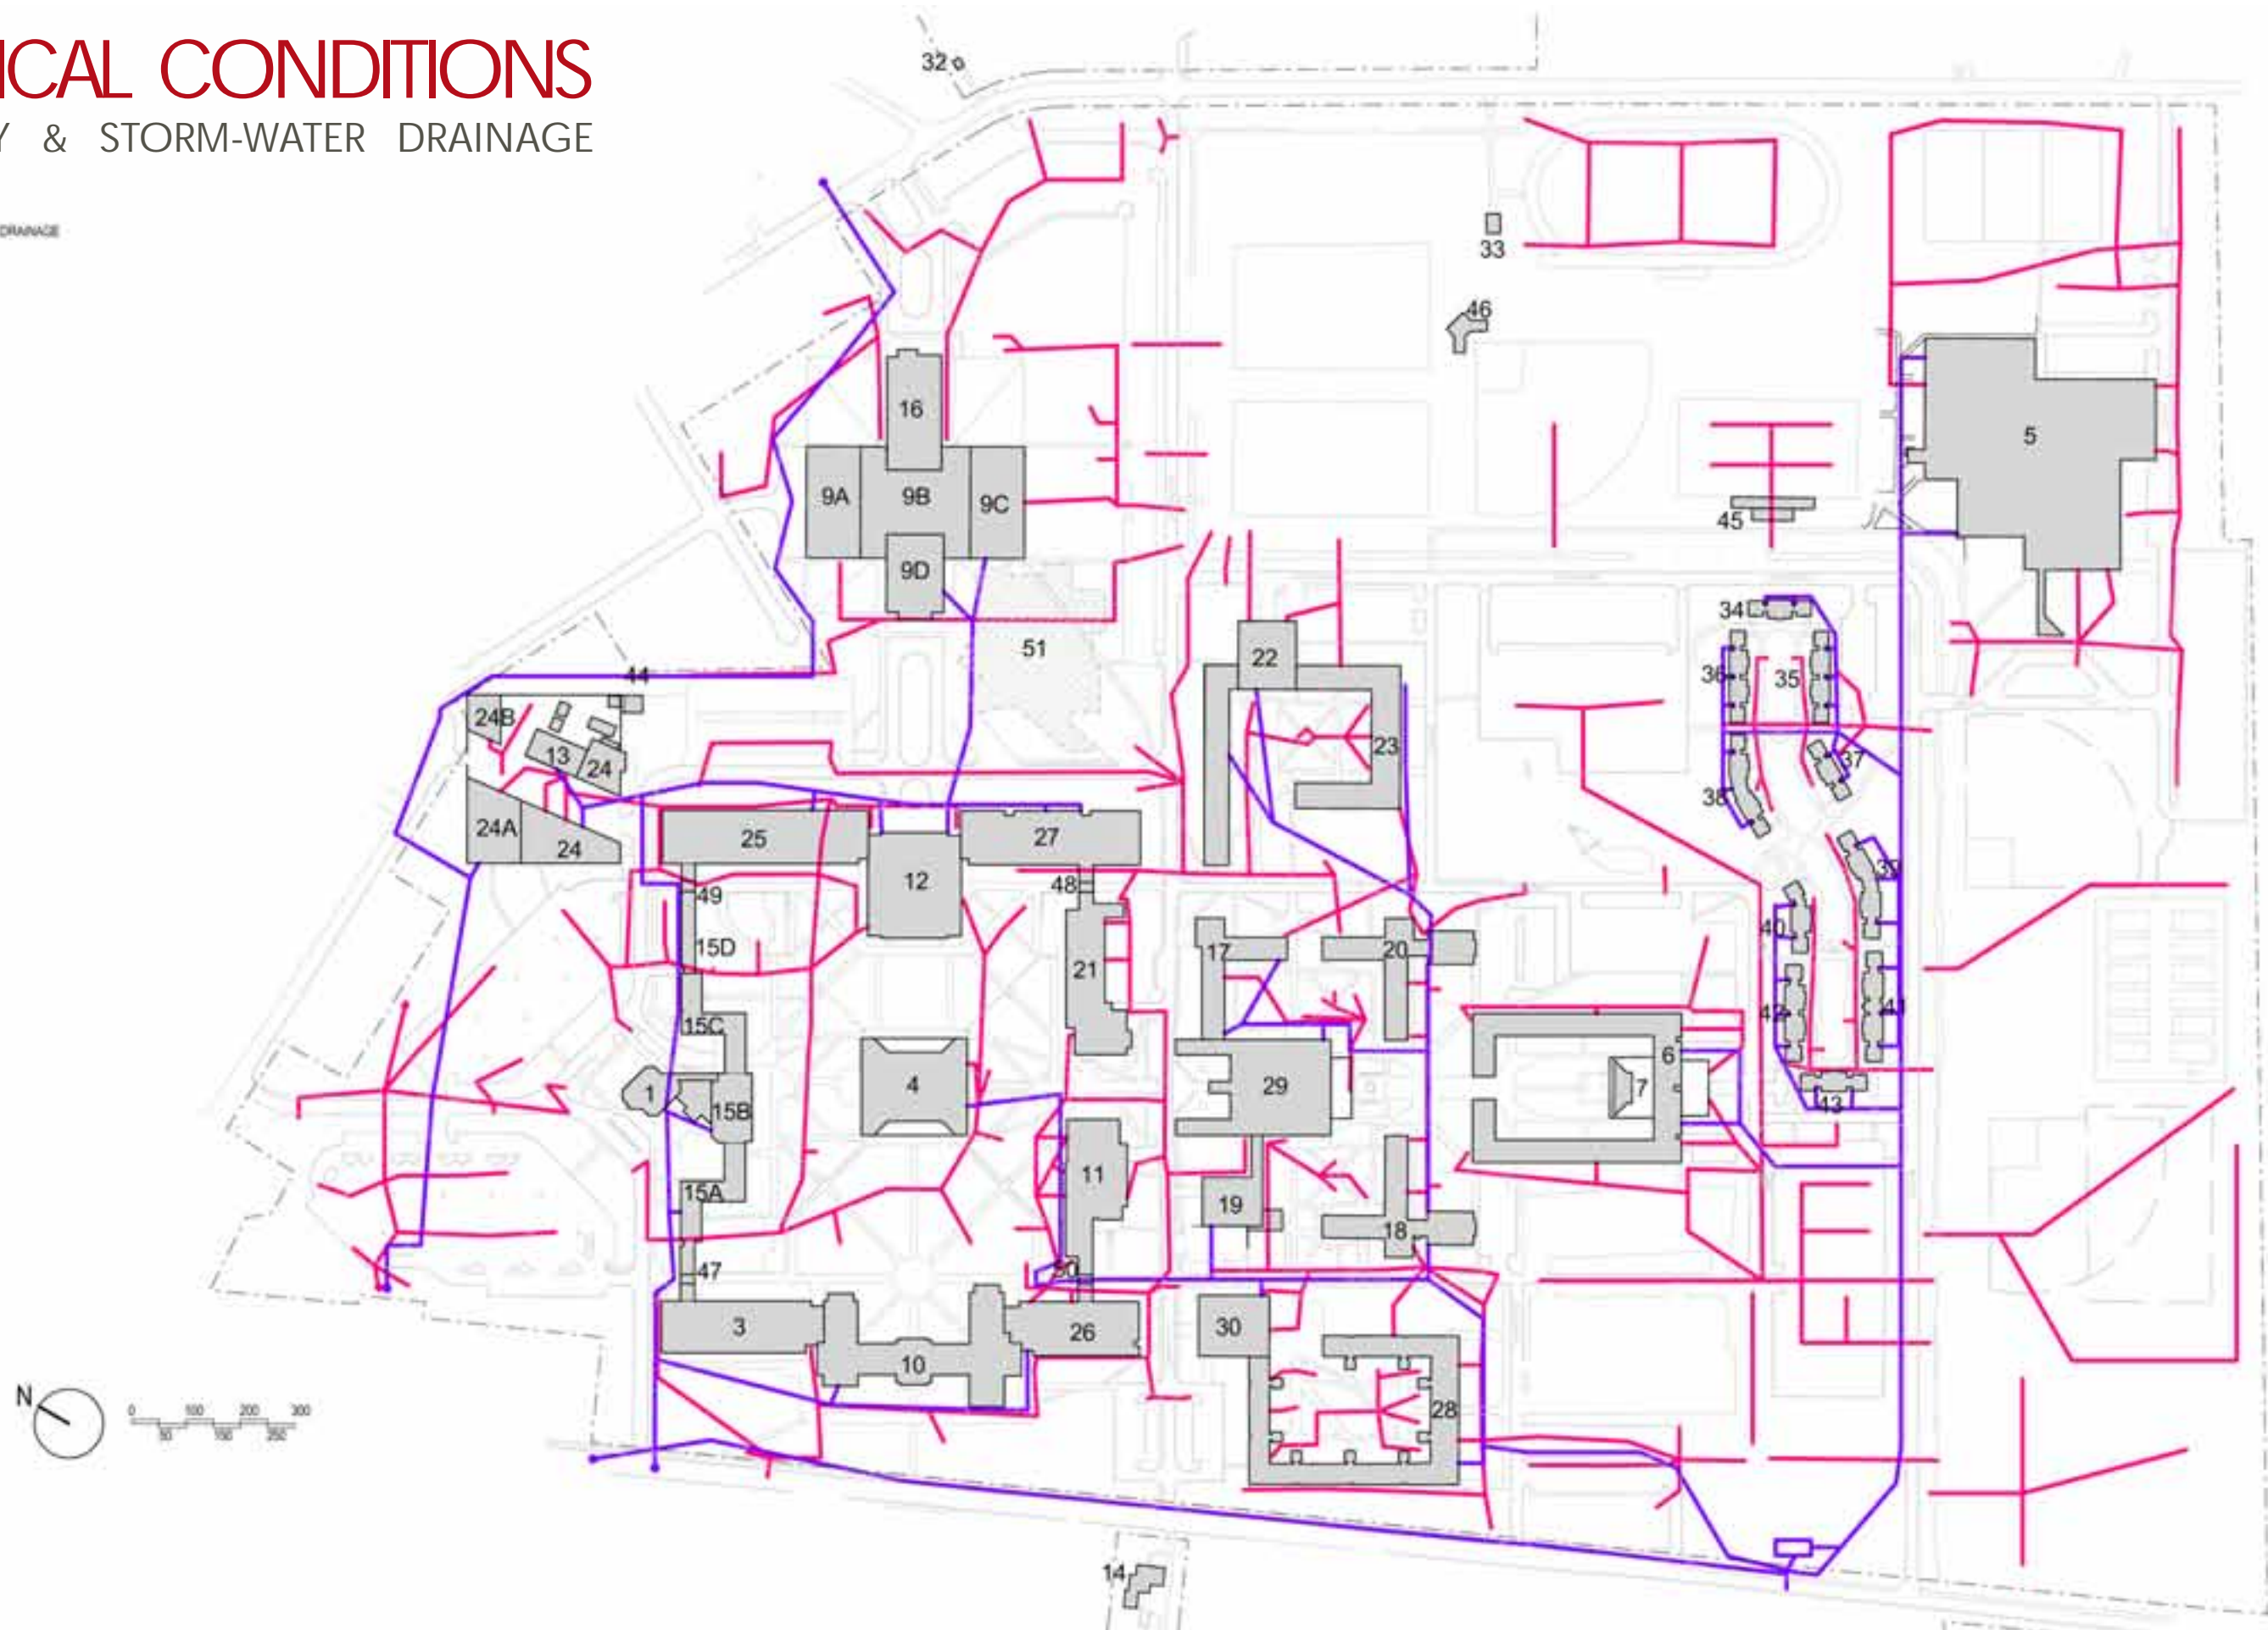
# PHYSICAL CONDITIONS

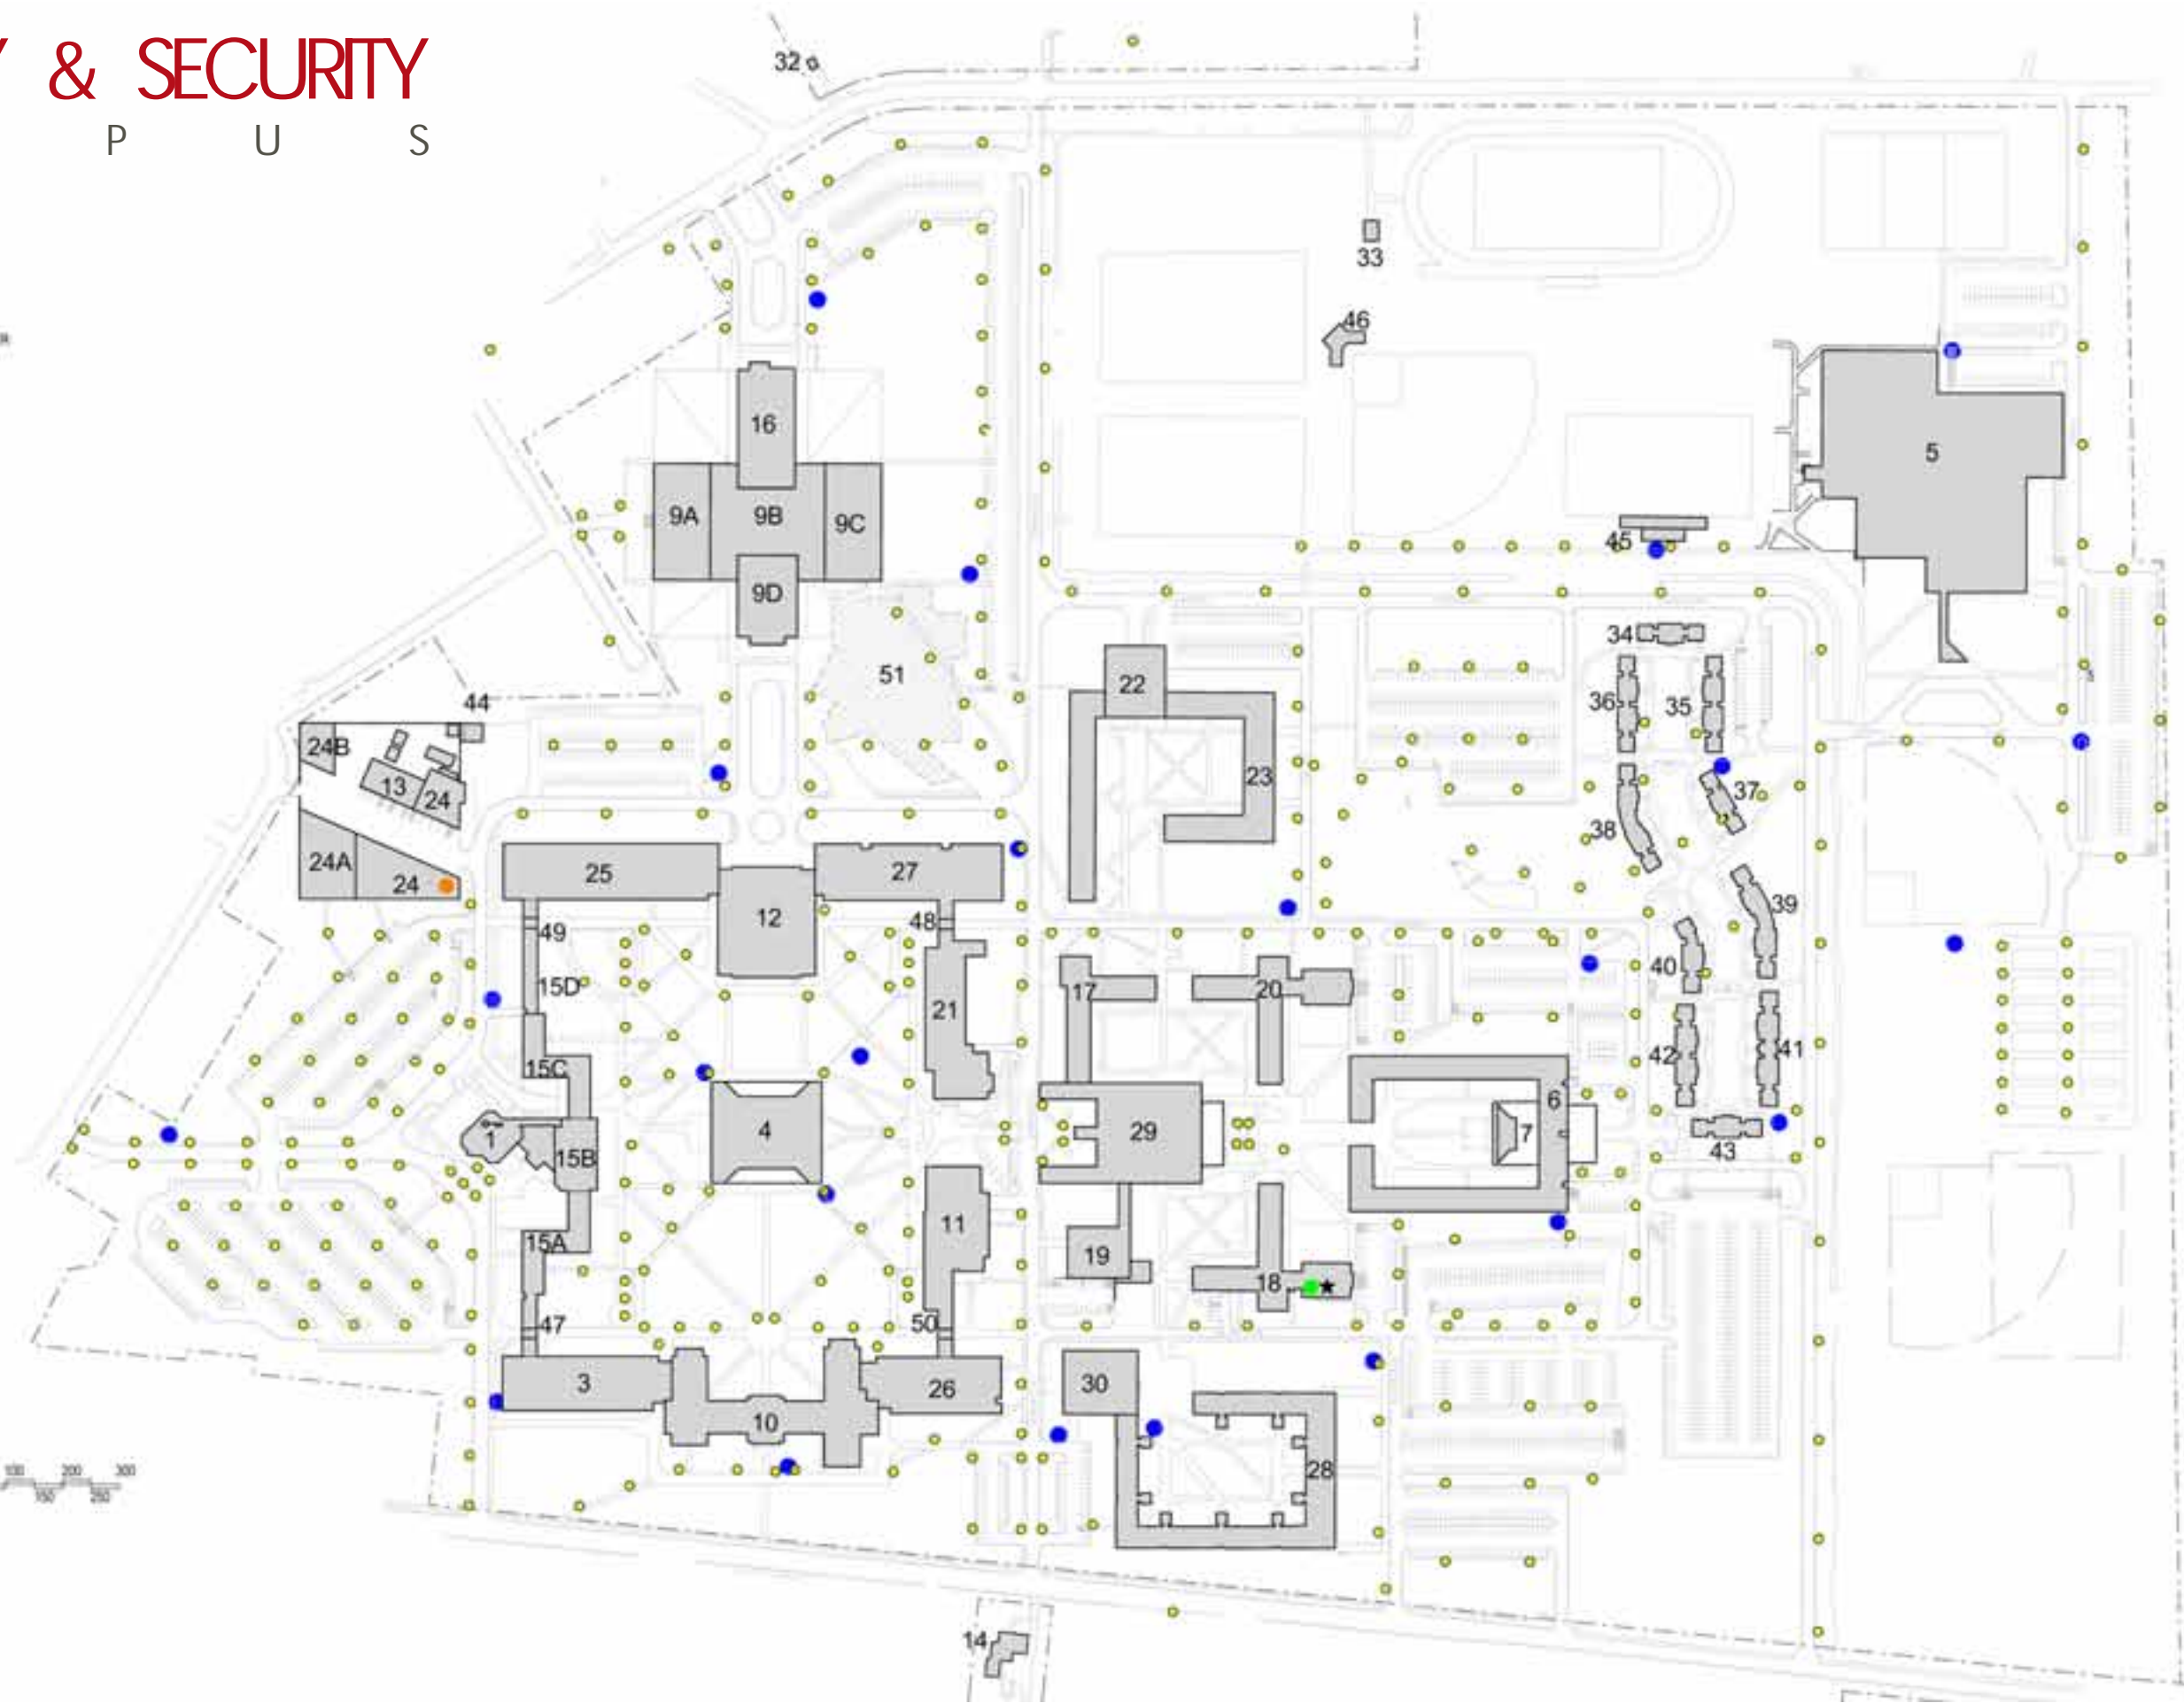
ASSESSMENT OF CONDITIONS

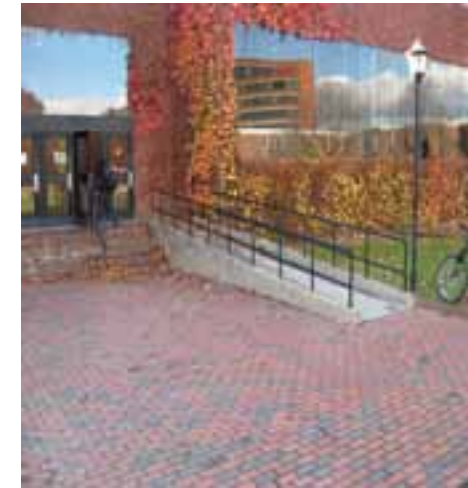
RAMP OUTSIDE OF FLAGG HALL

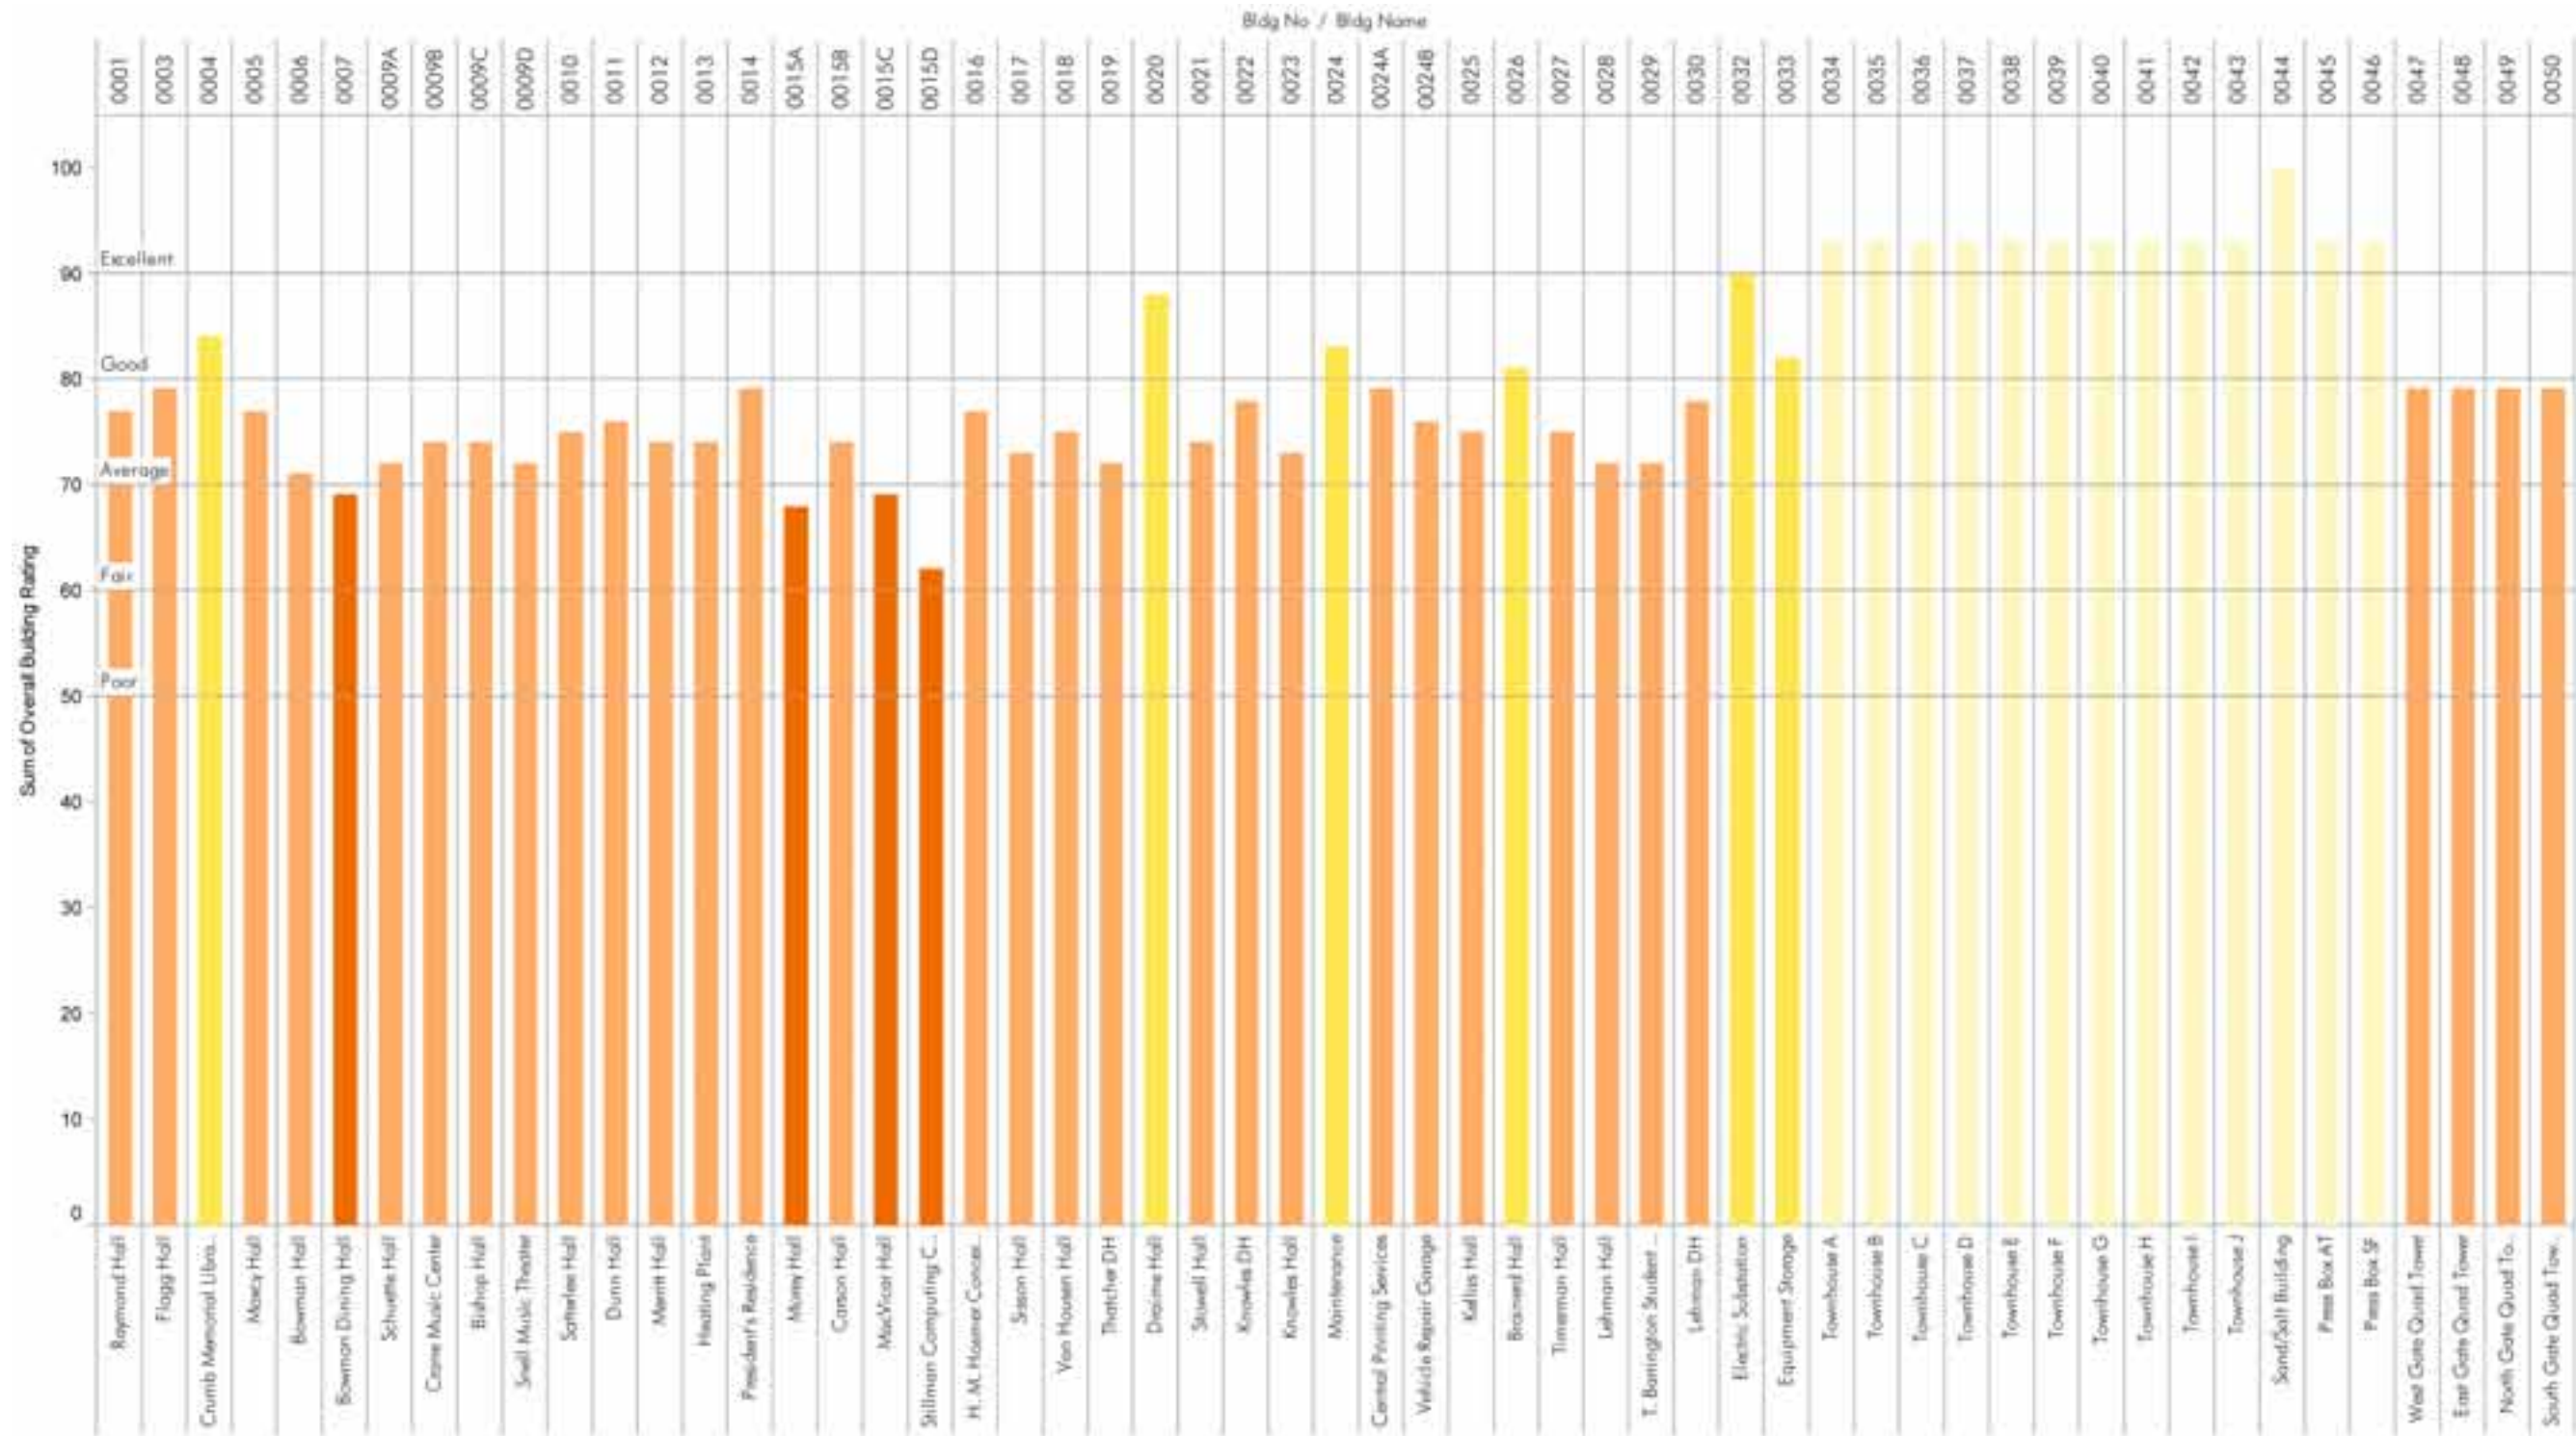
OVERALL BUILDING RATINGS BAR CHART

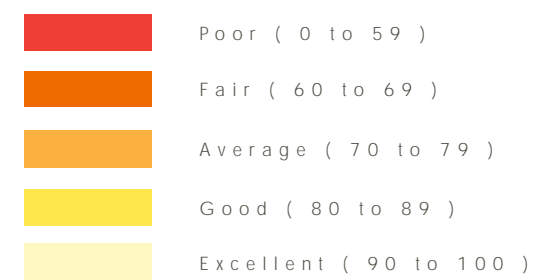
# O V E R A L L R A T I N G

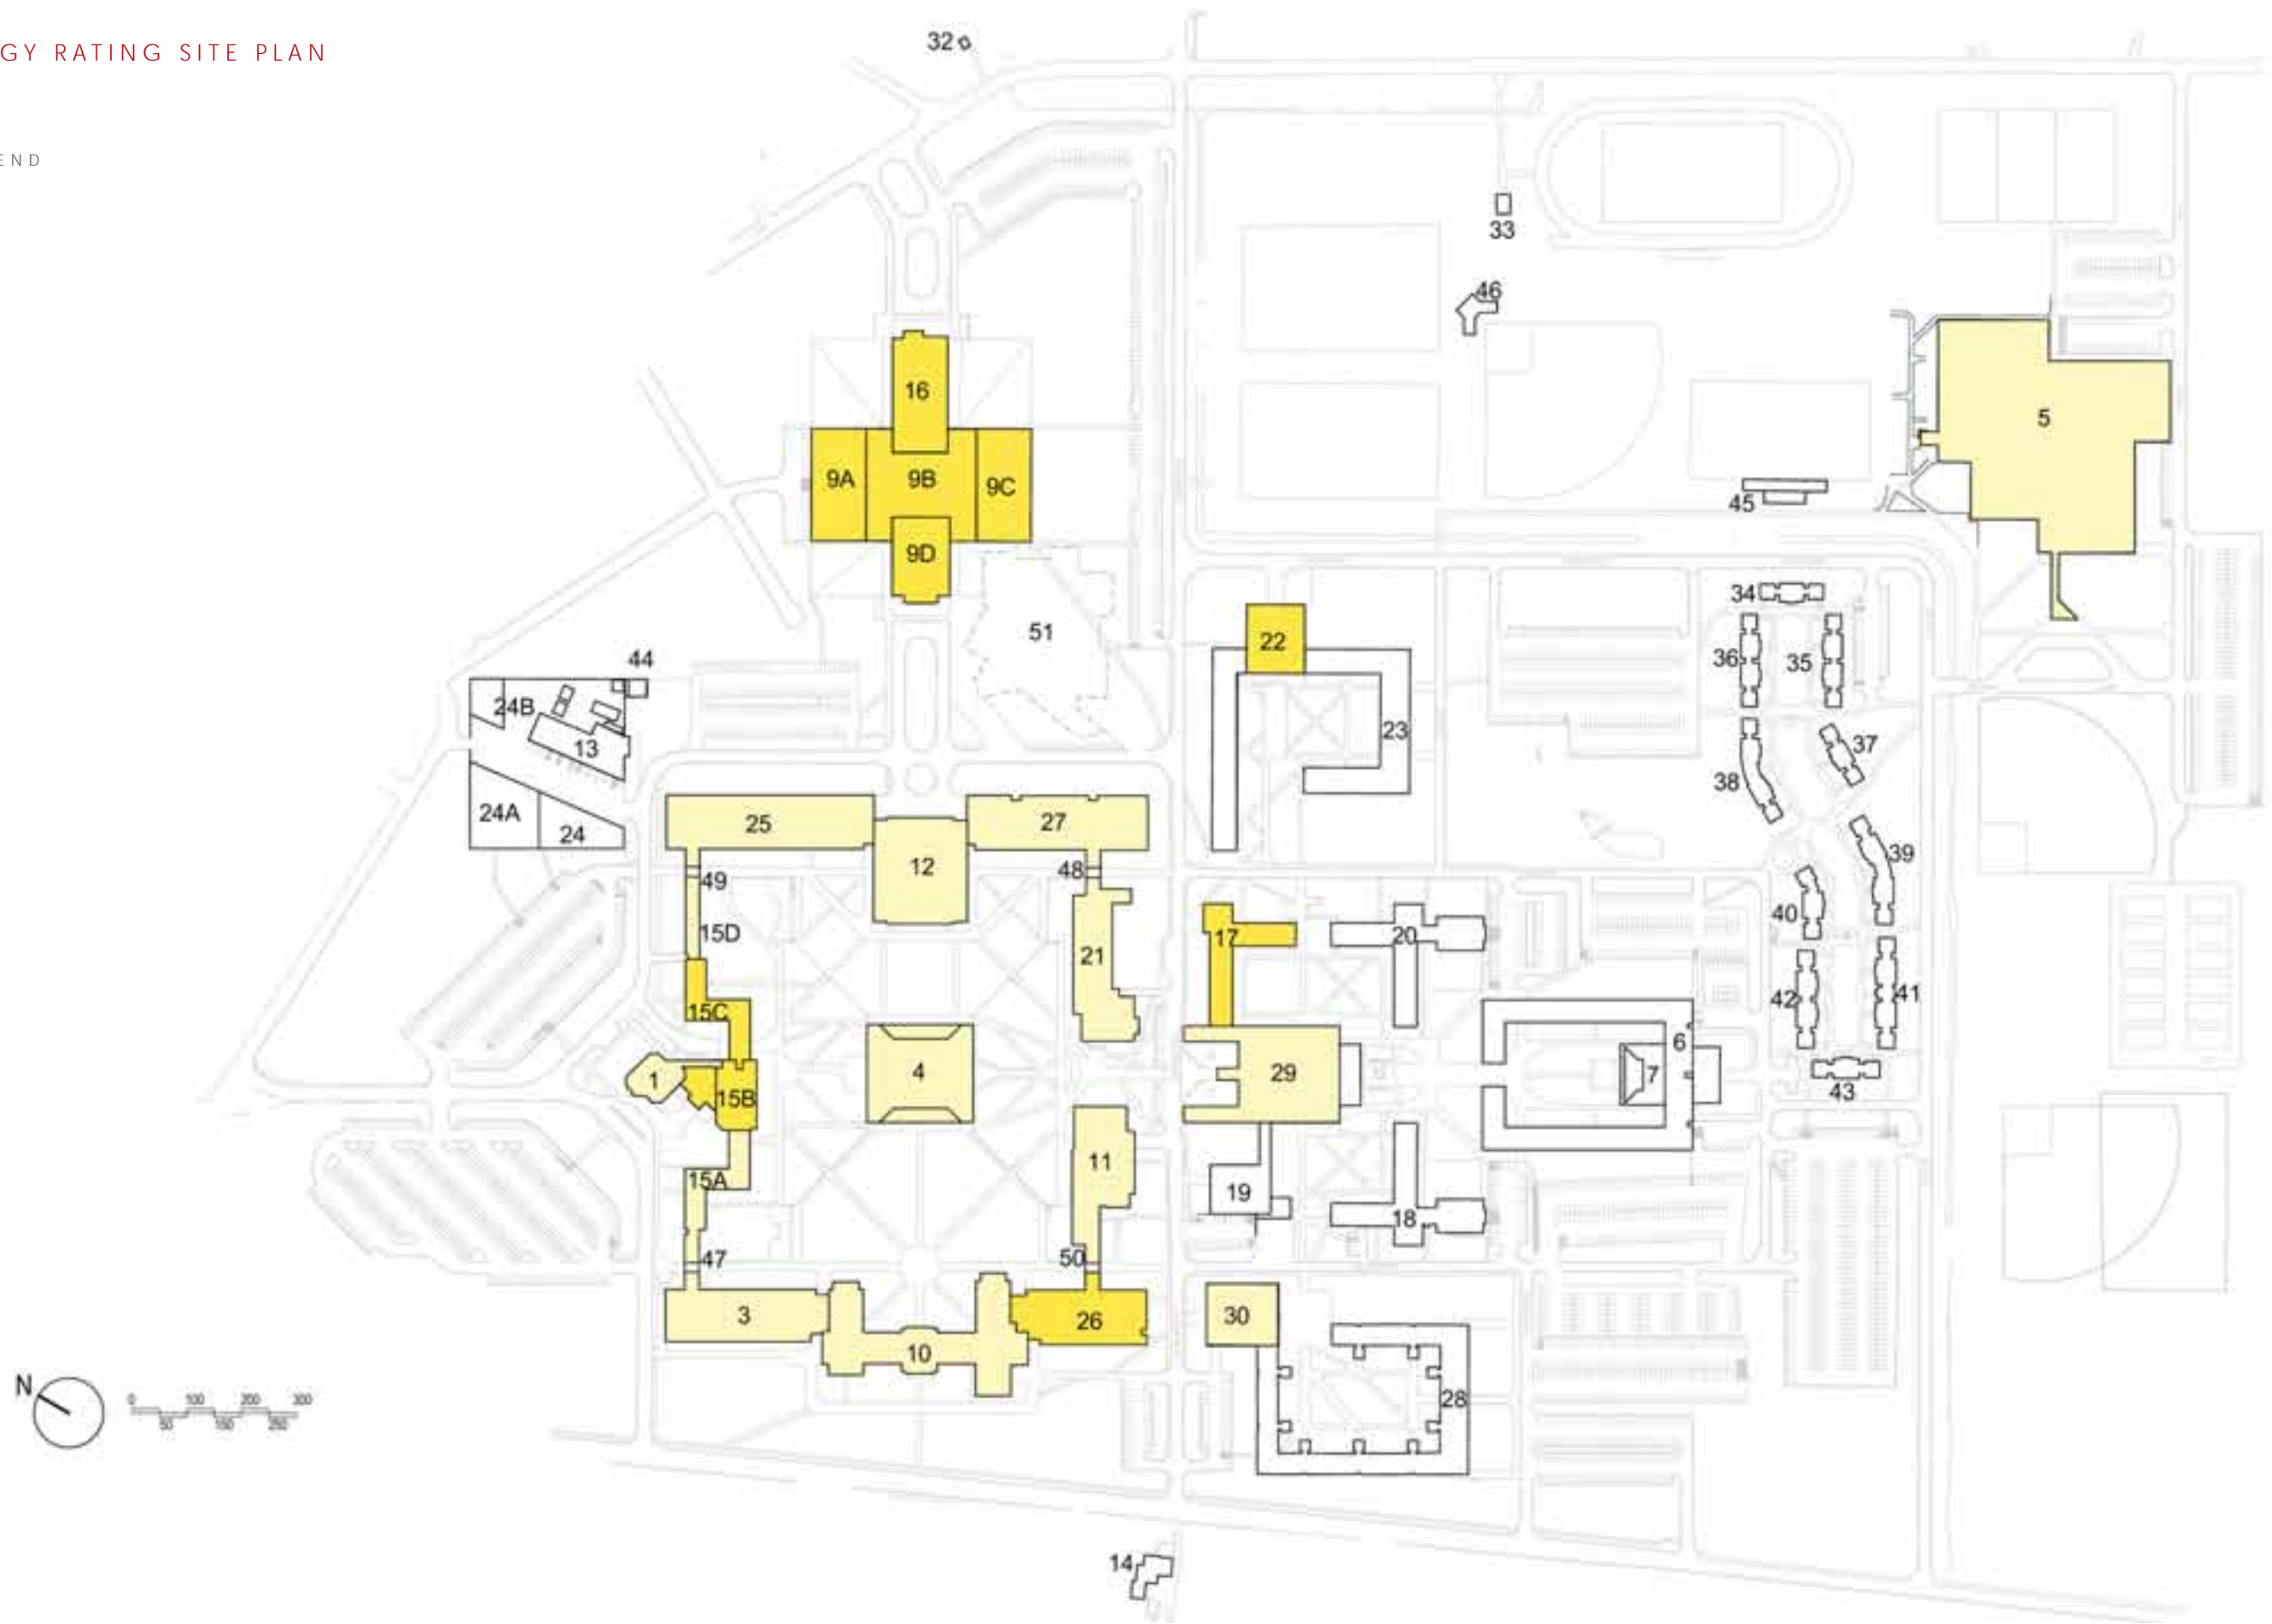
FACILITIES MASTER PLAN  
**BUILDING**  
**CONDITION**  
BUILDING SHEETS

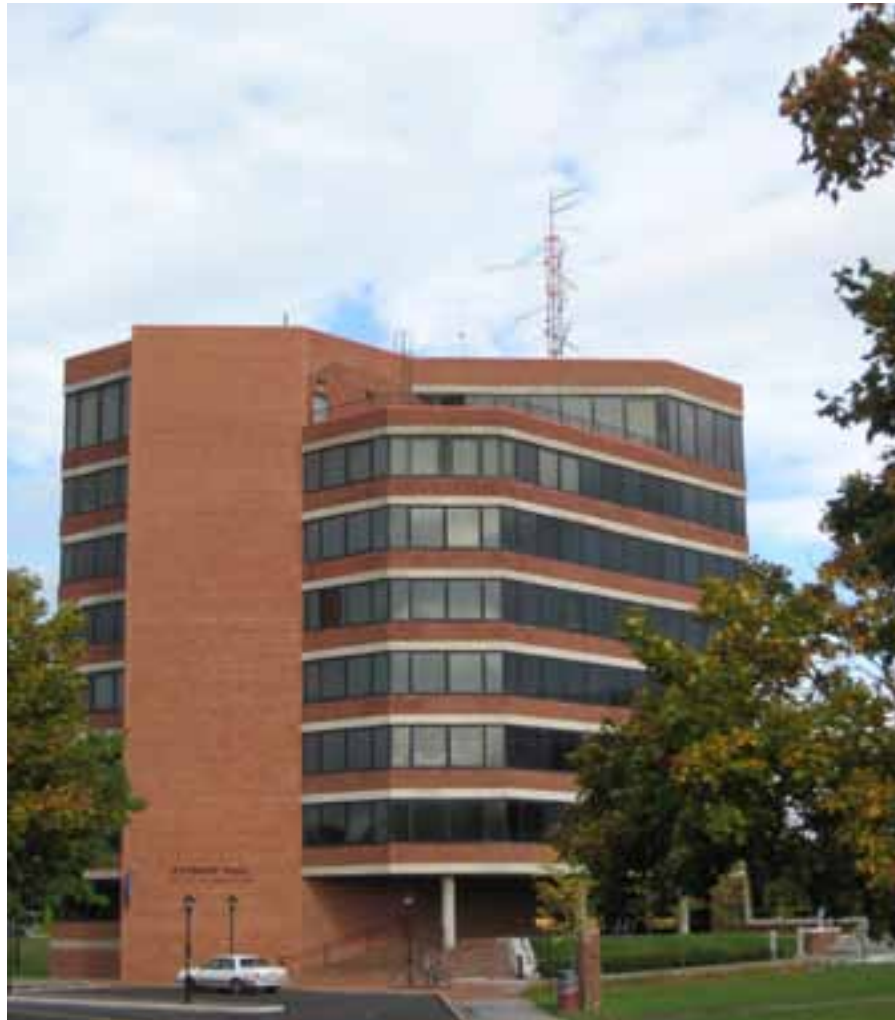
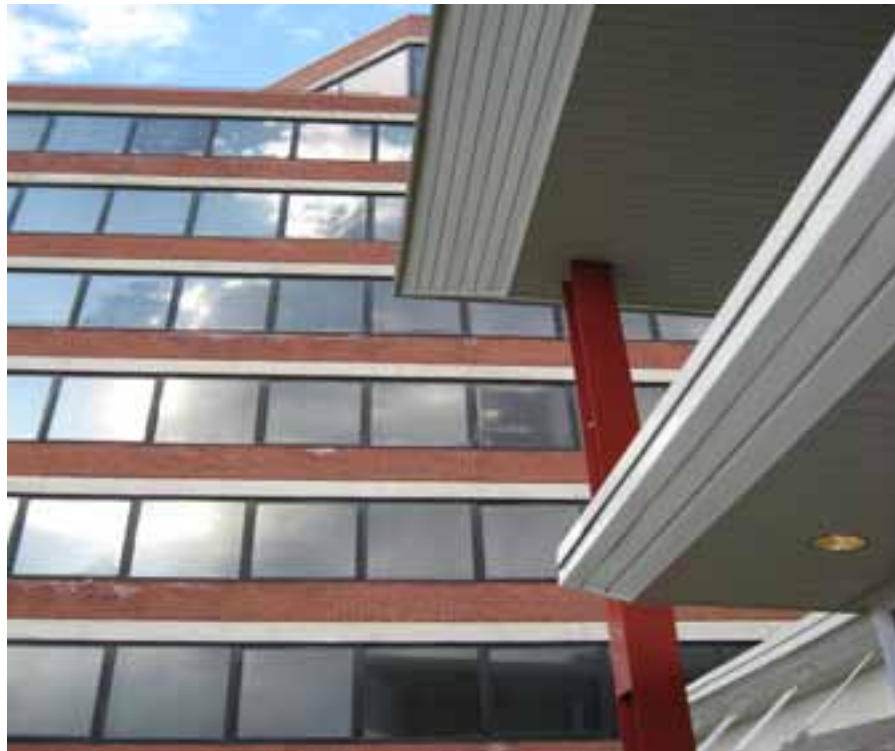
ASSESSMENT OF CONDITIONS

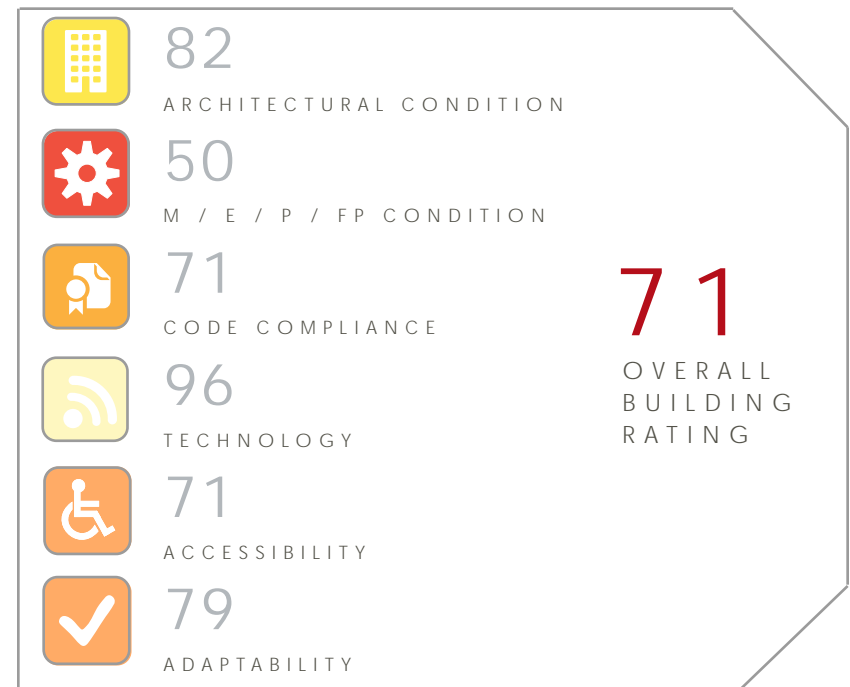
**BUILDING SUMMARY** Constructed in 1971 and originally intended to function as an administrative building, Raymond Hall serves as the main entry to campus for most visitors and houses some, but not all, student services. Raymond's relatively small floor plate prohibits the facility from becoming a classroom facility.

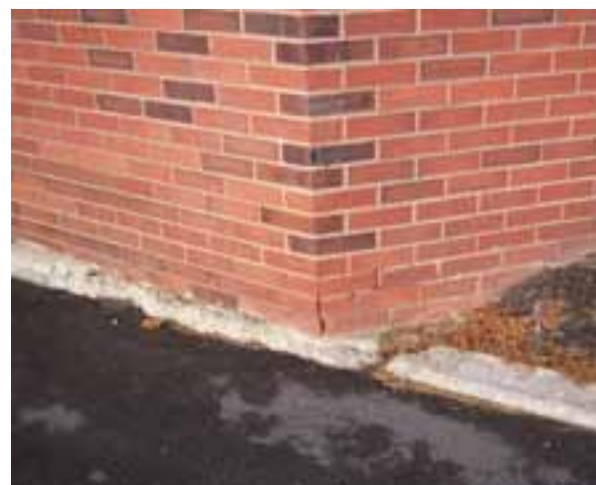
CRACKS IN EXTERIOR BRICK WALL

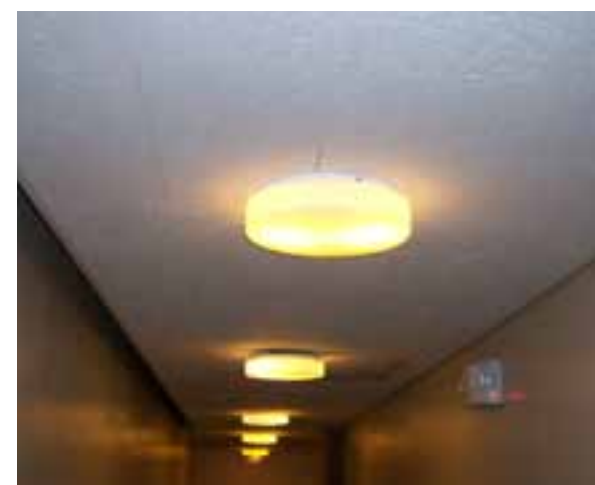
OVERALL THE INTERIORS ARE IN GOOD CONDITION.

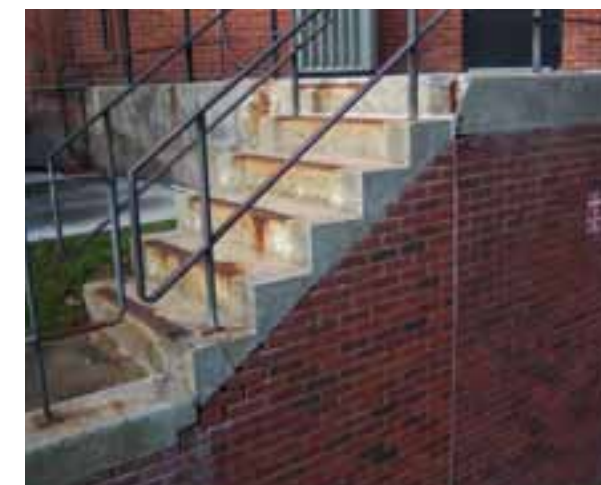
THE PAVED ACCESS STAIR AND LANDINGS HAVE CRACKS DUE TO WATER PENETRATION AND THE USE OF MELTING SALT.
