“BEING MORE THAN A COLLECTION OF INDIVIDUALS, SUNY POTSDAM IS A COMMUNITY DEDICATED TO THE PURSUIT OF COMMON GOALS.”

- SUNY POTSDAM PLEDGE

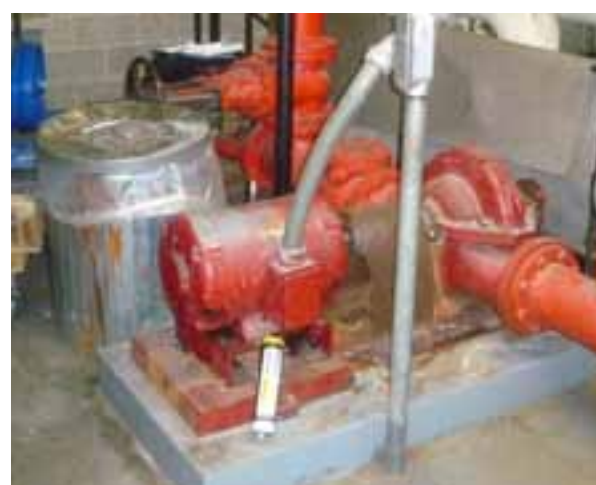
THE PAVED ACCESS STAIR AND LANDINGS HAVE CRACKS DUE TO WATER PENETRATION AND THE USE OF MELTING SALT.

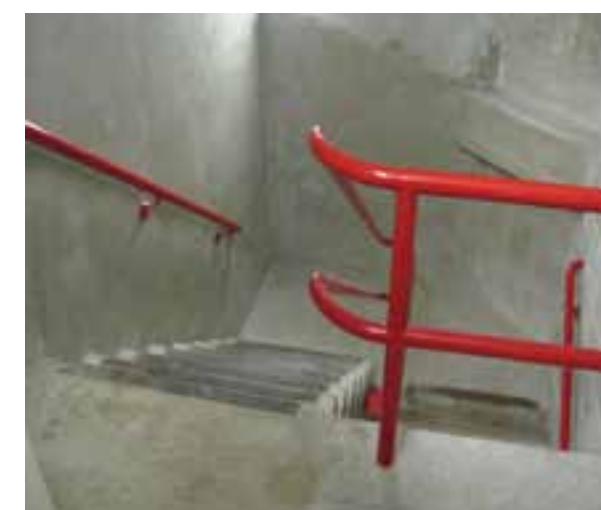
THE STAIRWELLS ARE TOO NARROW AND ARE MISSING GUARDRAILS AND PICKETS.

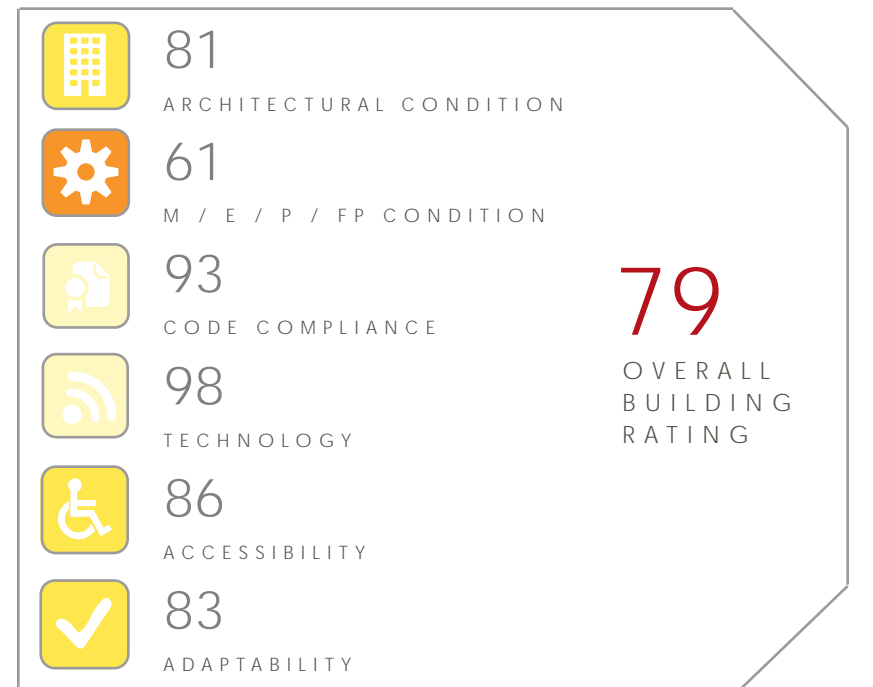
**BUILDING SUMMARY:** Flagg Hall was constructed in 1967. The building currently serves as a workhorse classroom building for the campus. Similar to Brainerd Hall, Flagg Hall is organized with a one-third/two-thirds double-loaded corridor layout. Faculty offices are located along the narrow zones, while large classrooms are situated along the wide bands. A small corridor located along the upper floor wide band contains small, specialized research laboratories and an audiology center. The building's steel structural system allows for interior retro-fit.

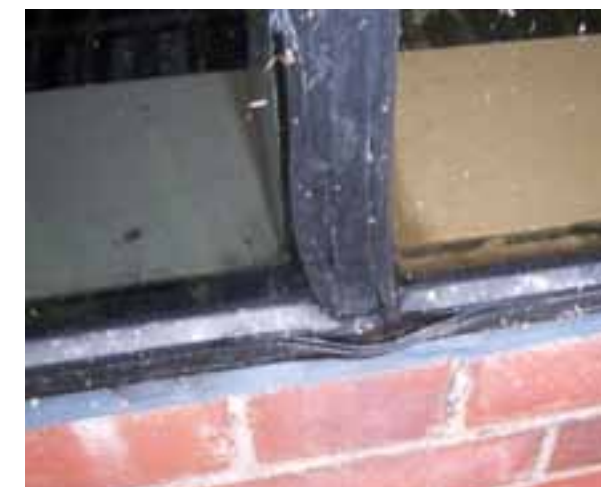
WINDOW FRAME IN POOR CONDITION

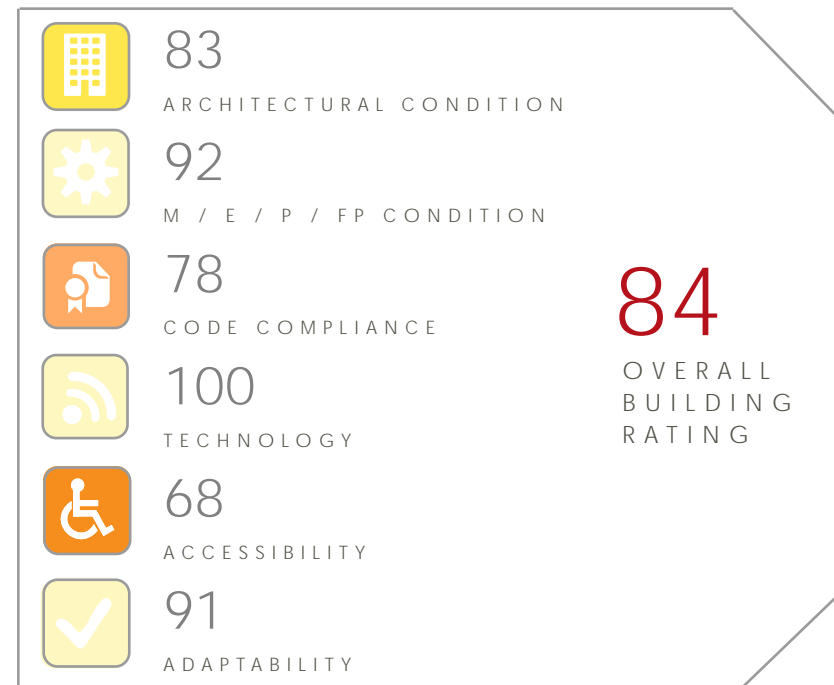
**BUILDING SUMMARY** Crumb Library, constructed in 1967, is the focal point of the academic quad. This important location is justified by Crumb's programmatic use as a library. Overall, the building is in good condition.

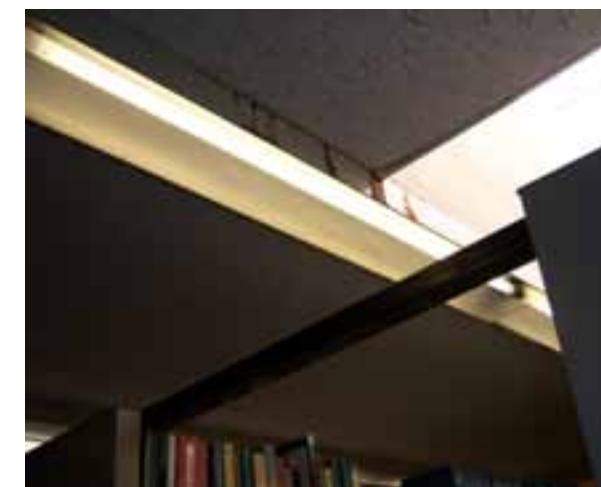
WATER LEAK AT SKYLIGHT.

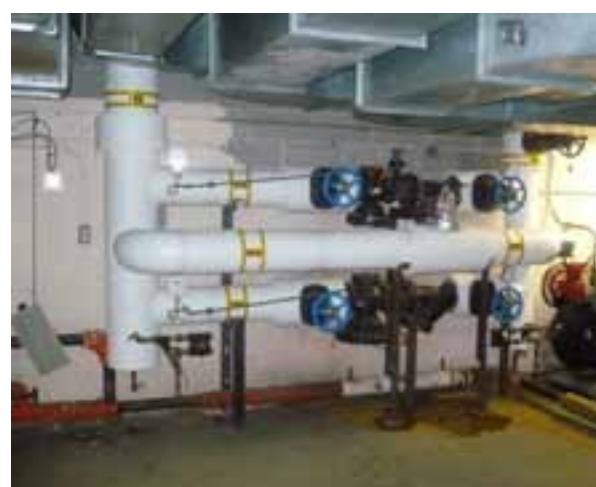
HIGH PRESSURE STEAM ENTRANCE AND PRESSURE REDUCING STATION

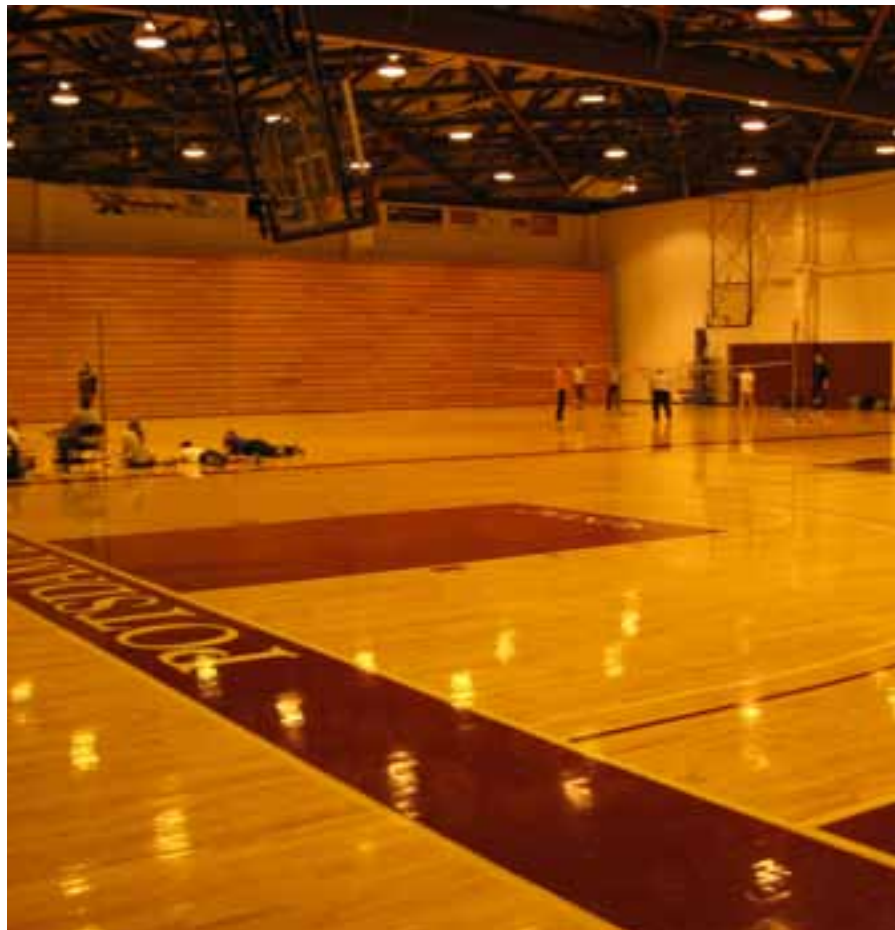
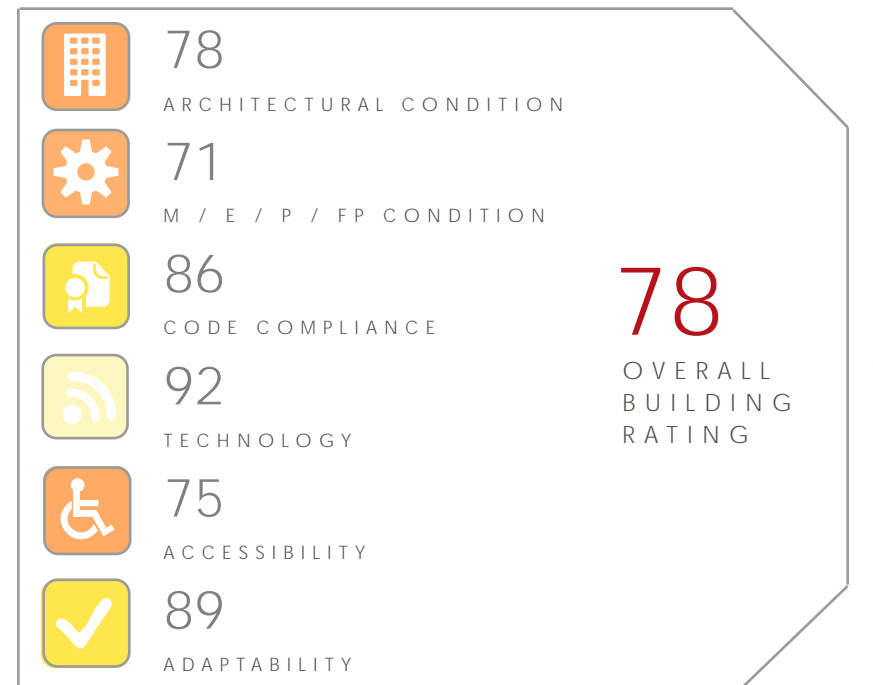
**BUILDING SUMMARY** Maxcy Hall was constructed in 1972 as the campus' athletic facility. The facility consists of large, open-span spaces for athletic functions. The athletic facility has some exterior envelope issues and is in need of some interior maintenance repairs. The air systems serving many spaces in the facility need to be addressed. The current use of the building is appropriate; and is not conducive to any other use.

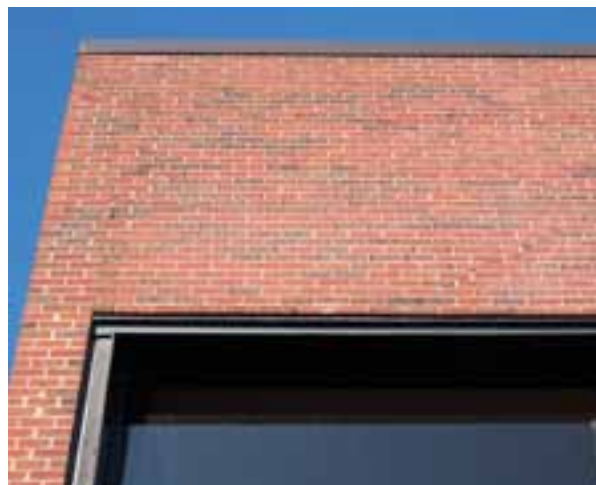
CRACKS IN EXTERIOR MASONRY.

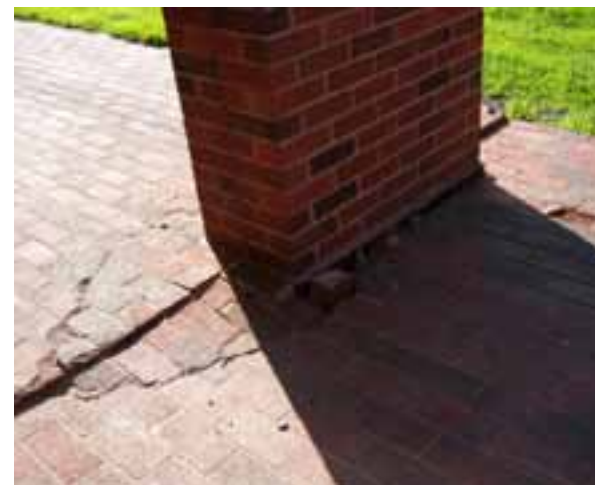
THE PAVING ADJACENT TO THE BUILDING IS IN POOR CONDITION.

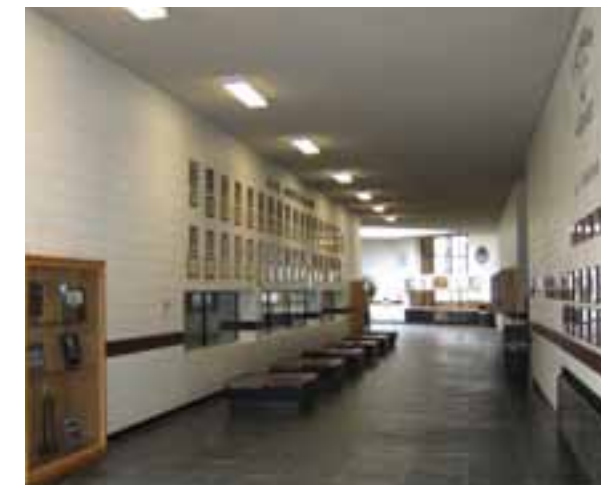
THE INTERIOR OF THE BUILDING APPEARS TO BE IN GOOD CONDITION.

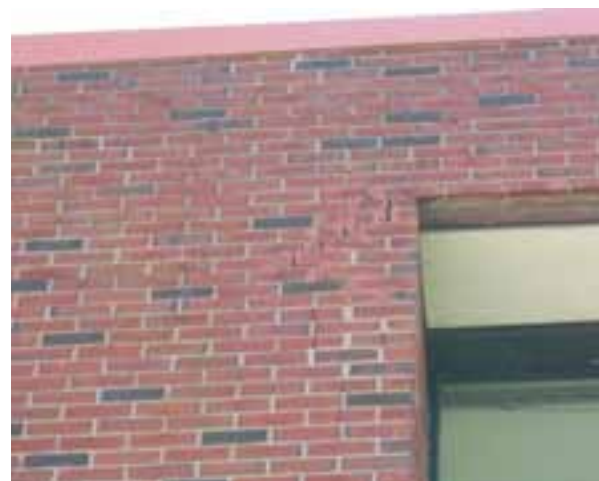
DETERIORATING MASONRY JOINTS.

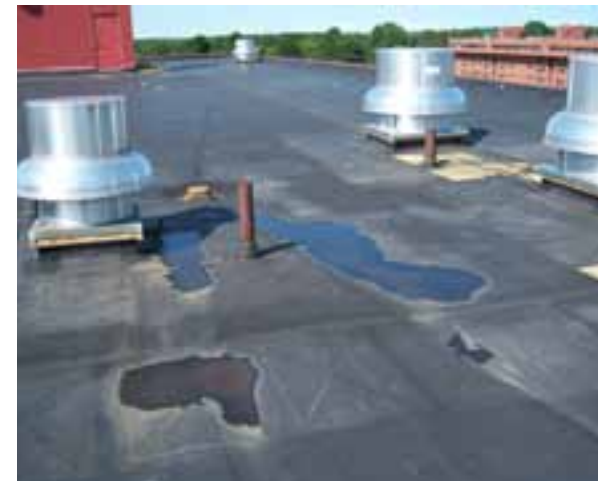
HIGH ROOF HAS MANY PATCHES AND THERE IS SOME PONDING IN AREAS

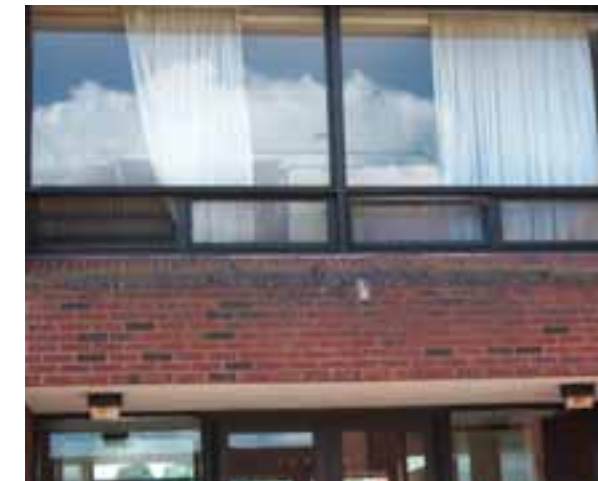
EXTERIOR ENVELOPE MASONRY STAINING.

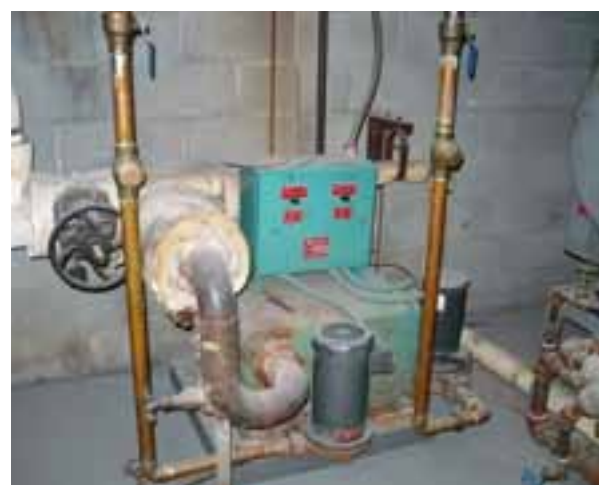
CONDENSATE TANK AND PUMPS

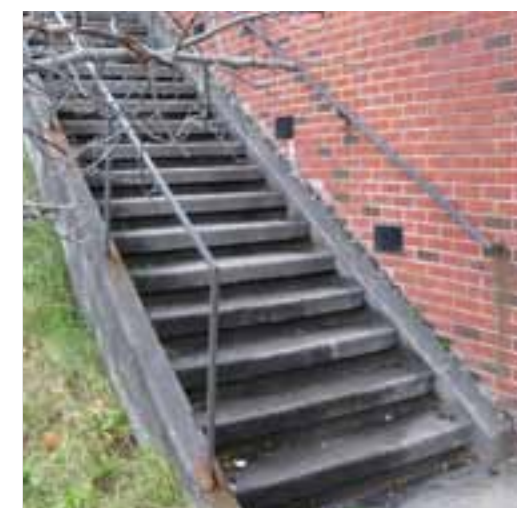
THE EXTERIOR RAMP IS MISSING HANDRAIL EXTENSIONS.

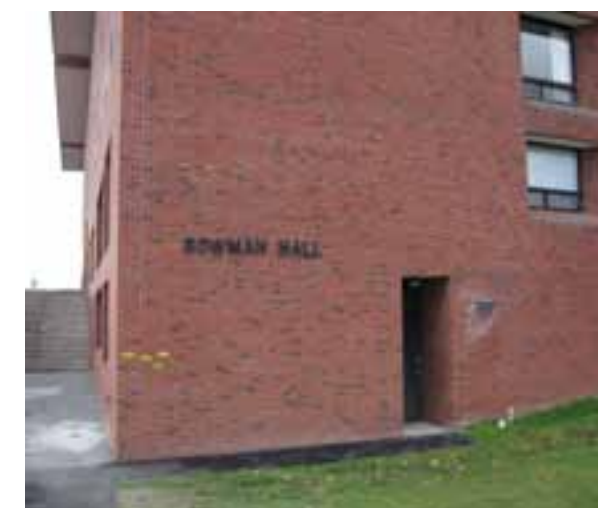
EXTERIOR ENVELOPE MASONRY STAINING.

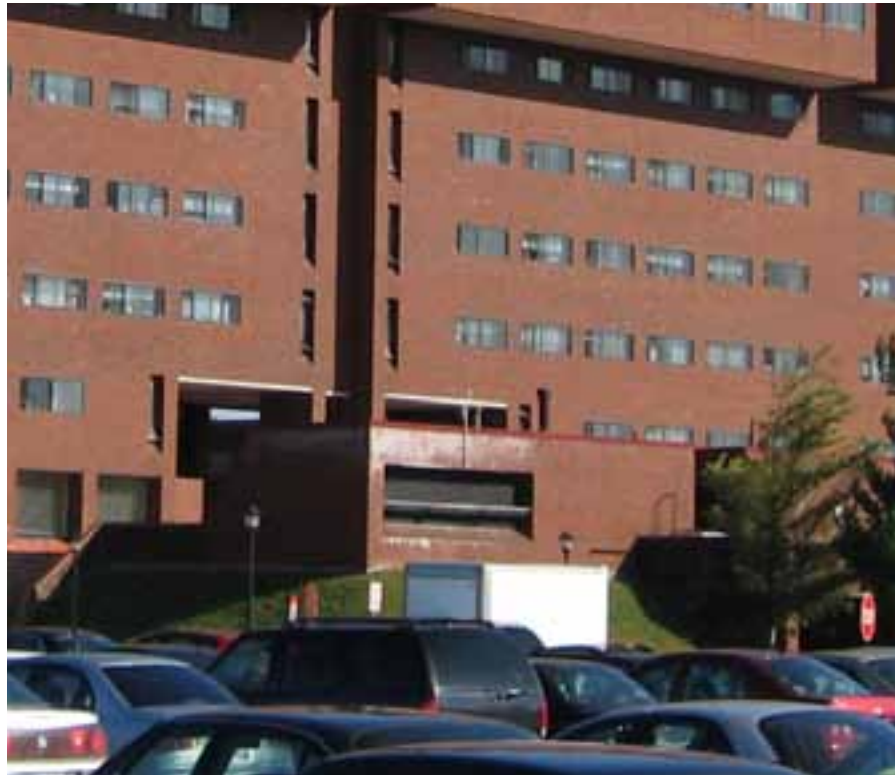
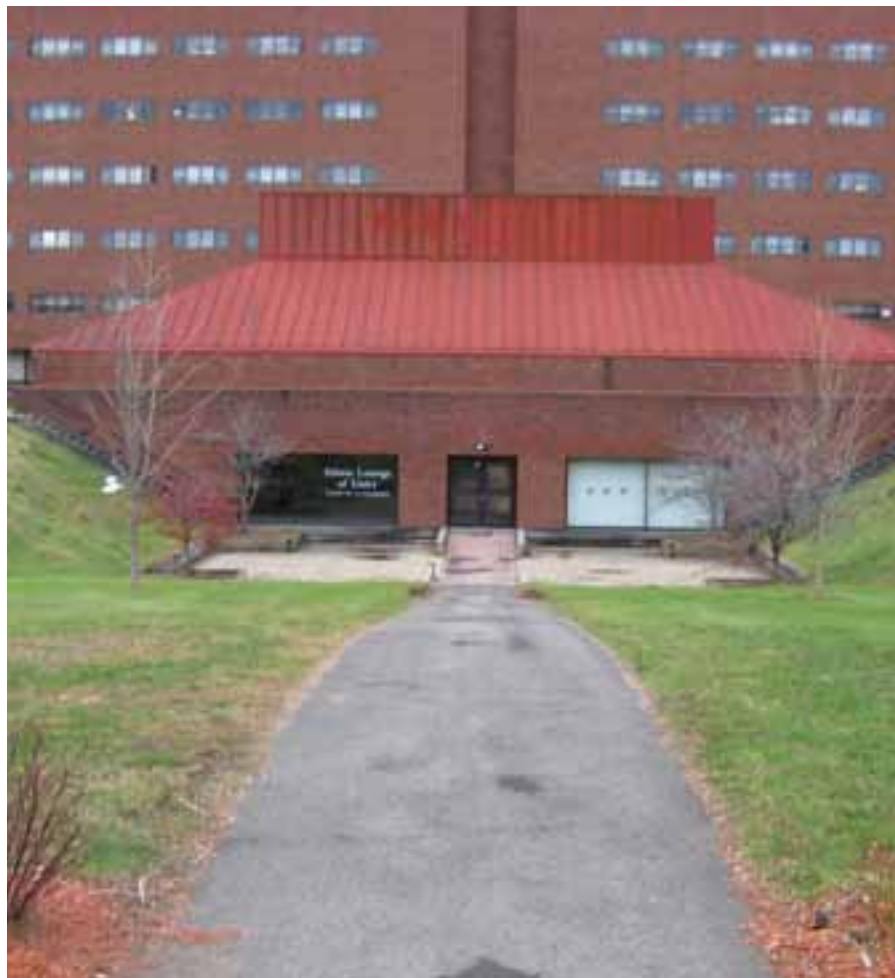
# BOWMAN DINING HALL

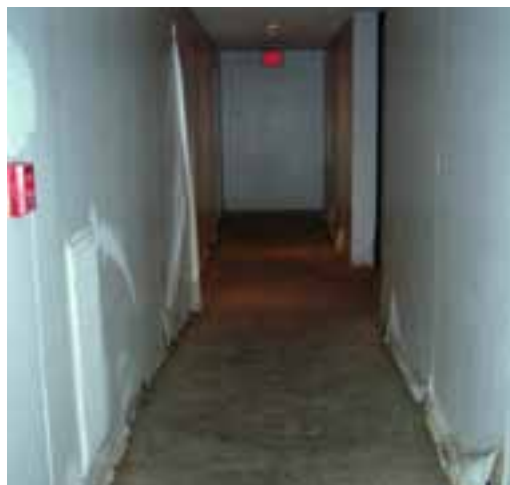
SUBSTANTIAL WATER DAMAGE TO INTERIOR WALLS.

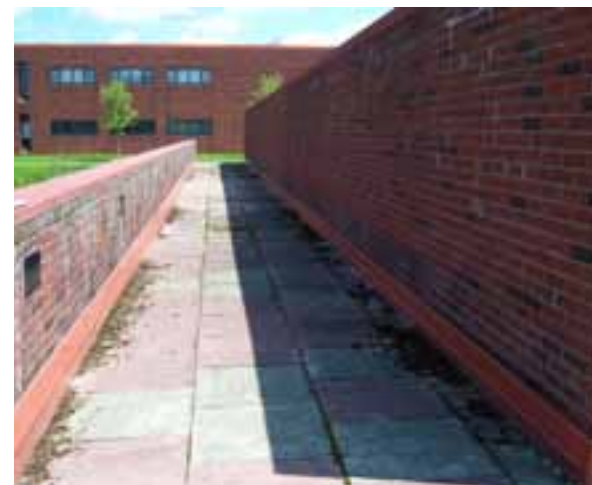
LOWER ROOF FORMS A PLAZA FOR BOWMAN HALL; IT IS FINISHED WITH PAVERS.

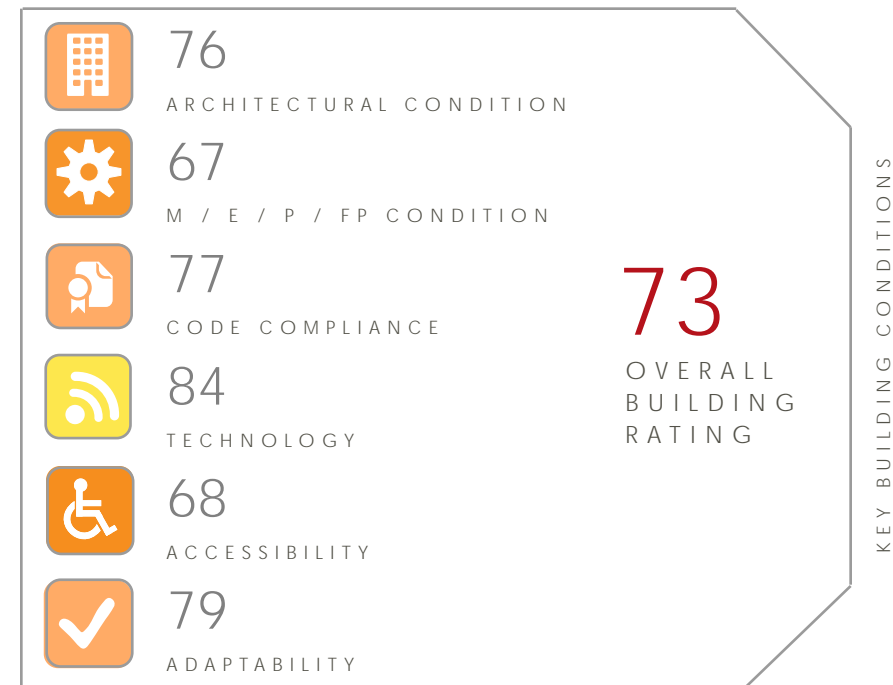
**BUILDING SUMMARY** Schuette Hall is an academic building dedicated to music education. The building is part of the larger Crane Complex. The facility effectively accommodates its academic functions. However, issues exist for both the building exterior and interior, particularly the mechanical system that need to be immediately addressed.

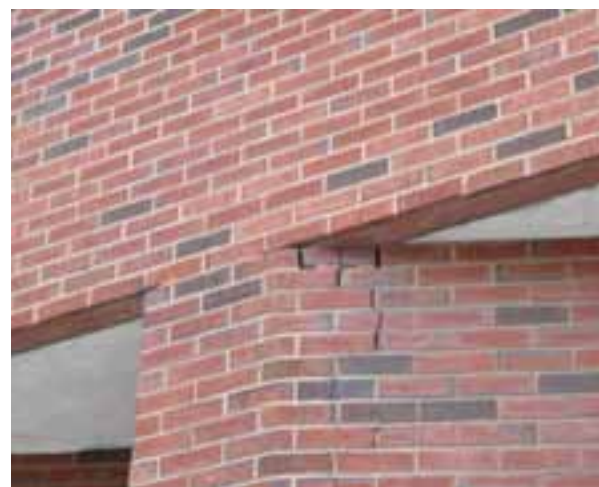
NUMEROUS FRACTURES OF THE MASONRY VENEER.

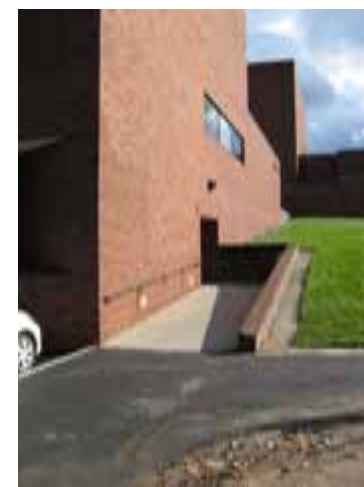
EXTERIOR RAMP DOES NOT HAVE HAND-RAIL EXTENSIONS.

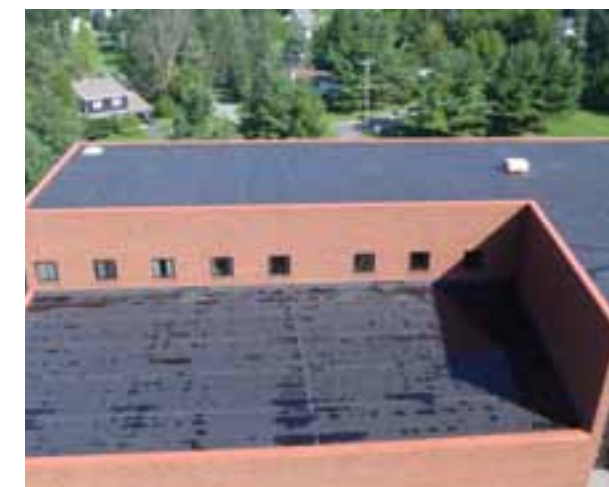
ROOF IS GENERALLY IN GOOD CONDITION.

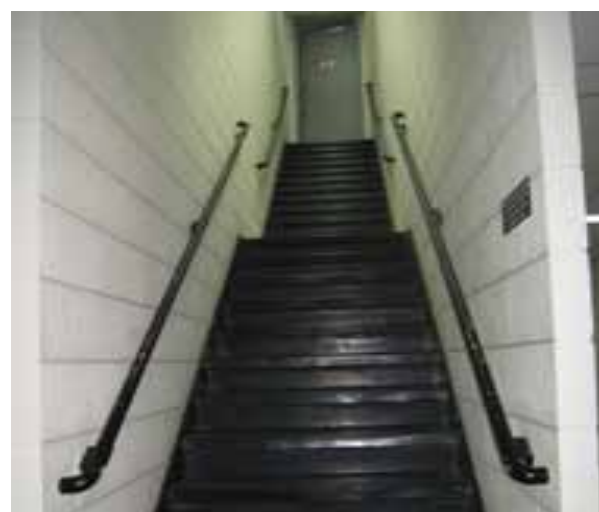
EGRESS STAIRWELLS WITH MISSING HANDRAIL EXTENSIONS.

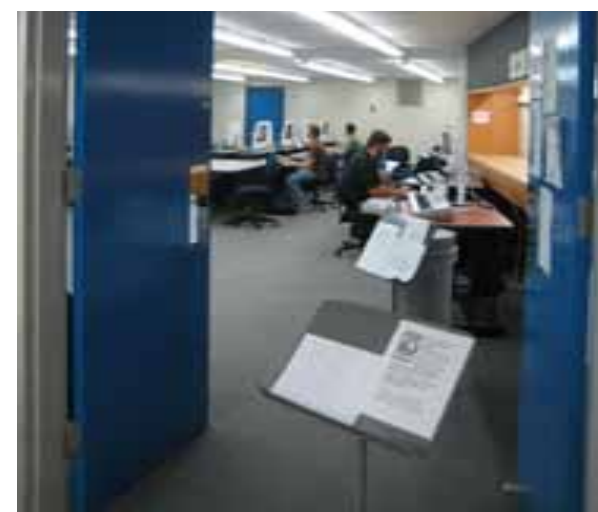
RECENTLY REFURBISHED COMPUTER LAB LOCATED IN THE MUSIC LIBRARY

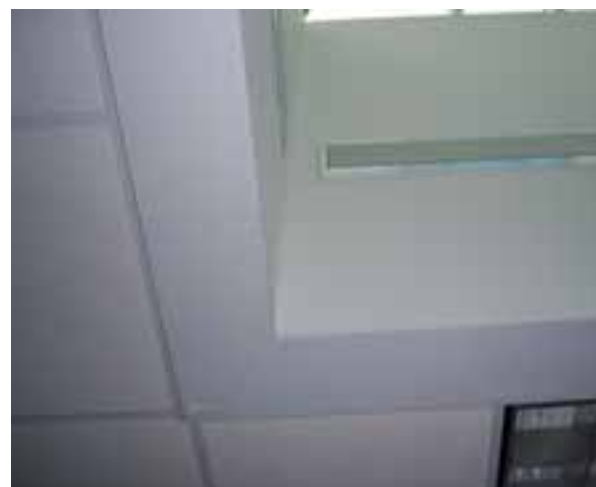
DAMAGE AT SKYLIGHT IN STUDENT COMMONS DUE TO LEAKS.

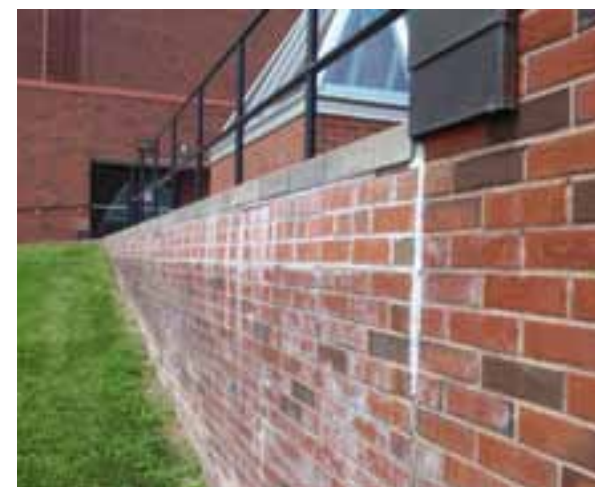
MASONRY AROUND THE PLAZA SHOWS EVIDENCE OF EFFLORESCENCE.

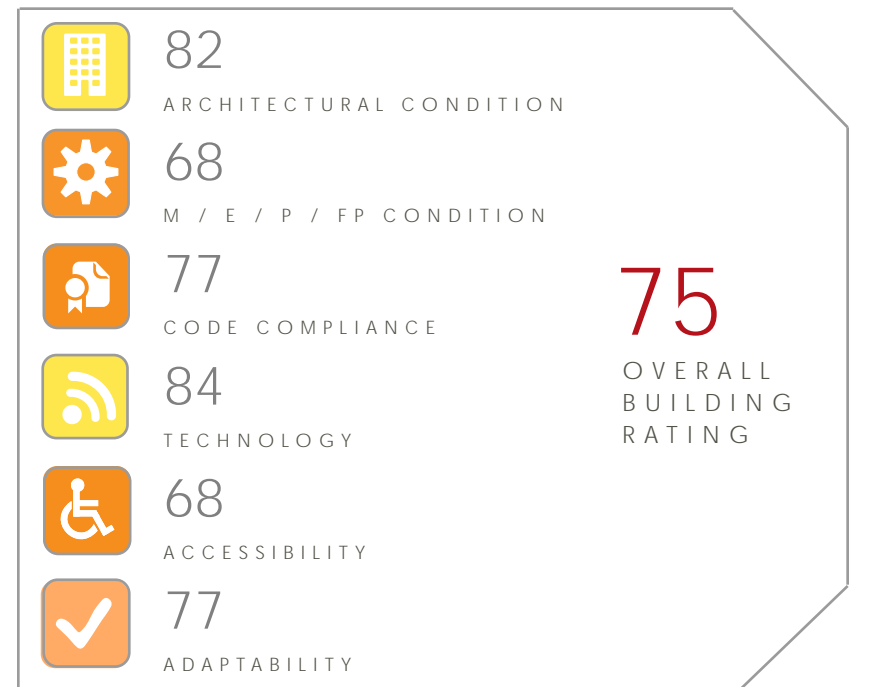
**BUILDING SUMMARY** Bishop Hall is an academic building dedicated to music education. The building is part of the larger Crane Complex. The facility effectively accommodates its academic functions. However, issues exist for both the building exterior and interior, particularly the mechanical system, that need to be immediately addressed.

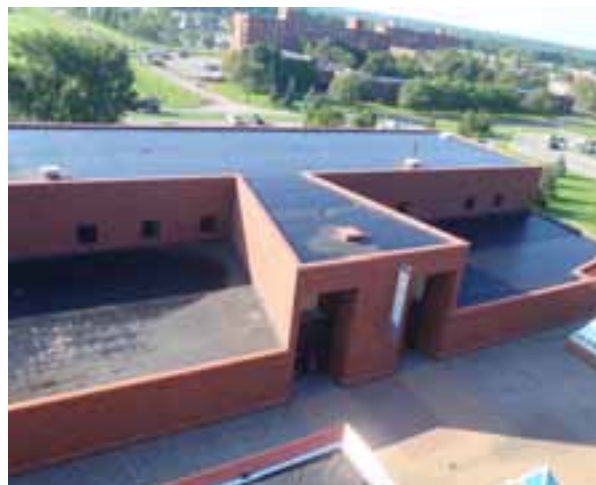
THE ROOF IS IN TWO LEVELS AND IS GENERALLY IN GOOD CONDITION.

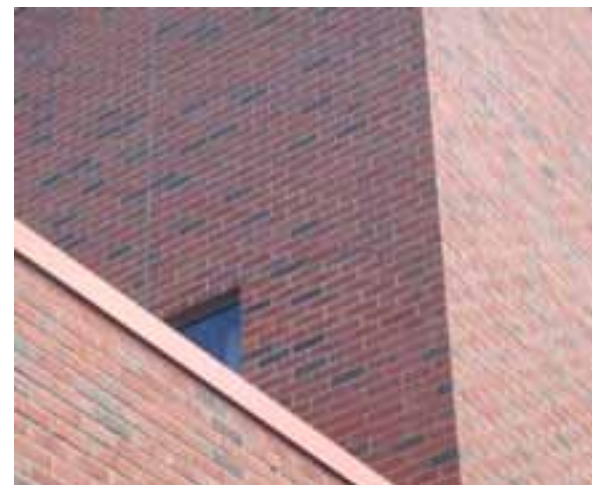
THE BRICK MASONRY IS IN GOOD CONDITION.

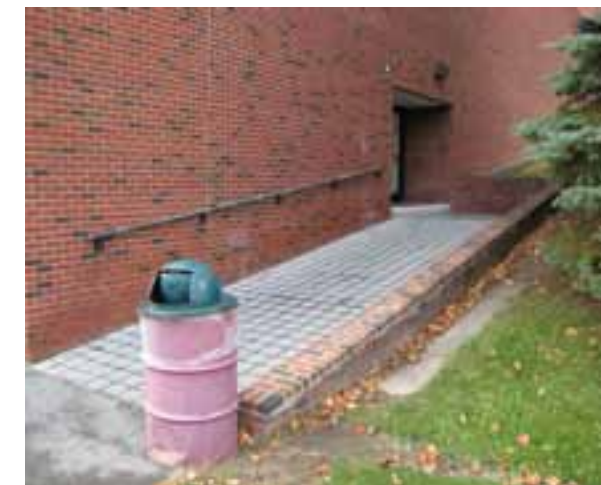
EXTERIOR RAMP'S SLOPE IS GREATER THAN 1:12 AND ONLY ONE HANDRAIL.

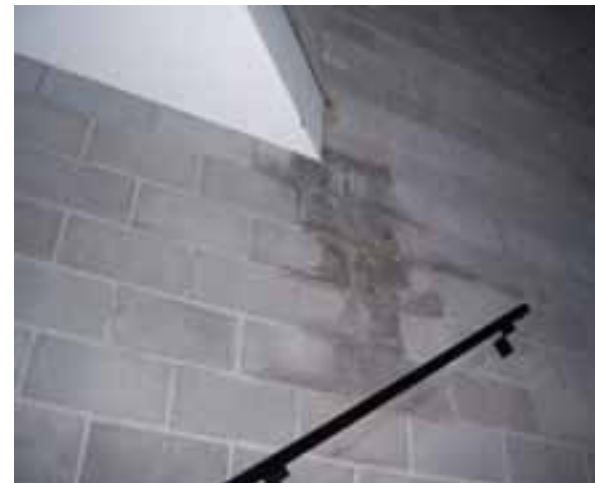
WATER LEAK AT INTERIOR STAIRWELL

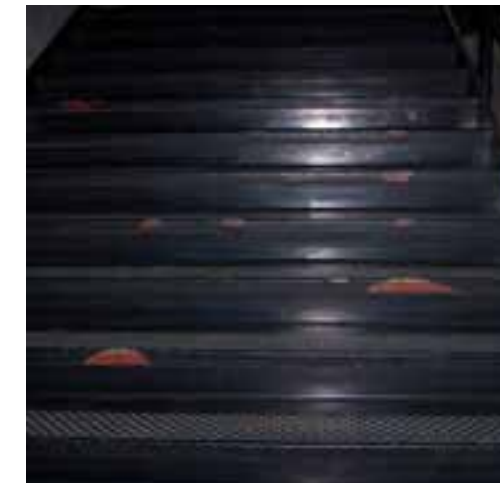
NOSING ON EXISTING STAIR NEEDS REPAIR.

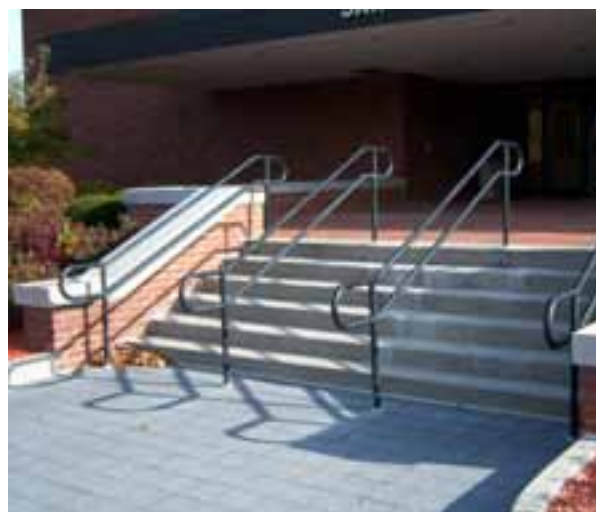
EXTERIOR ENTRY STAIR IS CODE COMPLAINT.

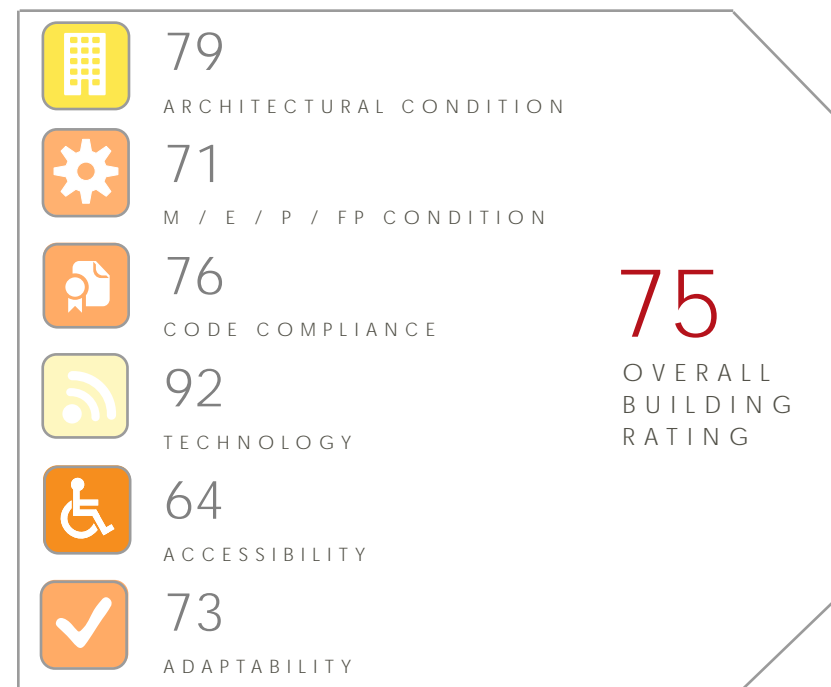
**DEPARTMENTS:** TEACHER CERTIFICATION, GRADUATE STUDIES, HISTORY, POLITICS, REBECCA V. SHEARD LITERACY CENTER, SCHOOL OF EDUCATION AND PROFESSIONAL STUDIES, SECONDARY EDUCATION, SOCIOLOGY, SPECIAL EDUCATION, UNDERGRADUATE ADVISING OFFICE

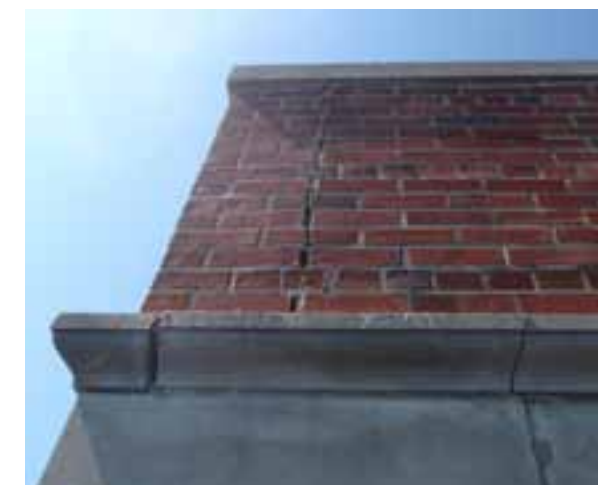
CRACKING OF EXTERIOR MASONRY.

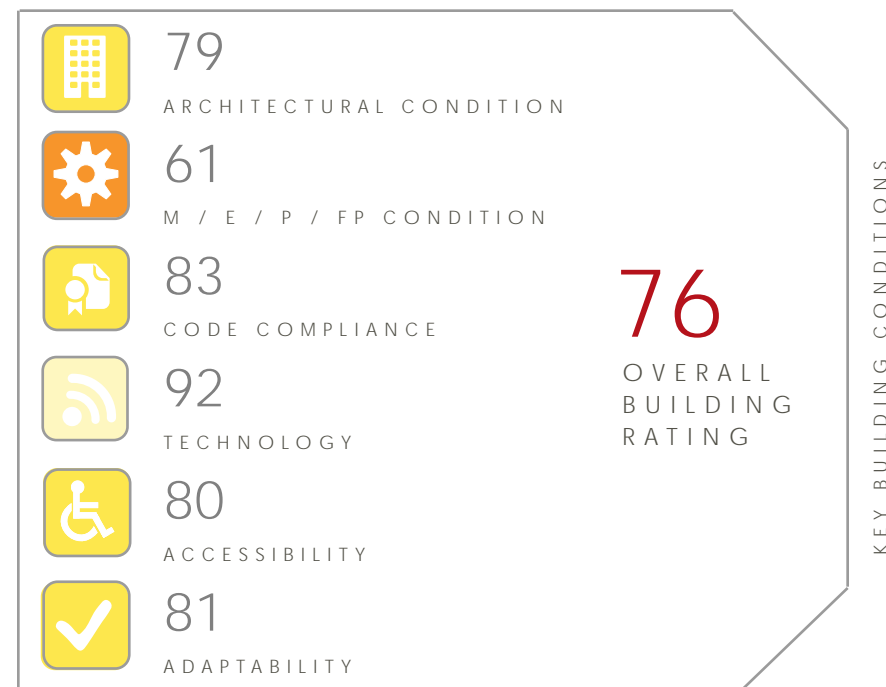
**BUILDING SUMMARY** Dunn Hall is an academic building located in the central quadrangle on campus. The building accommodates classrooms, faculty rooms, instruction spaces for performing arts, and an auditorium. A double-loaded corridor classroom building, Dunn's layout is ideal for academic use. The facility has reasonable floor-to-floor heights, which will allow for future air delivery upgrades. Interior retro-fit modifications might be costly, as the partitions are masonry. The theater offers an open structural layout that can be retro-fitted for other programs.

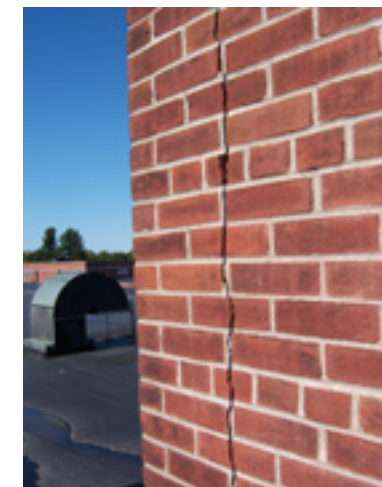
EXTERIOR WALL MASONRY CRACKS.

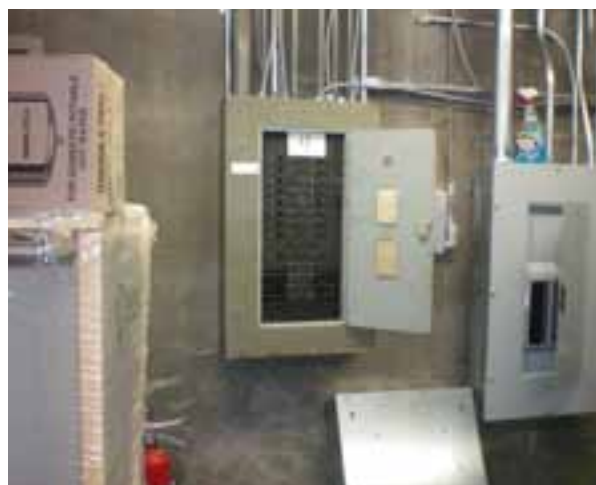
ELECTRICAL PANEL BOARDS

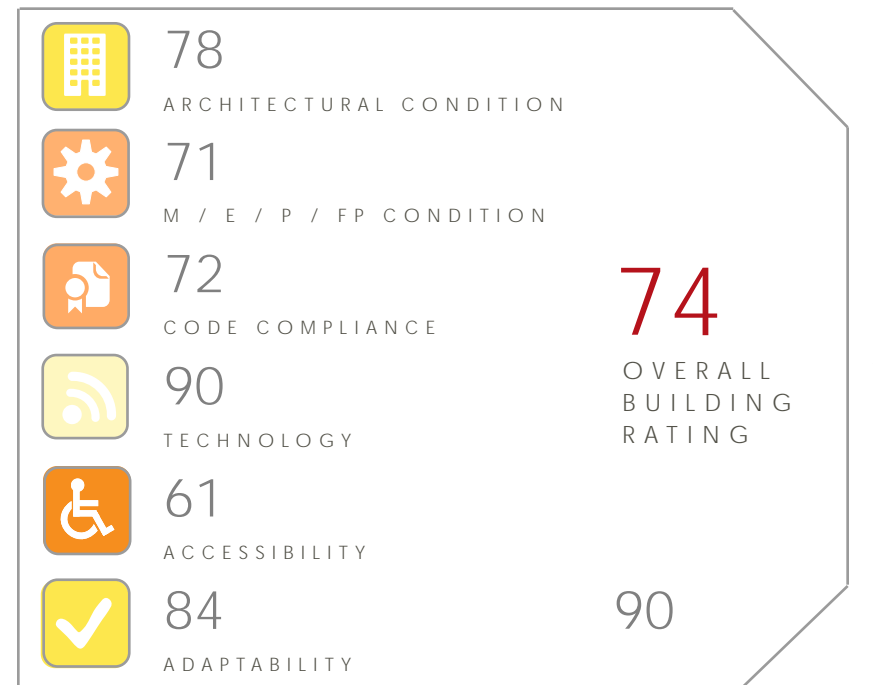
**BUILDING SUMMARY** Merritt Hall was originally constructed as the campus' athletics and recreation building. With the advent of Maxcy Hall, Merritt was relinquished to being a community recreational building, as well as also housing miscellaneous administrative offices. Merritt has a combination of masonry bearing walls and steel framing. The large-span areas over the swimming pool and gymnasium afford greater flexibility for alternative academic programs. Merritt's high floor-to-floor height will allow for improved air delivery space requirements.

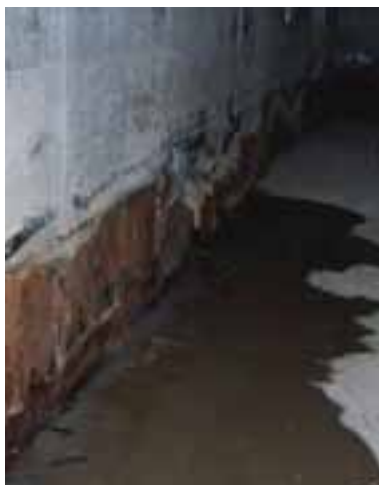
LEAK IN BASEMENT ACCESS ACCESS SPACE BELOW SWIMMING POOL.

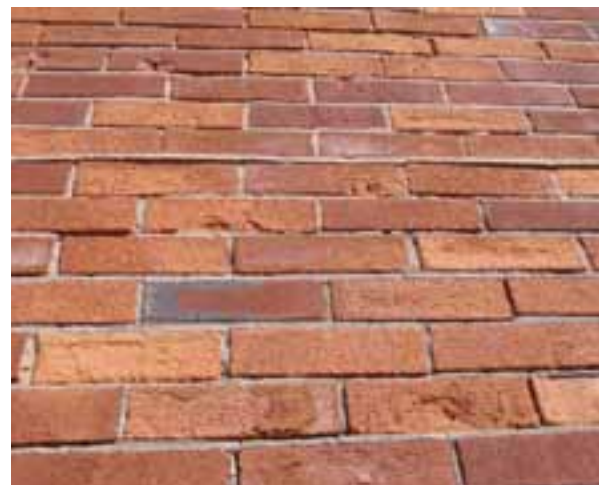
SPALLING AND MORTAR JOINT ISSUES.

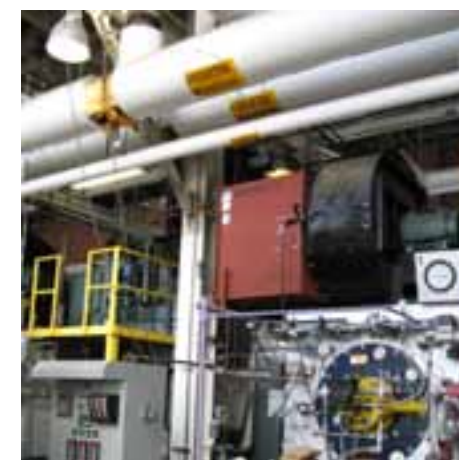
VIEW OF BOILER BURNER

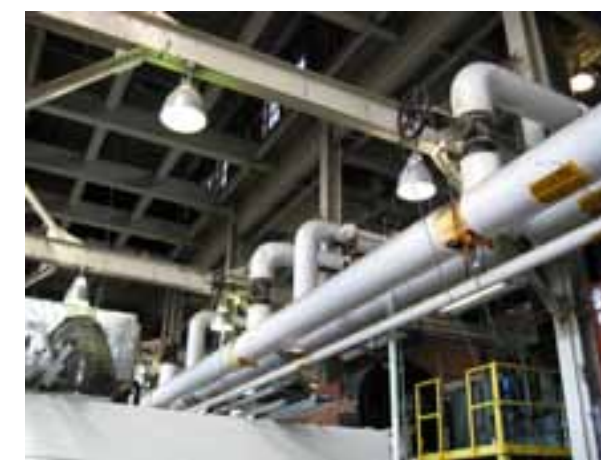
VIEW OF STEAM HEATERS

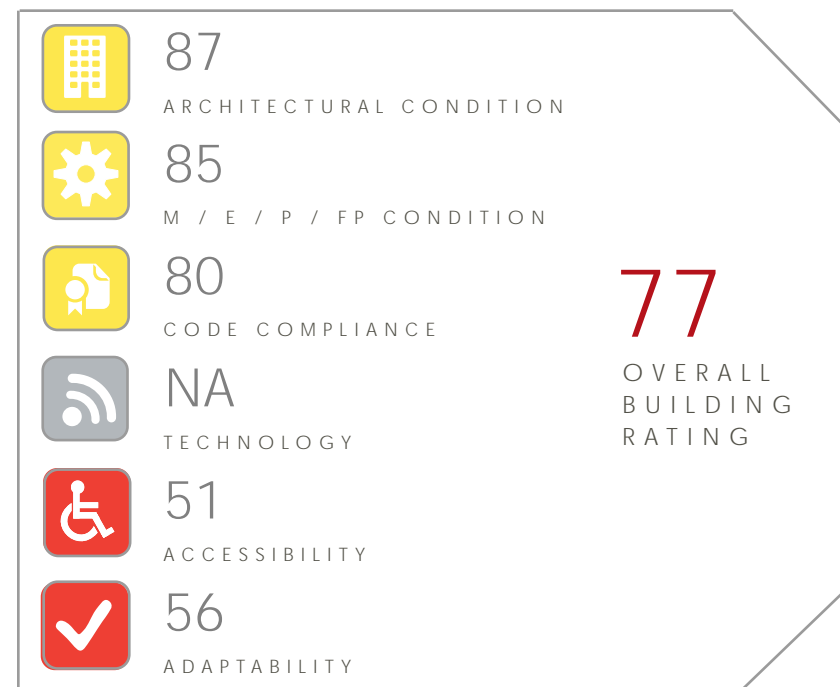
**BUILDING SUMMARY** The building is a farmhouse constructed in 1814. There have been multiple additions added to the home since its original construction, the first major renovation occurred in 1900. The property extends from Pierrepoint Ave to the Raquette River shoreline. The house serves as the primary residence of the president. Both the house and the property are used for special events. While the overall appearance of the house is very good and the building is suitable to its function, it does need immediate attention to significant physical conditions.

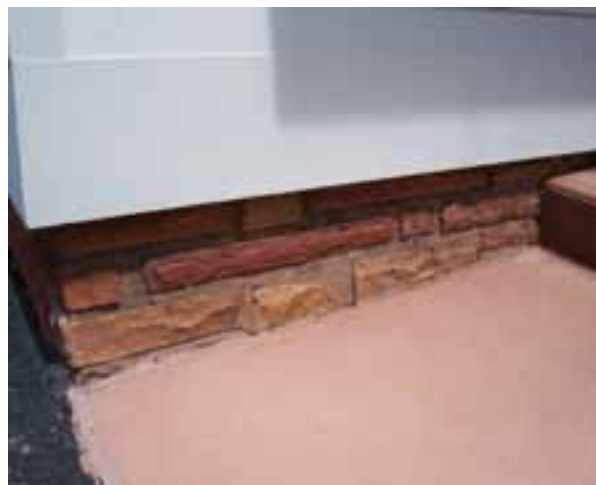
ROUGH CUT STONE MASONRY AT THE FOUNDATION

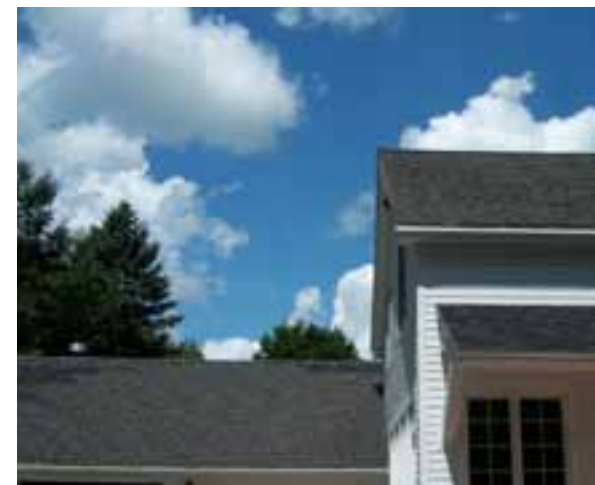
THE ROOF SHINGLES ARE FAIR TO POOR CONDITION.

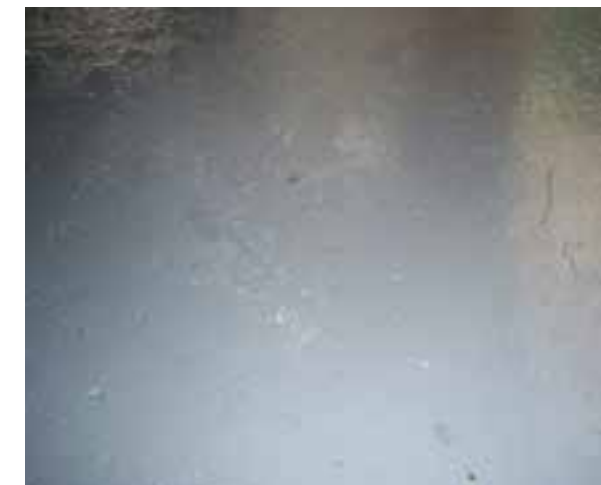
CONCRETE FLOOR IN GARAGE SWEATS LEAVING SALT DEPOSIT

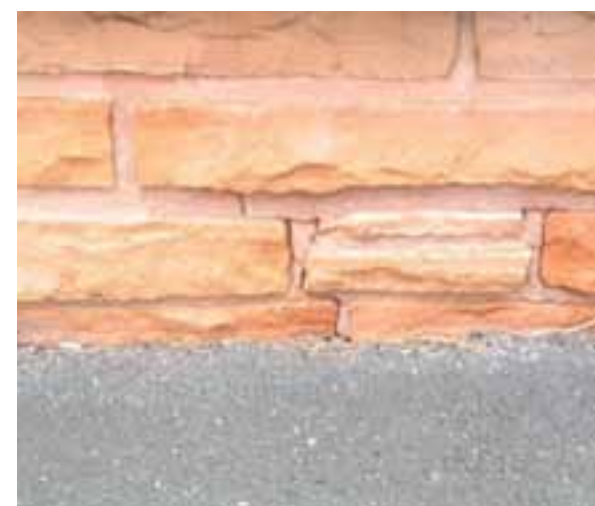
CRACK IN FOUNDATION VENEER MORTAR JOINT.

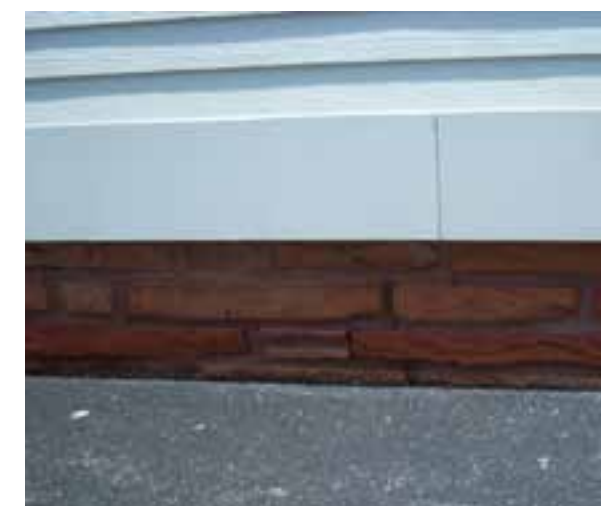
EXTERIOR CUT STONE FOUNDATION.

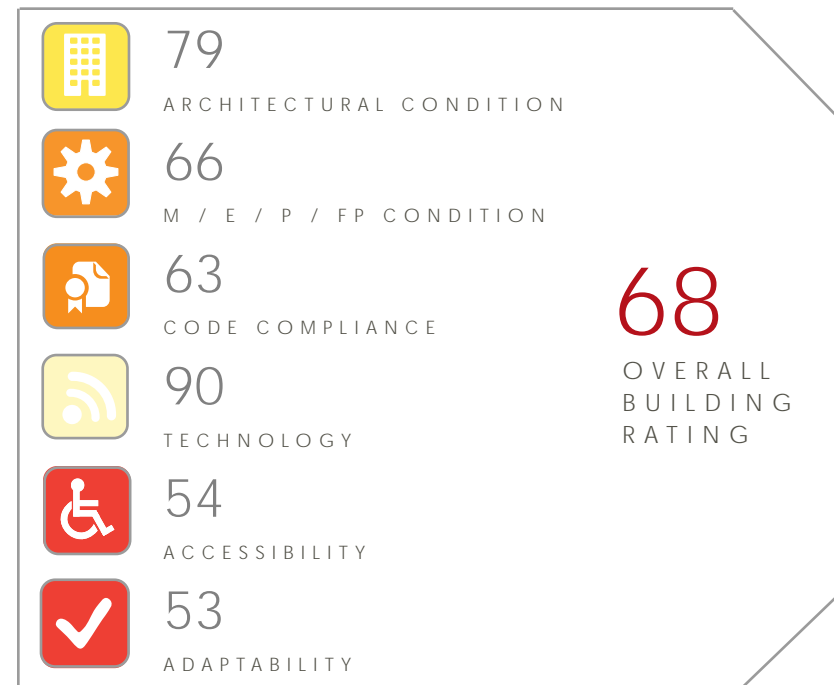
**BUILDING SUMMARY** Morey was one of the first buildings constructed on the campus in 1951. Originally constructed to serve as a residence hall, Morey functions as an academic building, accommodating mostly faculty offices with a few classrooms. The building is connected to Carson Hall, therefore, internally accessible to MacVicar, Stillman, and Raymond Halls. While the indoor connection to other buildings is ideal, the existing narrow, double-loaded corridors do not provide comfortable circulation and are not code compliant. The only possible use for Morey is the return to a residence hall, with significant upgrades for accessibility and code compliance.

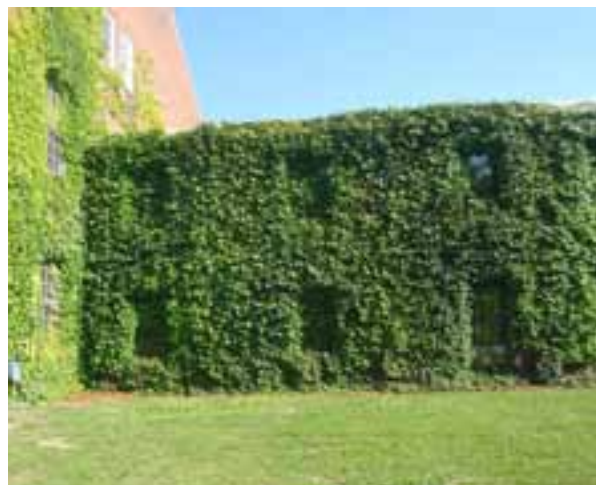
SEVERE IVY GROWTH ON EXTERIOR BUILDING ENVELOPE.

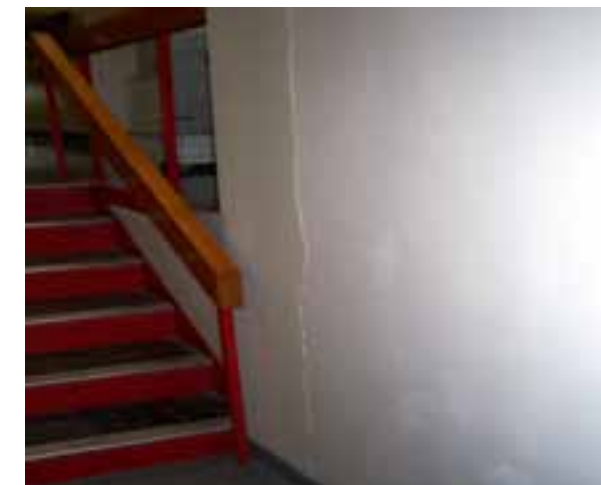
MAJOR CRACK ON THE WALL WHERE THE BUILDING CONNECTS TO CARSON HALL.

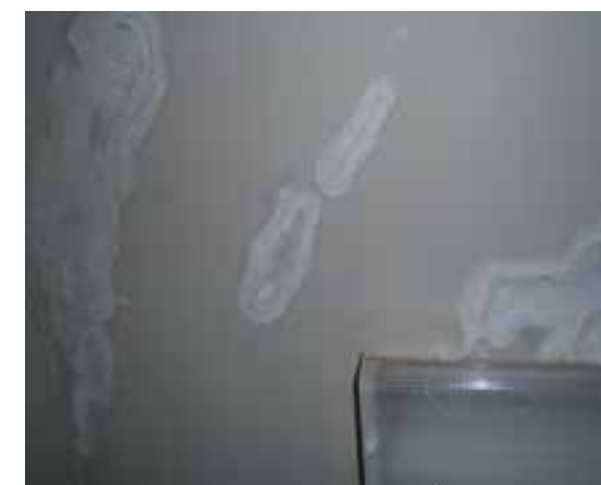
MOISTURE DAMAGE ON PLASTER WALLS.

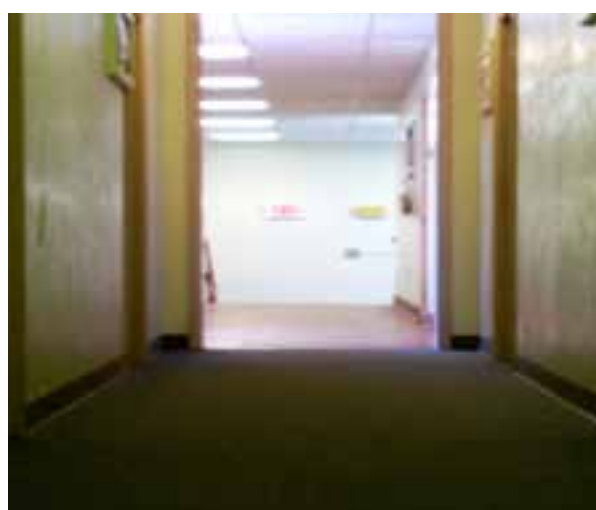
FIRST FLOOR DOOR THRESHOLD HEAVING AT MOREY LINK (BEFORE THE GATE)

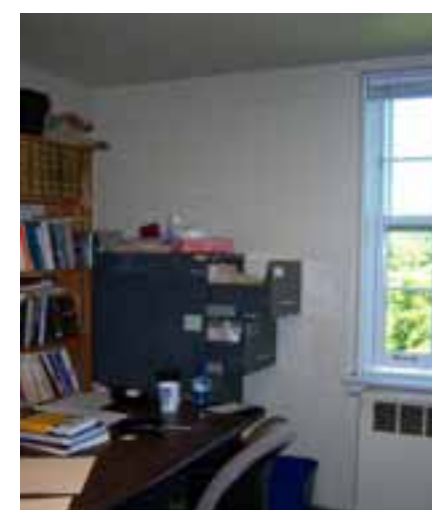
TYPICAL OFFICE WITH RECENTLY REPLACED WINDOWS.
