“BEING MORE THAN A COLLECTION OF INDIVIDUALS, SUNY POTSDAM IS A COMMUNITY DEDICATED TO THE PURSUIT OF COMMON GOALS.”

- SUNY POTSDAM PLEDGE

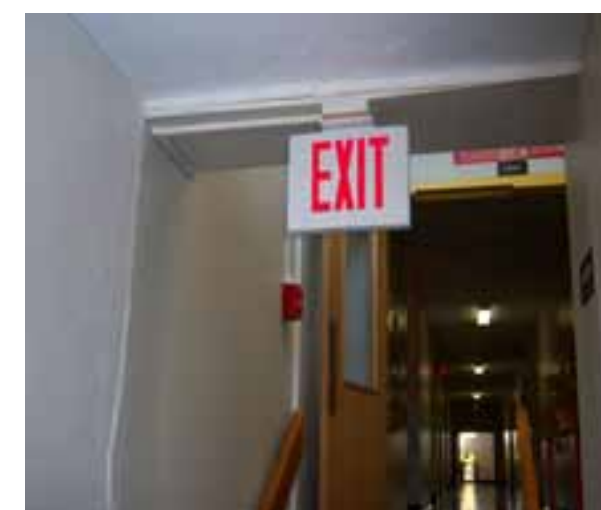
SECOND FLOOR CONNECTOR TO CARSON.

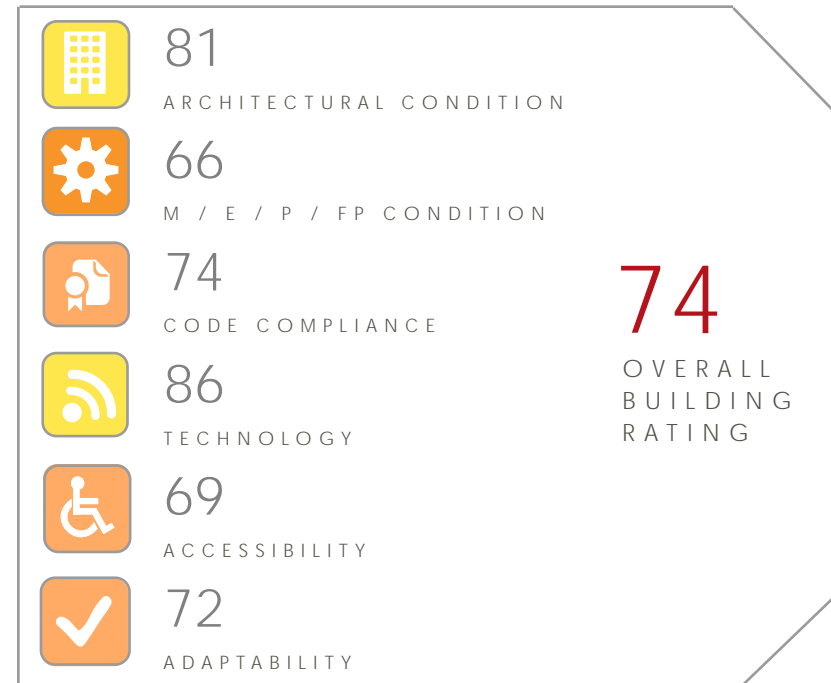
**BUILDING SUMMARY** Carson Hall was the first building constructed on the main campus. It was also the last building to receive a partial renovation with the advent of Becky's Place. The building is internally linked to Becky's Place and Raymond Hall to the north, Morey Hall to the west, and MacVicar Hall to the east. The indoor connection is a highly utilized feature by students and faculty. Carson serves as the main entrance from the quad to Becky's Place and Raymond Hall. The building has wide, double-loaded corridors suitable for an academic classroom facility. Overall, the building is effectively serving its function but does need some attention to its mechanical systems and accessibility upgrades.

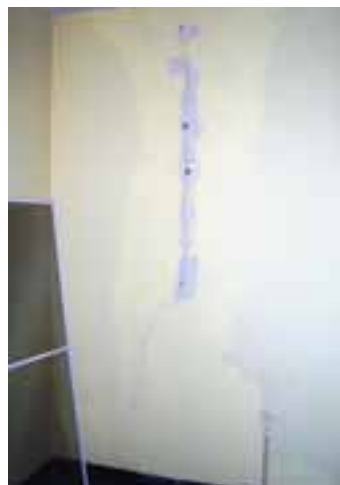
BUILDING CRACKS CAUSED BY MOVEMENT

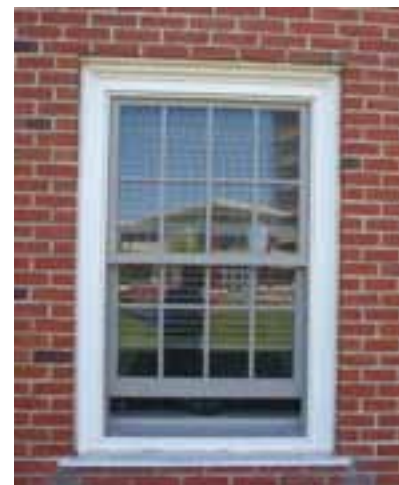
IT HAS NEWLY REPLACED VINYL-CLAD WOOD WINDOWS.

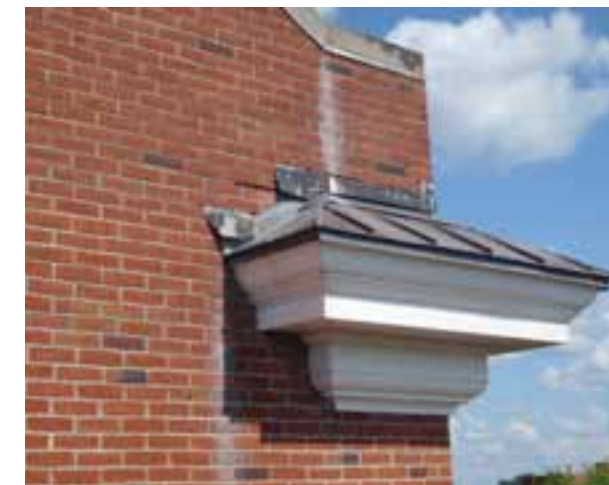
STAINING, SPALLING AND CRACKING OF THE BRICK MASONRY.

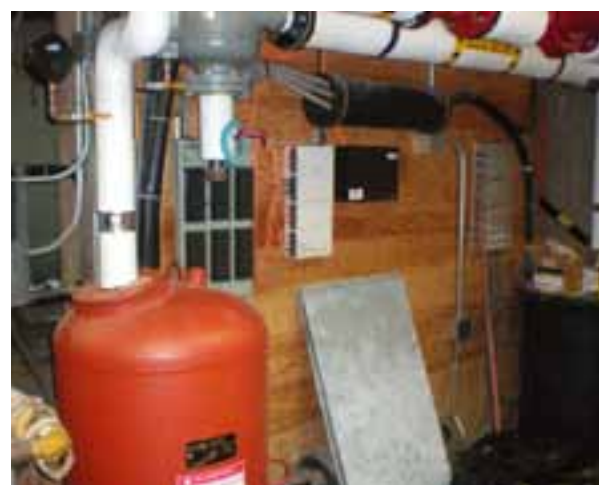
VIEW OF EXPANSION TANK

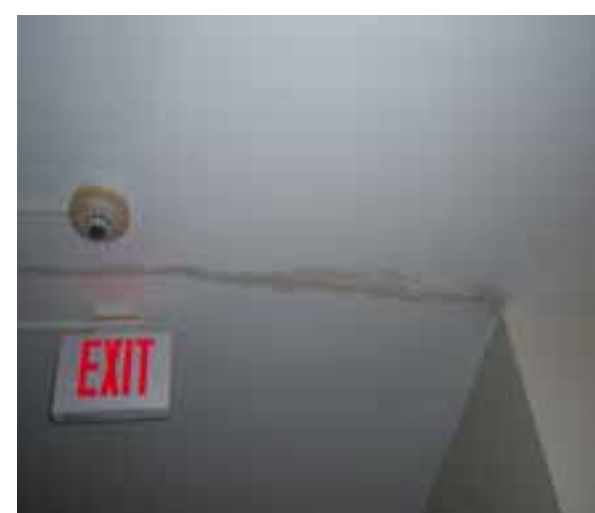
CRACK IN CORRIDOR CEILING AT CARSON HALL AND MACVICAR CONNECTION

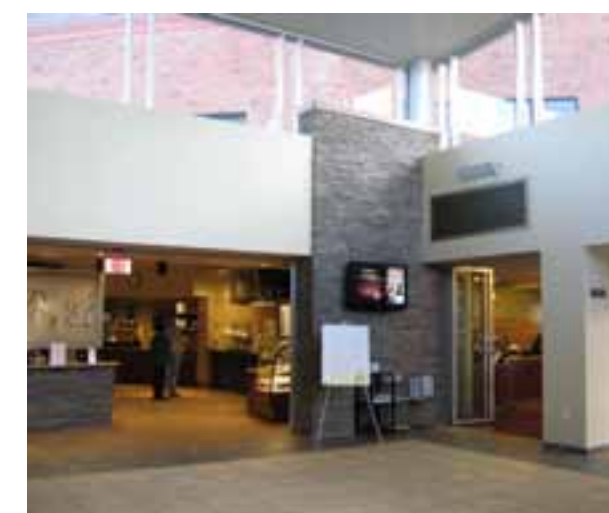
ENTRY TO BECKY'S PLACE LINKING CARSON AND RAYMOND HALLS.

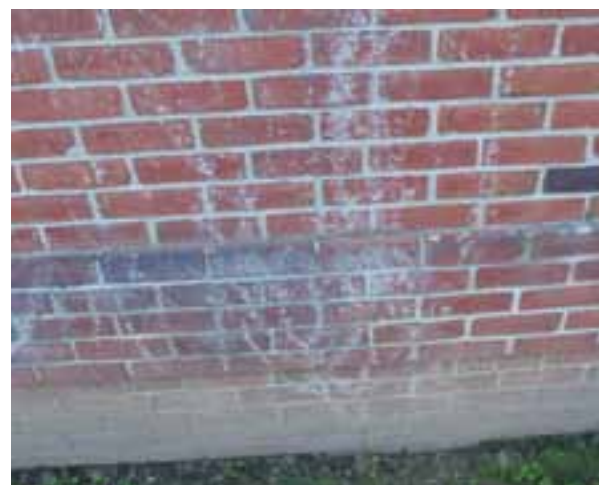
EFFLORESCENCE OCCURRING AT EXTERIOR MASONRY.

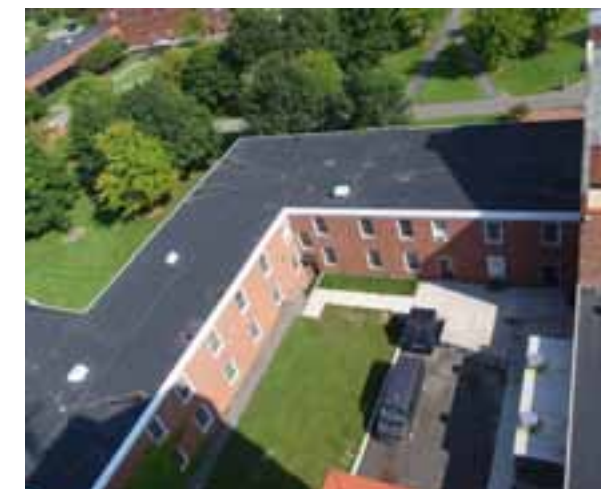
EPDM MEMBRANE IS GENERALLY IN GOOD CONDITION.

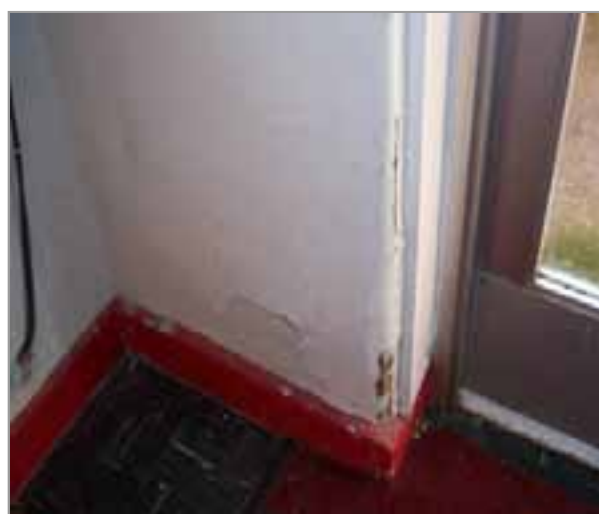
DAMAGE AT INTERIOR WALLS

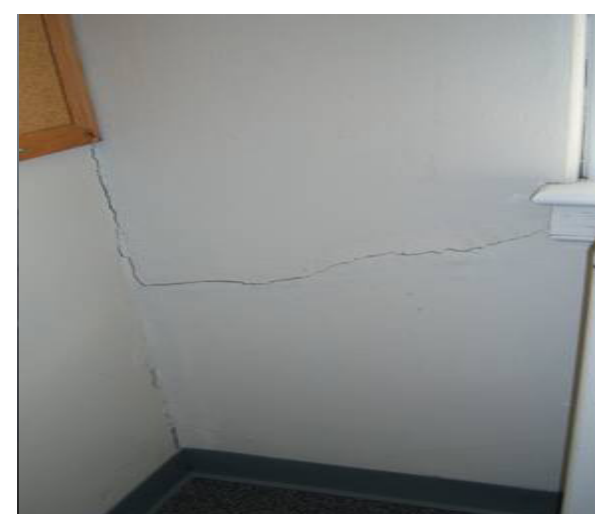
FINISHES ARE DATED AND HAVE MINOR DAMAGE.

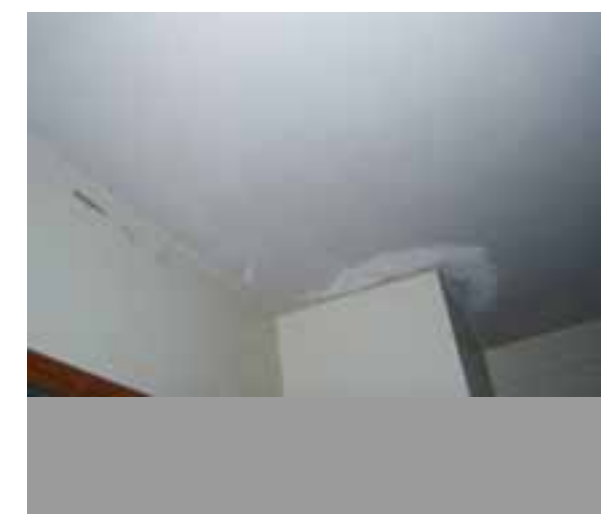
WATER DAMAGE AND CRACKING AT THE WALL-CEILING JUNCTIONS.

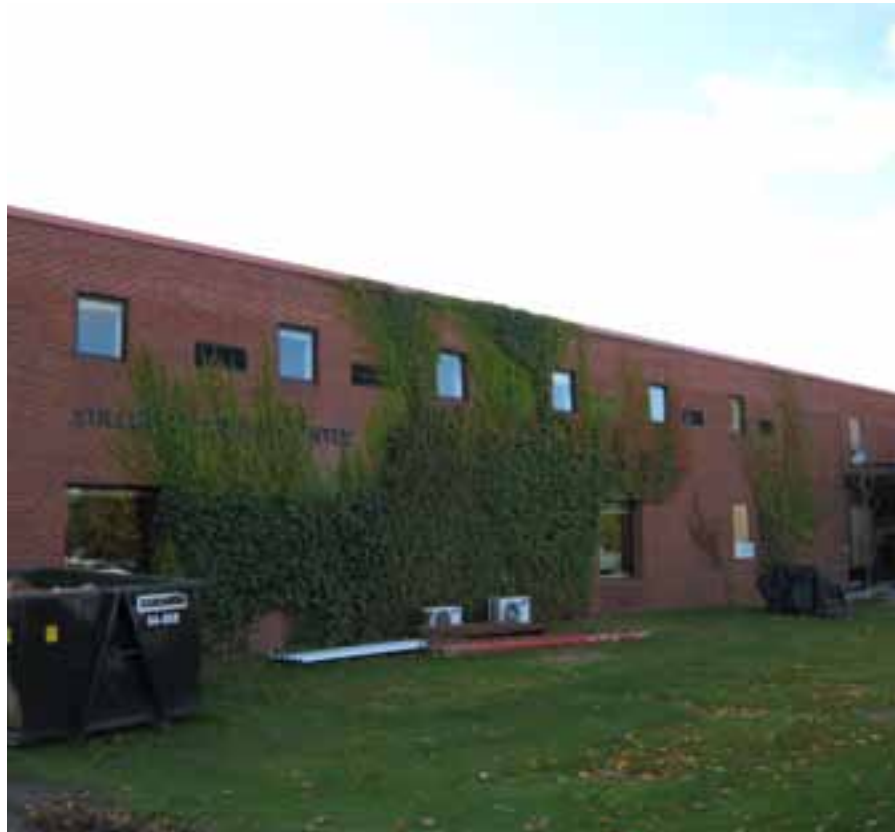
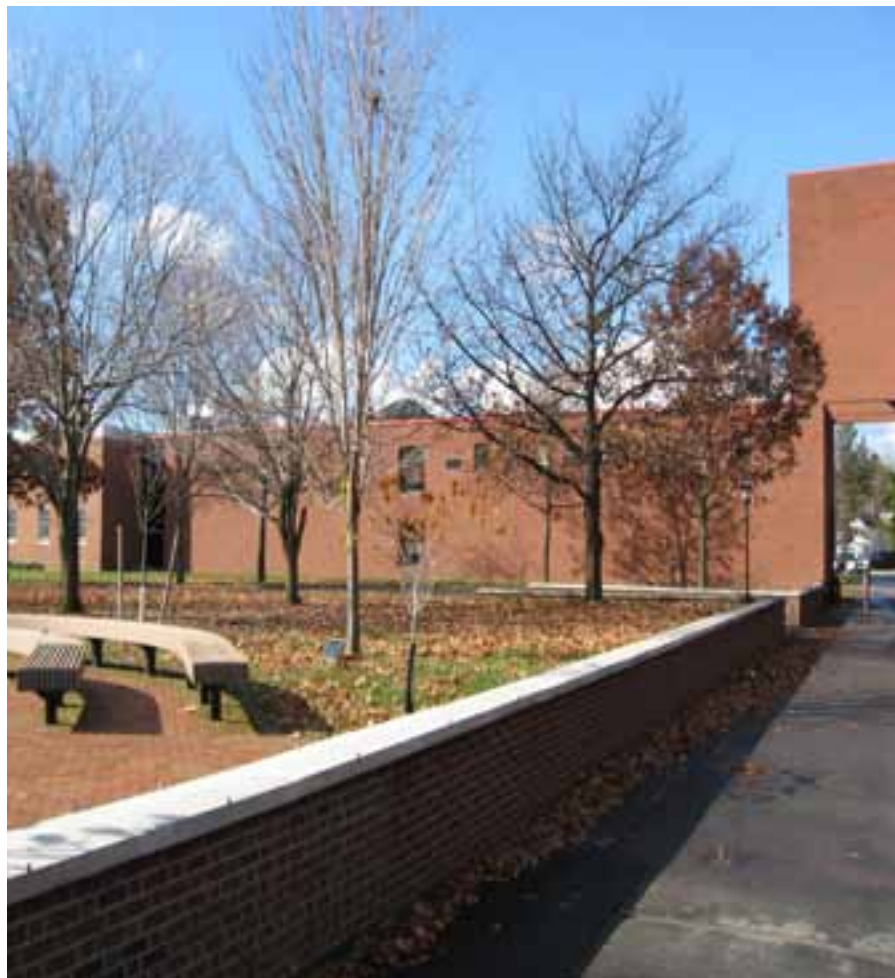
# STILLMAN COMPUTER CENTER

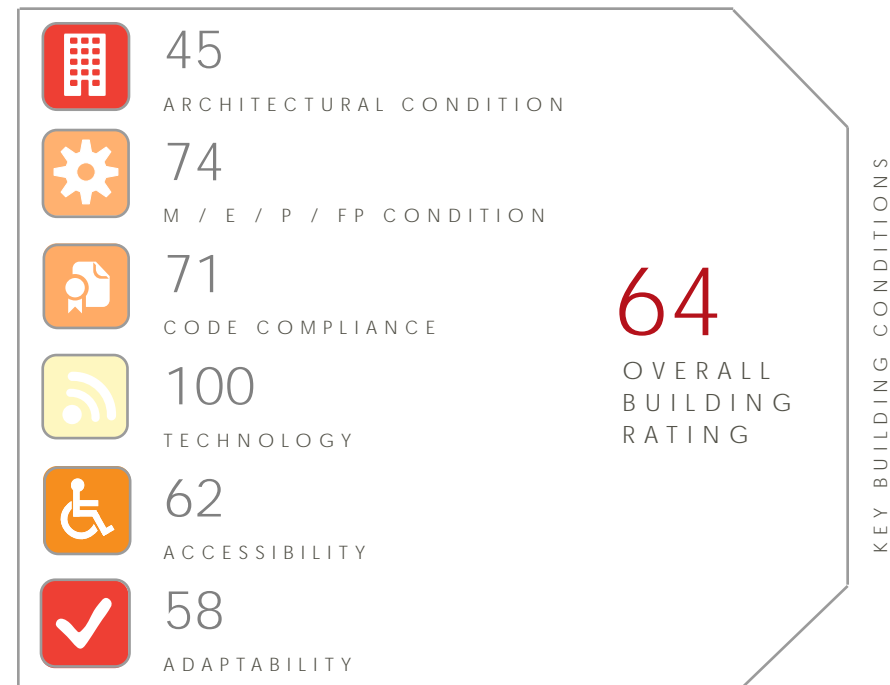
**BUILDING SUMMARY** Constructed in 1970, the Stillman Computer Center is currently undergoing renovations and houses up-to-date computer technology. The facility is connected to MacVicar Hall on the west and exits at the northeast quad gate that is linked to Kellas Hall. The indoor corridor between the buildings is heavily utilized by students and faculty. The building is suitable for its current academic function and will be in overall fair condition once renovations are completed.

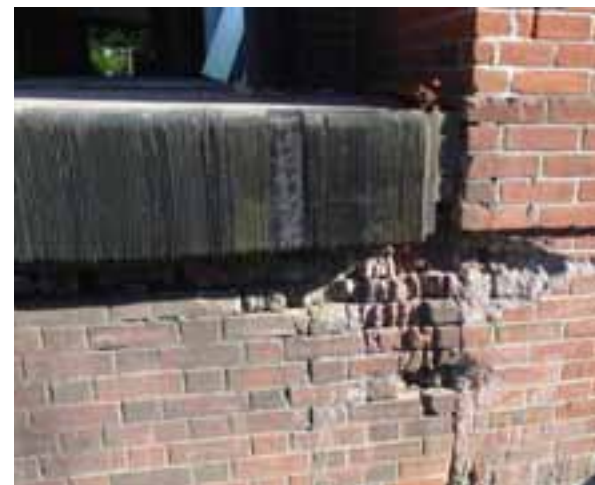
DAMAGE TO BRICK AT LOADING DOCK

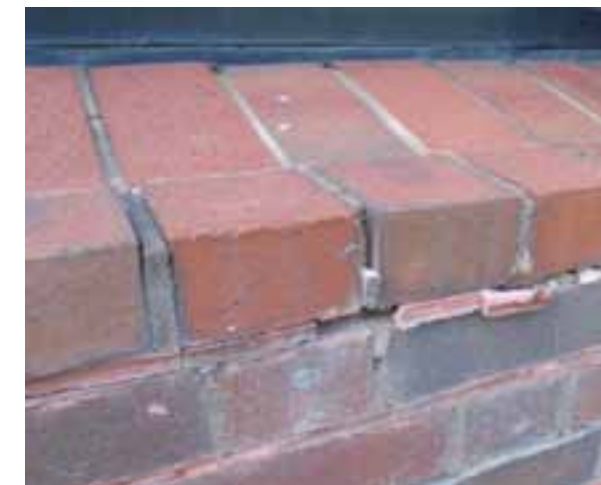
SIGNIFICANT RE-POINTING ISSUES AT THE BRICK SILLS

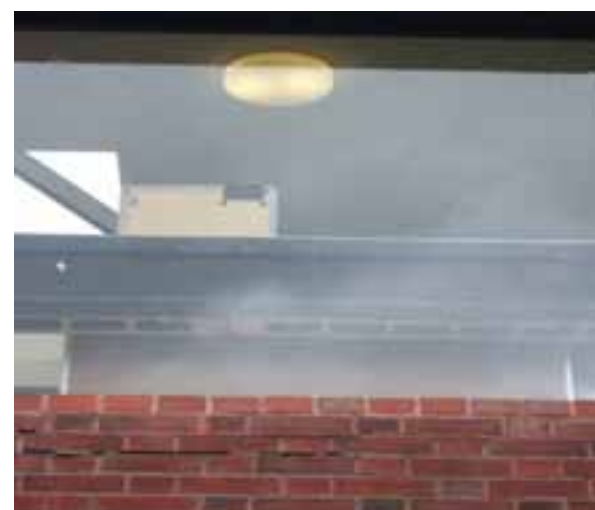
EXTERIOR MASONRY CRACKING.

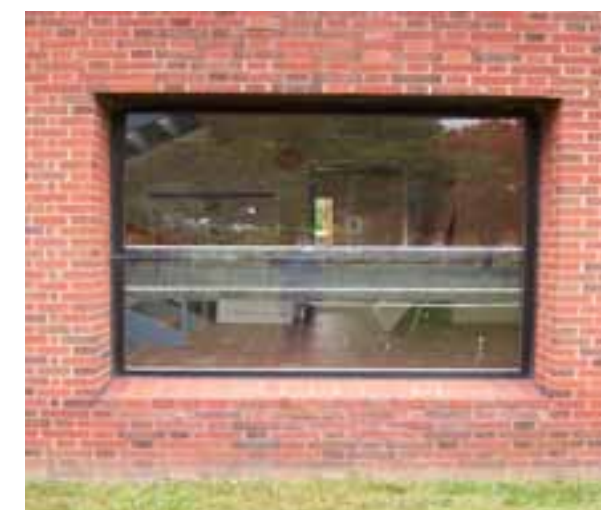
POINTING AND JOINT FAILURE

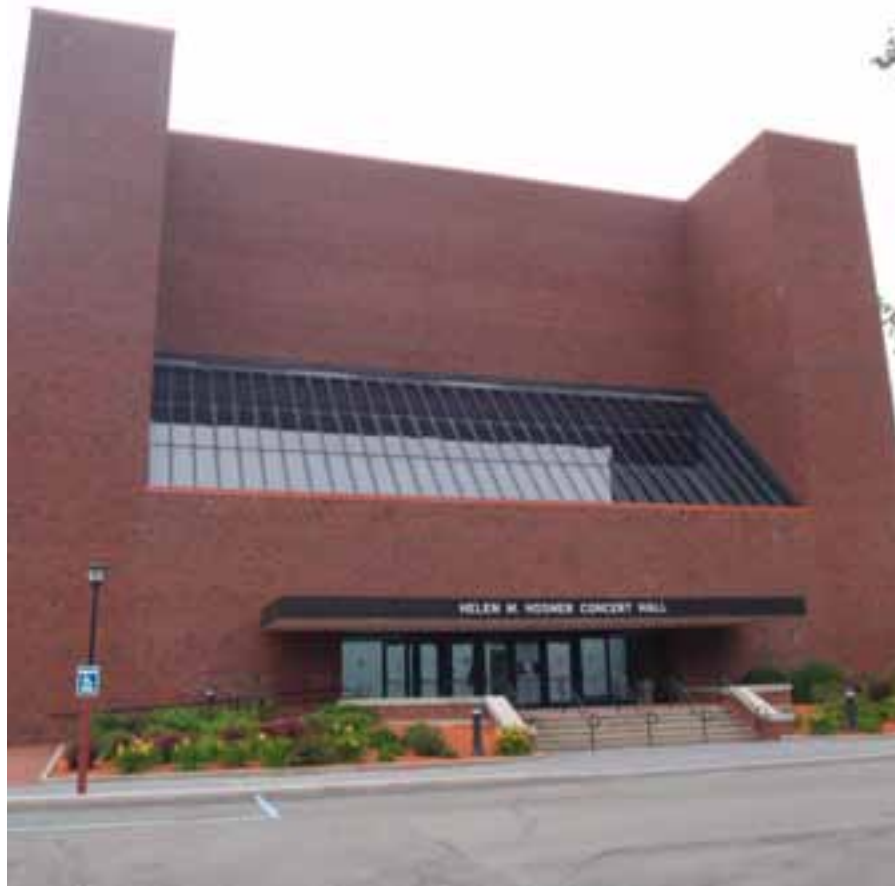
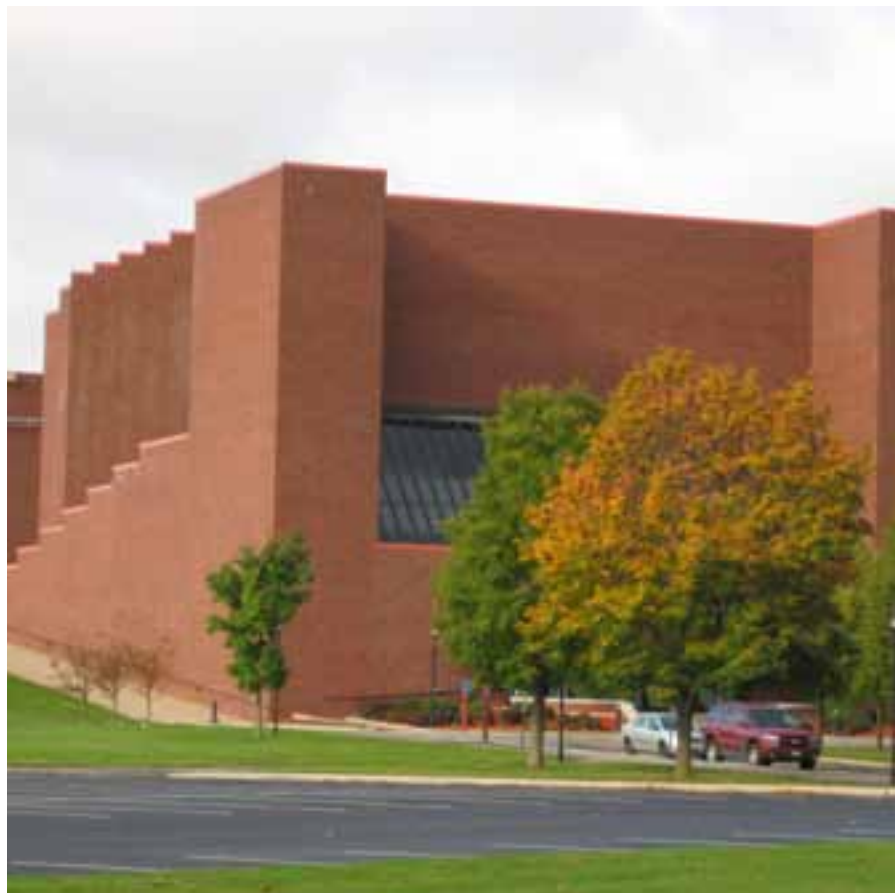
# H.M. HOSMER CONCERT HALL

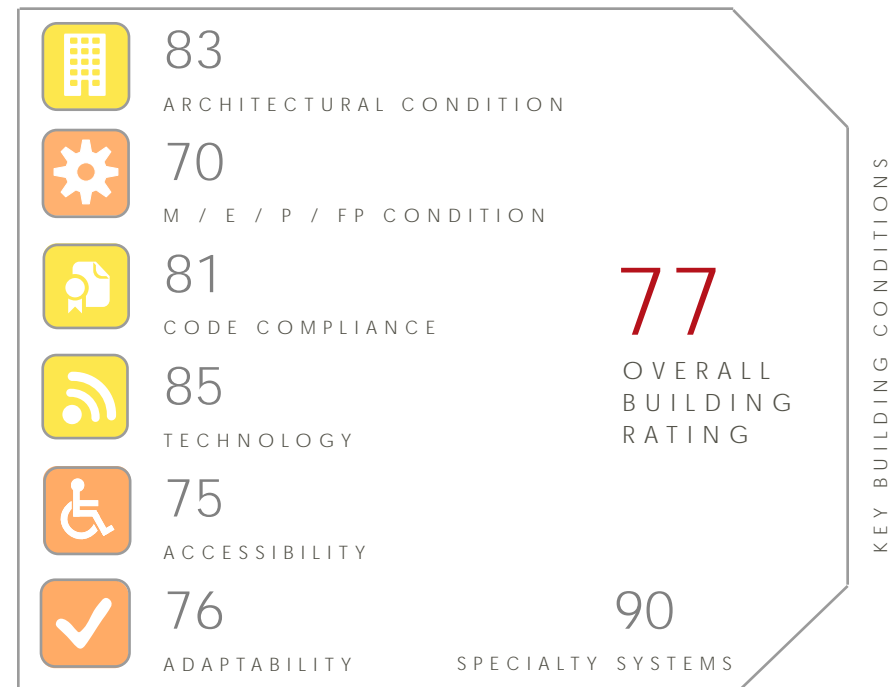
**BUILDING SUMMARY** The H. M. Hosmer Concert Hall was constructed in 1973 with a singular intended function and has undergone some recent renovations. The building serves effectively as a performance space and adapting it for any other function is not recommended. The concert hall contains 1,290 seats. The building is generally ADA accessible but needs some minor upgrades for ideal compliance.

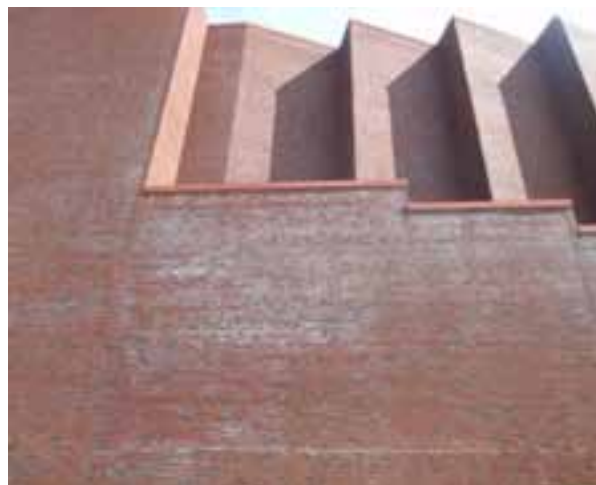
EXTERIOR ENVELOPE EFFLORESCENCE & STAINING

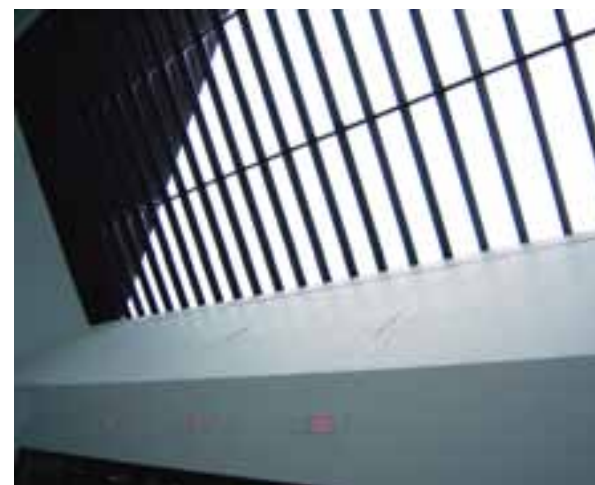
INADEQUATE MOISTURE CONTROL AT THE SKYLIGHT IN THE LOBBY.

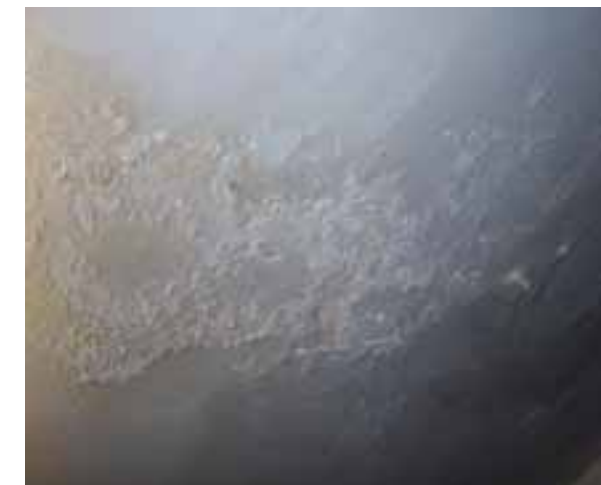
DAMAGE TO THE CEILING IN THE STAIR ROOM.

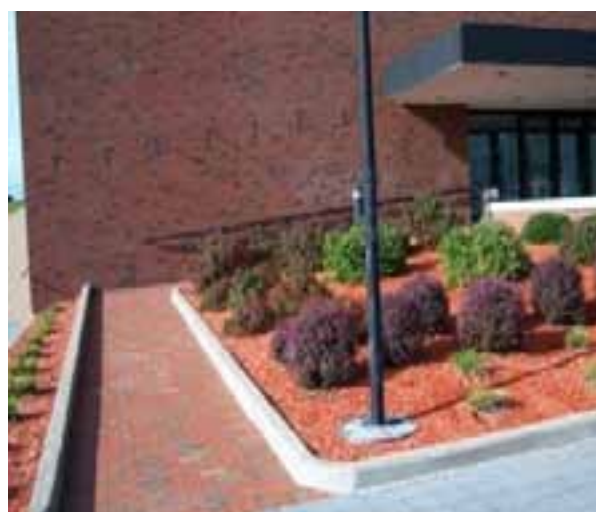
THE RAMP AT THE MAIN ENTRANCE TO THE BUILDING IS MISSING HANDRAILS

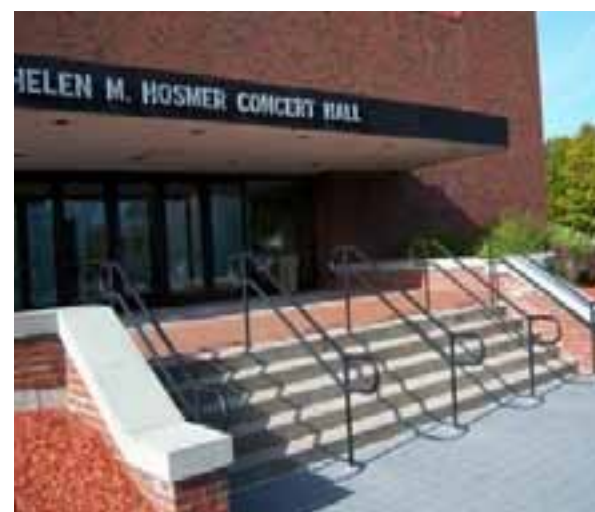
THE MAIN ENTRANCE STAIRS ARE COMPLIANT.

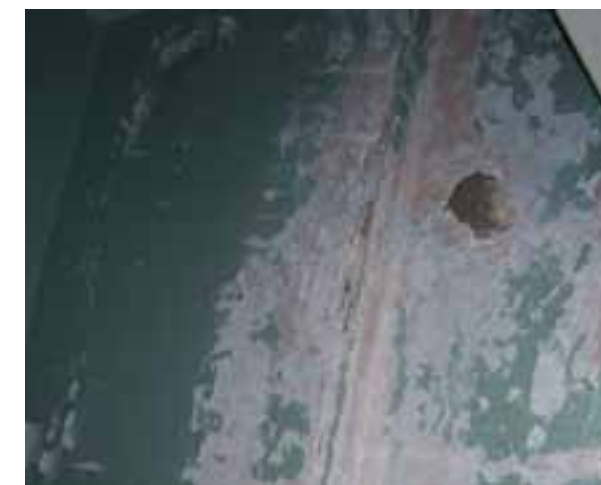
INTERIOR DAMAGE TO WALLS.

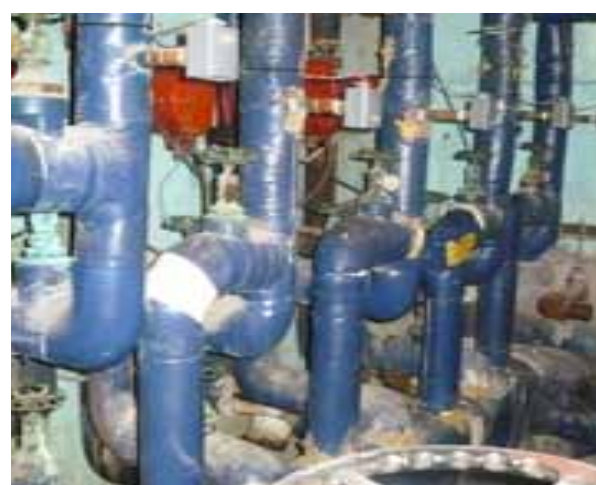
RADIATION ZONE PUMPS

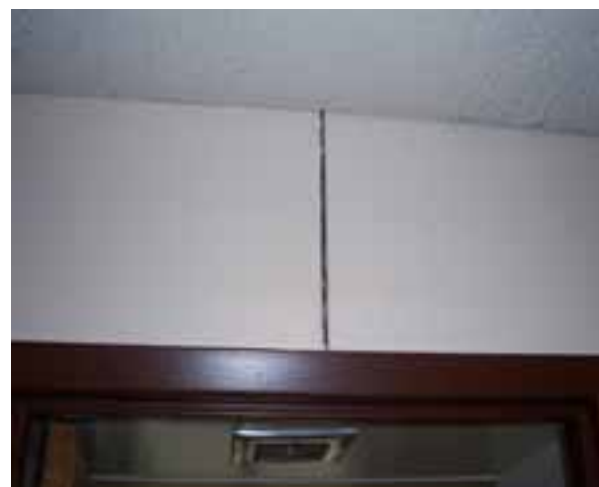
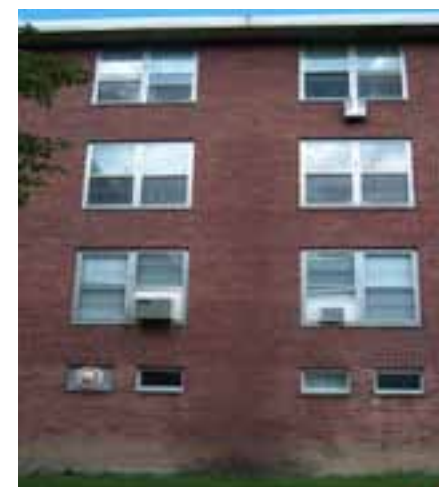
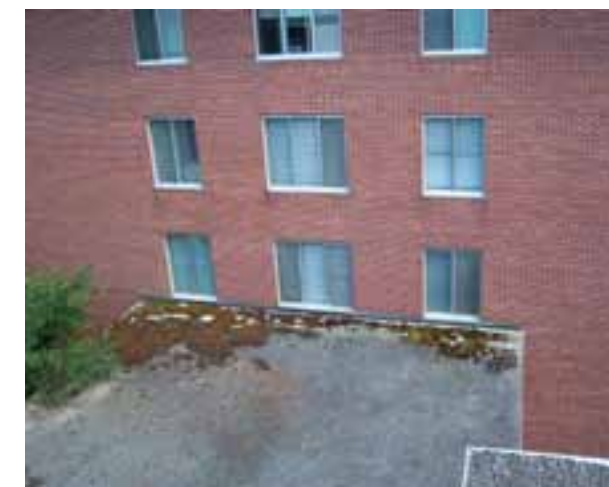
THE BRICK MASONRY SHOWS SIGNS OF SPALLING AND EFFLORESCENCE.

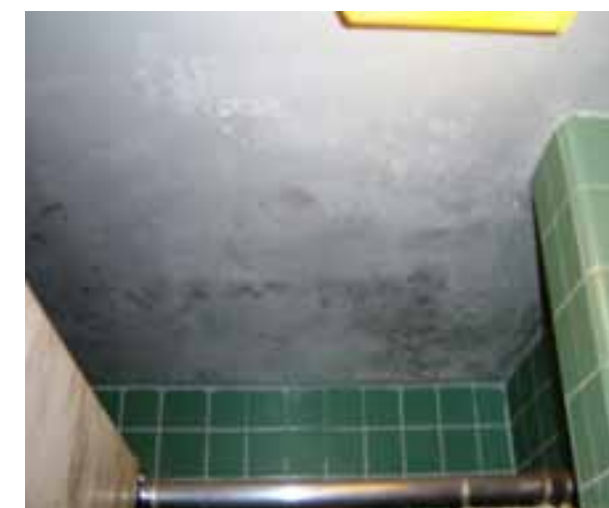
WATER DAMAGE TO CEILING ABOVE SHOWER.

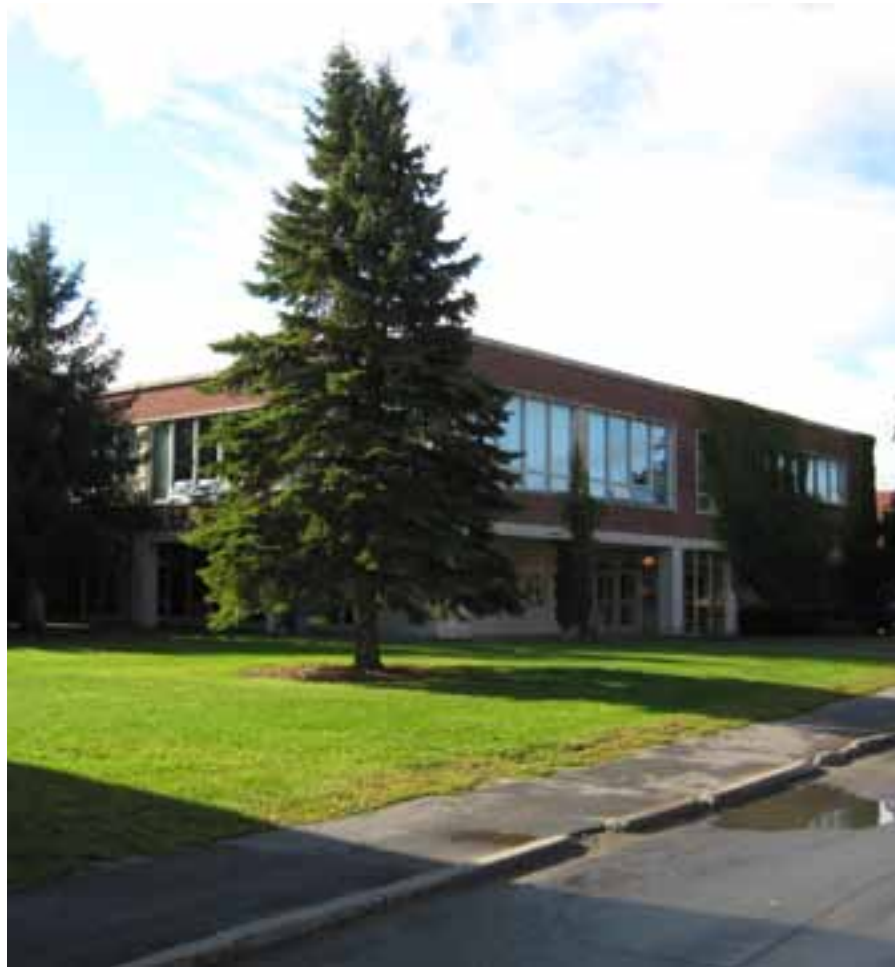
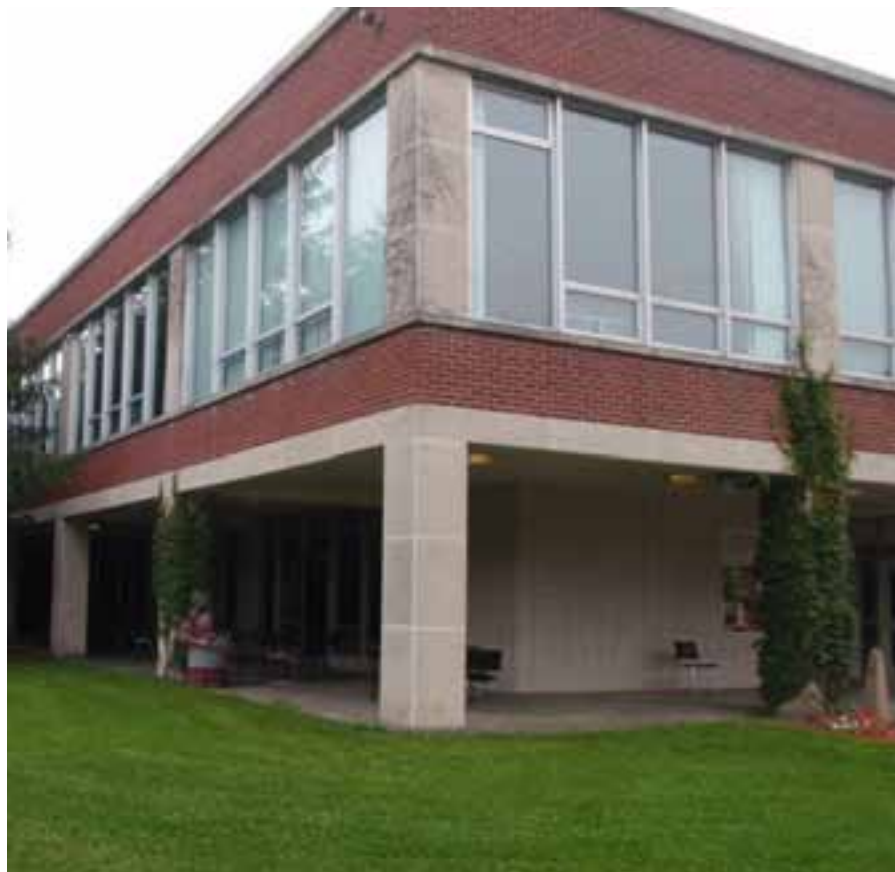
# THATCHER DINING HALL

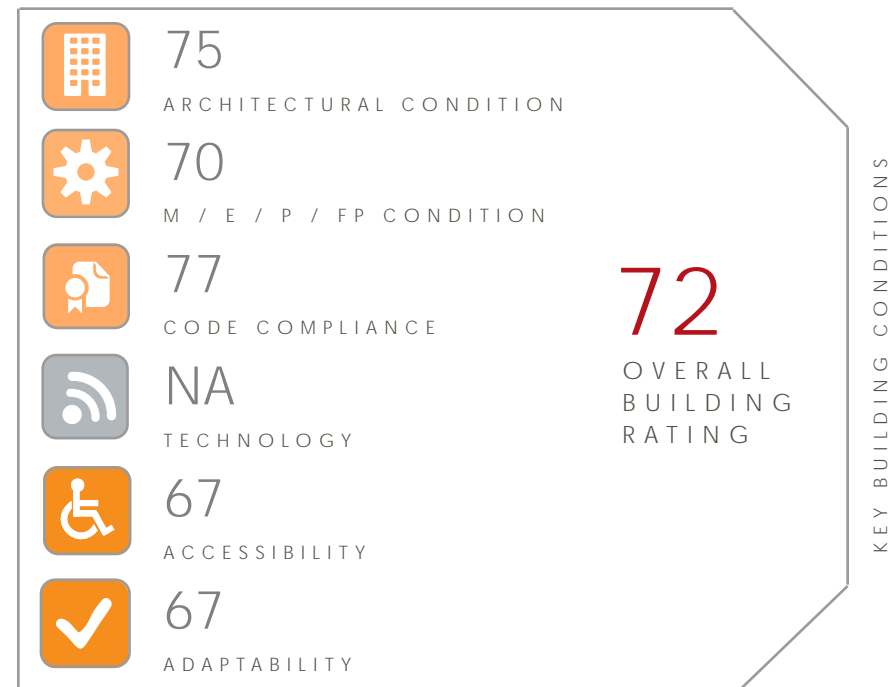
**BUILDING SUMMARY** Thatcher Dining Hall was constructed in 1961 as the campus' main kitchen. Today it provides food service for the campus' retail dining, the Barrington Student Union, and has the auxiliary role as dining room and food retail. The dining room is currently being used only for banquets and other commemorative occasions on campus. Dexter's, located on the ground floor, serves coffee and pastries, and has limited hours of operation. The facility is located to the west of the student union and connected internally for food transport between the kitchen and the servery in the union. The loading dock encompasses a major portion of the west façade. It is recommended that campus-wide food service locations be examined and the consolidation of all service areas be studied.

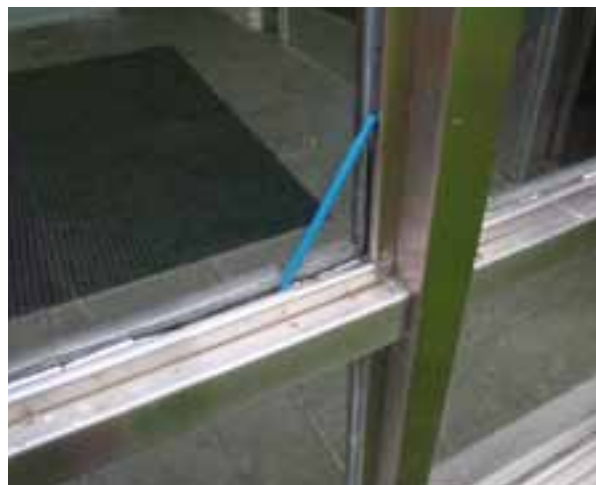
DETERIORATING SEALANT AT THE WINDOWS

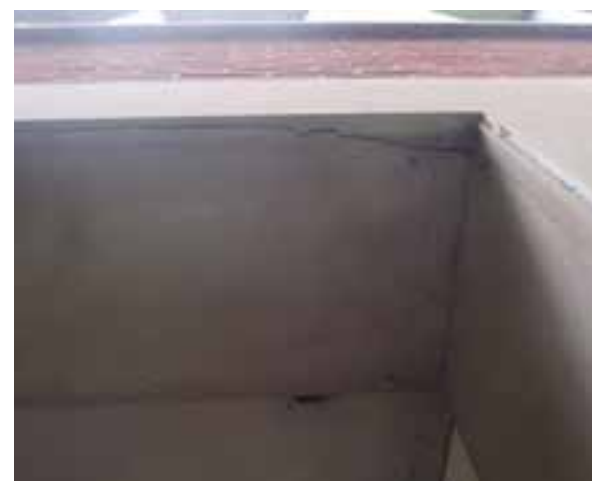
CRACKING IN EXTERIOR CONCRETE LINTEL

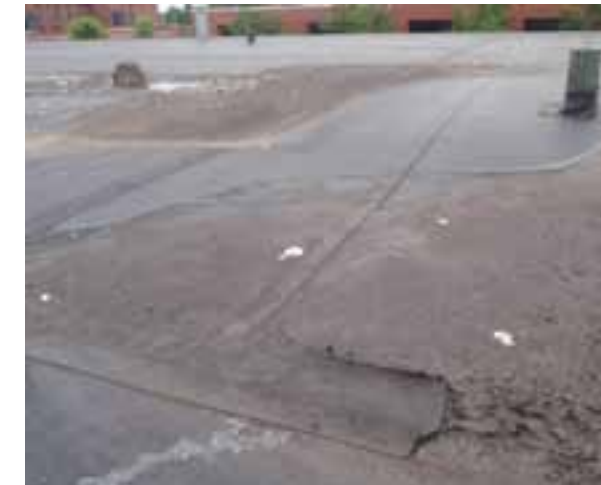
FAILED SEAMS ON THE EPDM ROOF AND DELAMINATED INSULATION

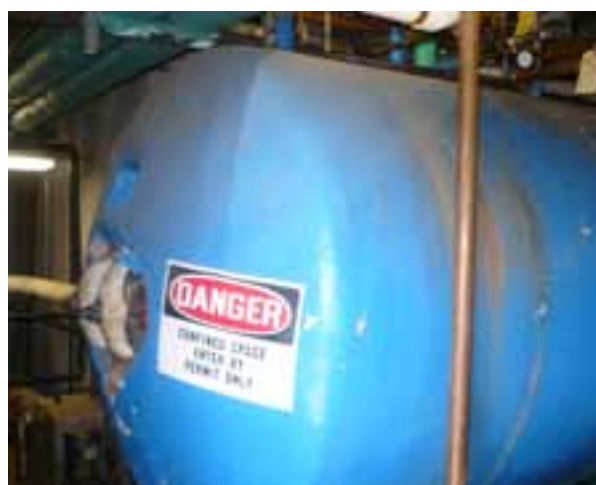
HOT WATER STORAGE TANK

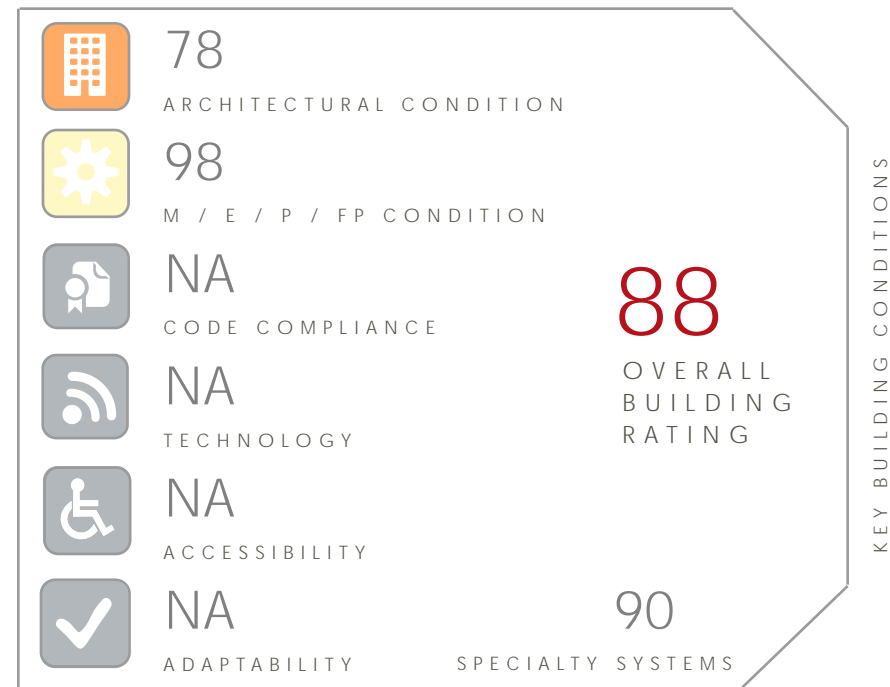
**BUILDING SUMMARY** Constructed in 1961, Draime Hall is located to the east of the Barrington Student Union. The majority of the building is a residence hall, but the building extension serves as home to Residence Life. The facility is a three story L-shaped building. It is well suited for its current function as a residential building; however, minor exterior repairs are recommended.

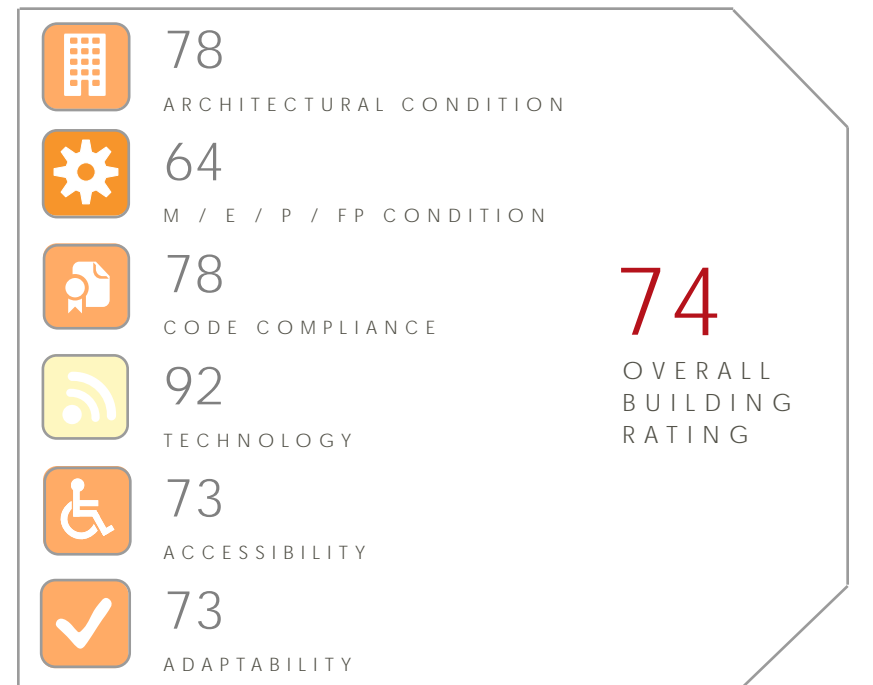
**BUILDING SUMMARY** Stowell Hall, constructed in 1964, is an academic building that accommodates classrooms, research labs, a planetarium, faculty offices, administrative offices and building service spaces. Stowell is a double-loaded corridor teaching laboratory facility. The building is situated between the quadrangle gateway to the east, Minerva Plaza to the west, Barrington Drive to the south, and the academic quadrangle to the north. It is recommended that Stowell continues to receive the renovation upgrades to the laboratories, as well as mechanical and accessibility upgrades.

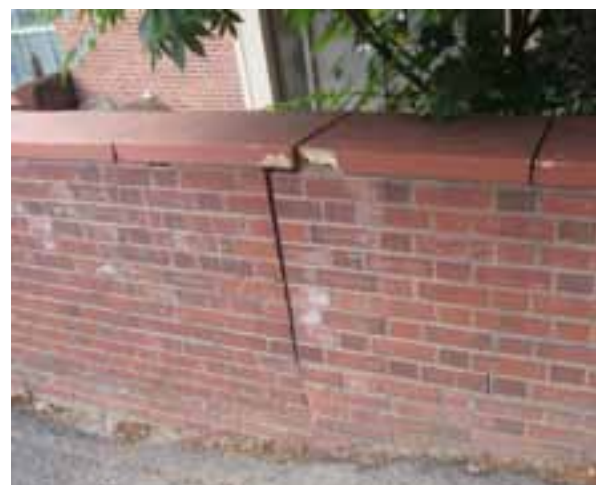
CRACKED RETAINING WALL ON THE EAST END OF THE BUILDING.

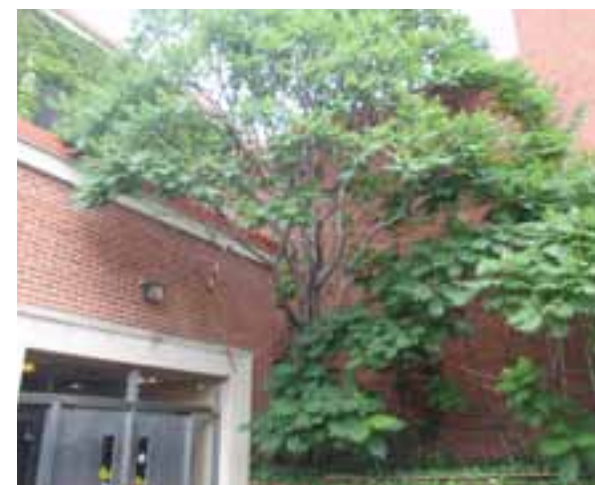
THERE ARE SHRUBS AND TREES GROWING TOO CLOSE TO THE BUILDING

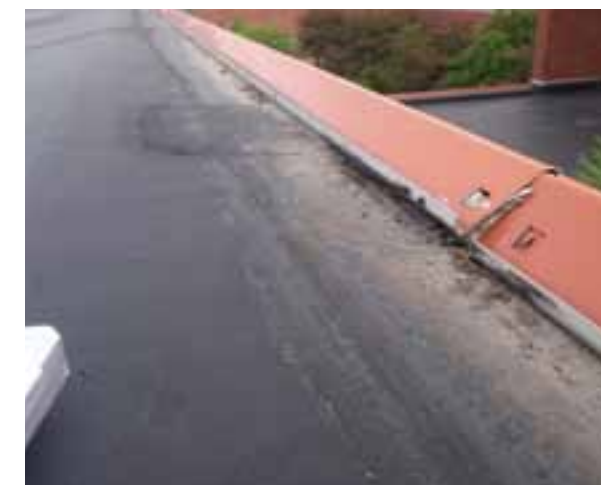
BUILDING PERIMETER - POSSIBLE WATER INFILTRATION INTO THE EXTERIOR WALL CAVITY.

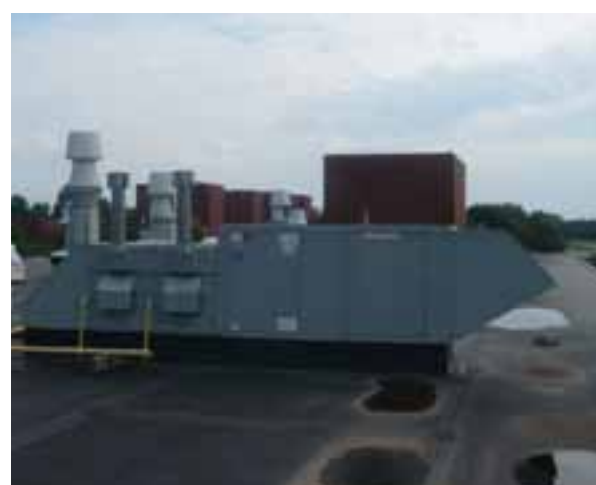
MAKE-UP AIR UNIT AND FUME HOOD EXHAUST FANS

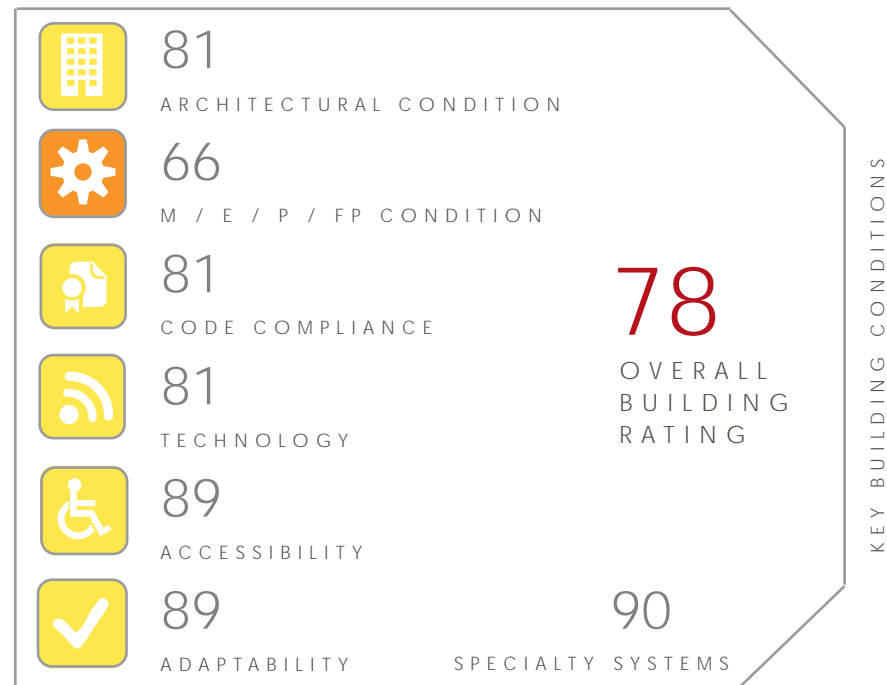
**BUILDING SUMMARY** Knowles Dining Hall was originally constructed in 1972 as a dining hall that would serve the adjacent residential hall. Today the facility is called the Knowles Conference Center and is used only for large group meetings and other special occasions on campus. The facility does not currently provide food service for any other spaces on campus. The dining hall's mechanical systems are in poor condition, and there are some minor exterior and interior issues that need attention.

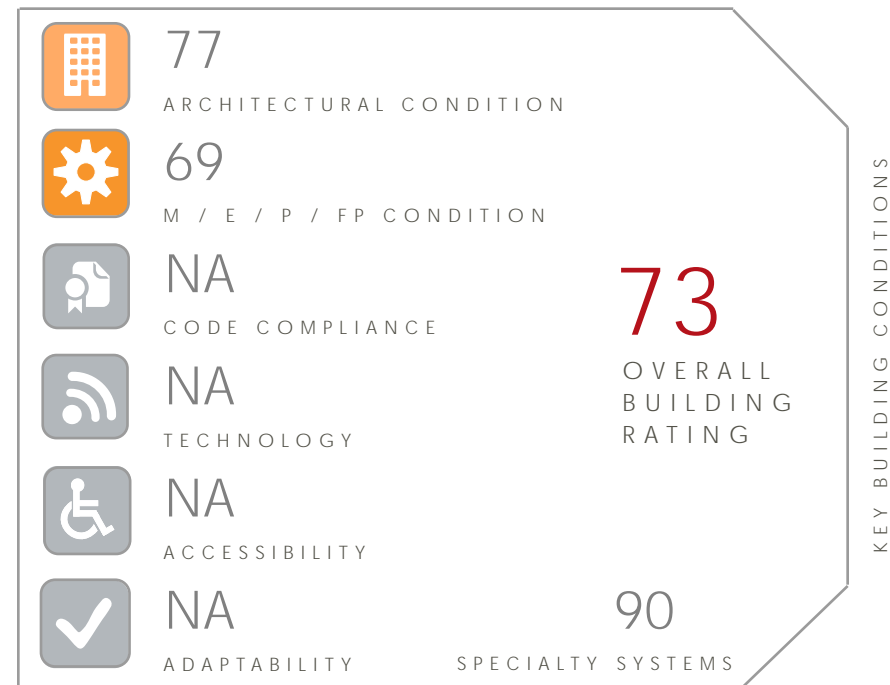
**BUILDING SUMMARY** Knowles Hall is a residential hall constructed in 1966 along with the Knowles Dining Hall (today known as the Knowles Conference Center). The building is located at the eastern side of the residential zone. The facility includes a seven-story high rise portion at the south-end of the complex with two two-story buildings and dining hall connected to complete the U-shaped Knowles Residential Quad. The building is very suitable for its current function.

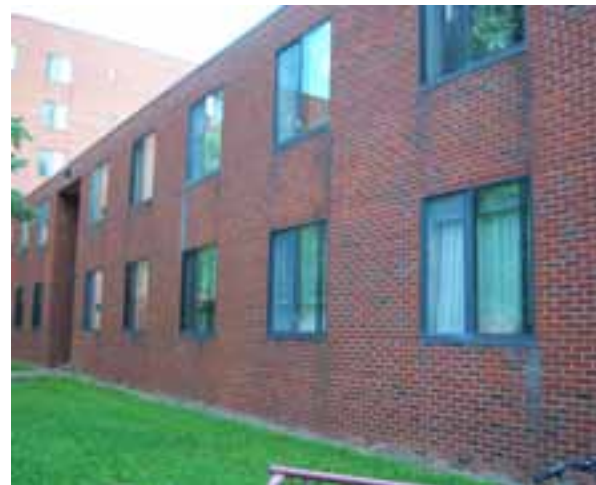
SPALLING AND CRACKS IN THE BRICKS ARE VISIBLE AT SOME LOCATIONS.

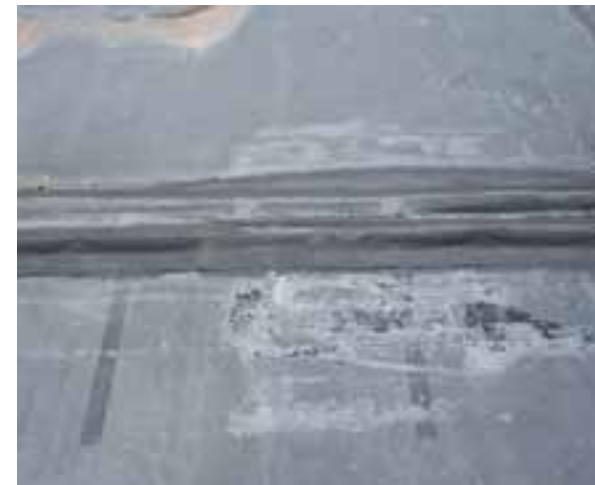
THE FULLY ADHERED EPDM MEMBRANE APPEARS TO BE IN FAIR CONDITION.

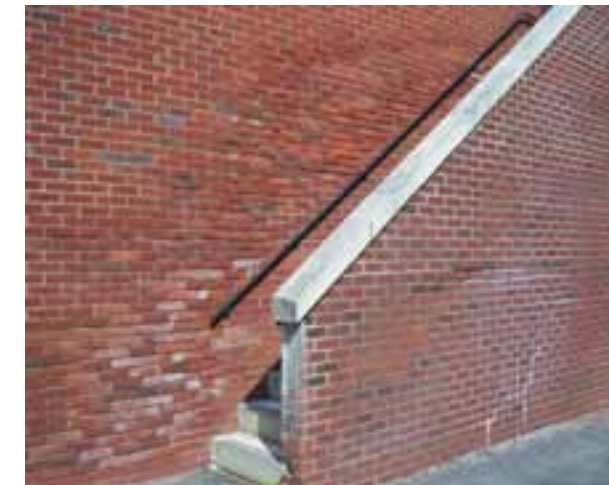
THE MASONRY WALL ENCLOSURE AT THE EXTERIOR STAIR IS IN POOR CONDITION

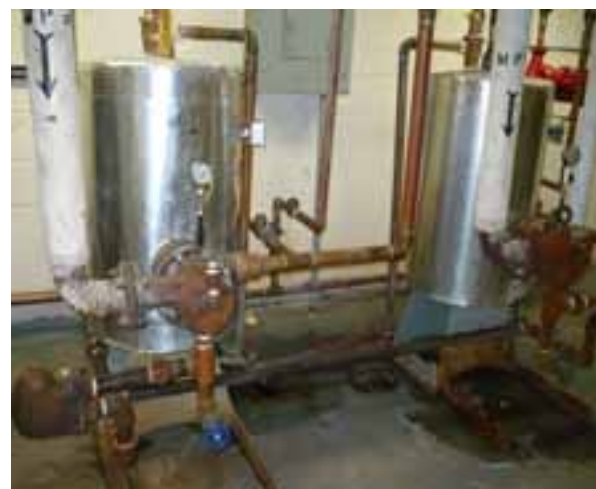
STEAM-TO-HOT WATER CONVERTORS

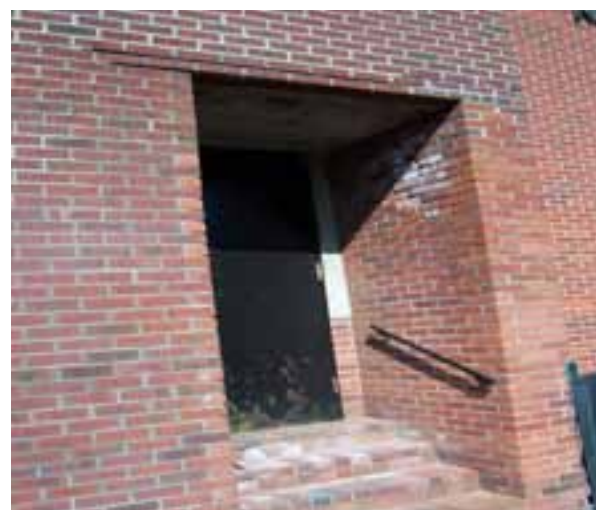
EXTERIOR MASONRY STAINING AND EFFLORESCENCE. EGRESS EXIT NOT TO CODE.
