“BEING MORE THAN A COLLECTION OF INDIVIDUALS, SUNY POTSDAM IS A COMMUNITY DEDICATED TO THE PURSUIT OF COMMON GOALS.”

- SUNY POTSDAM PLEDGE

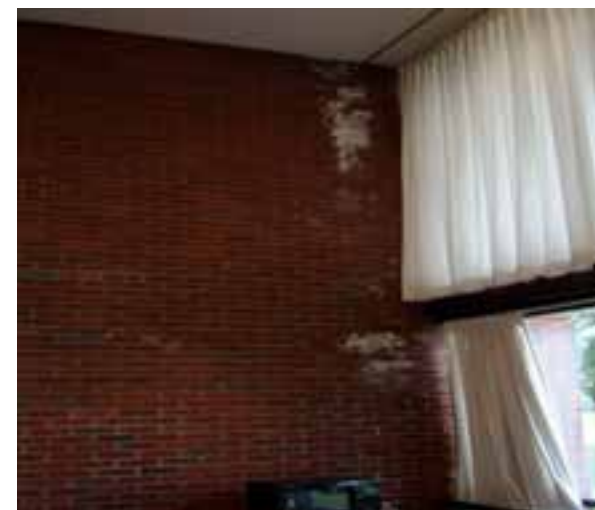
FIRST FLOOR LOUNGE INTERIOR MASONRY STAINING.

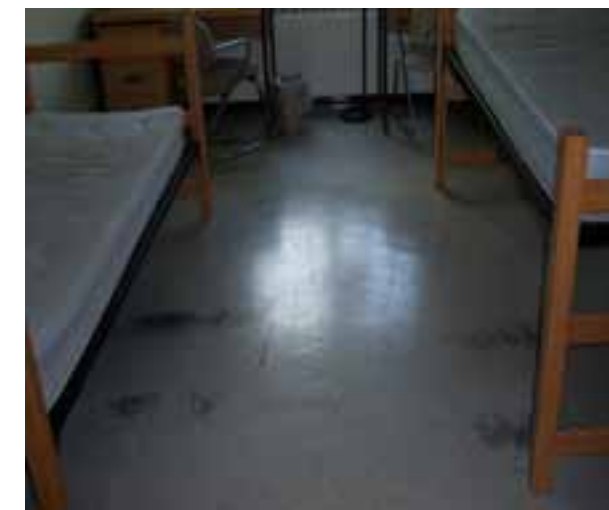
THE FLOOR FINISHES COULD BE REFINISHED TO UPGRADE AESTHETICS.

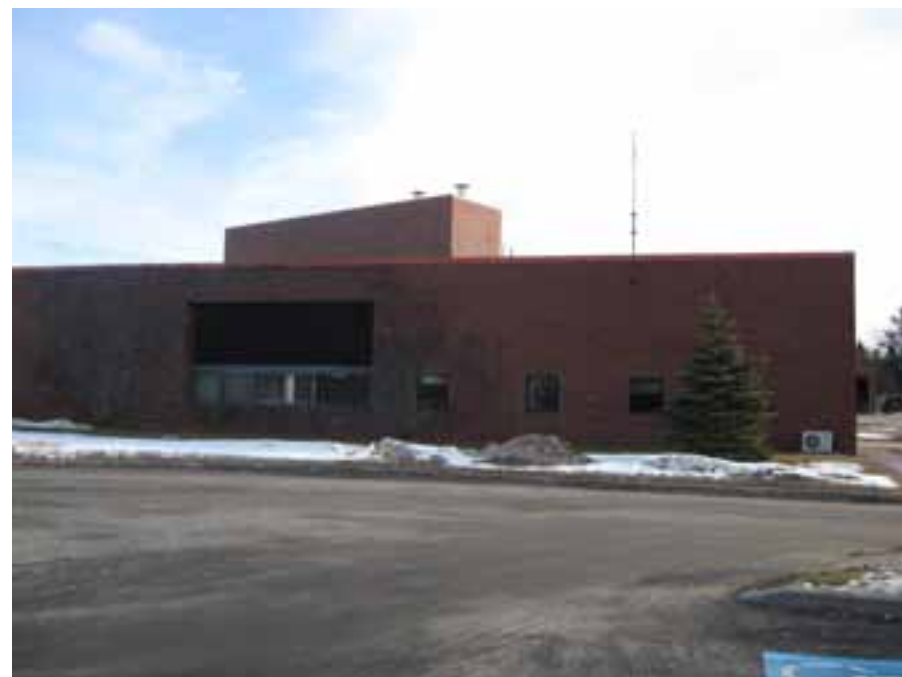
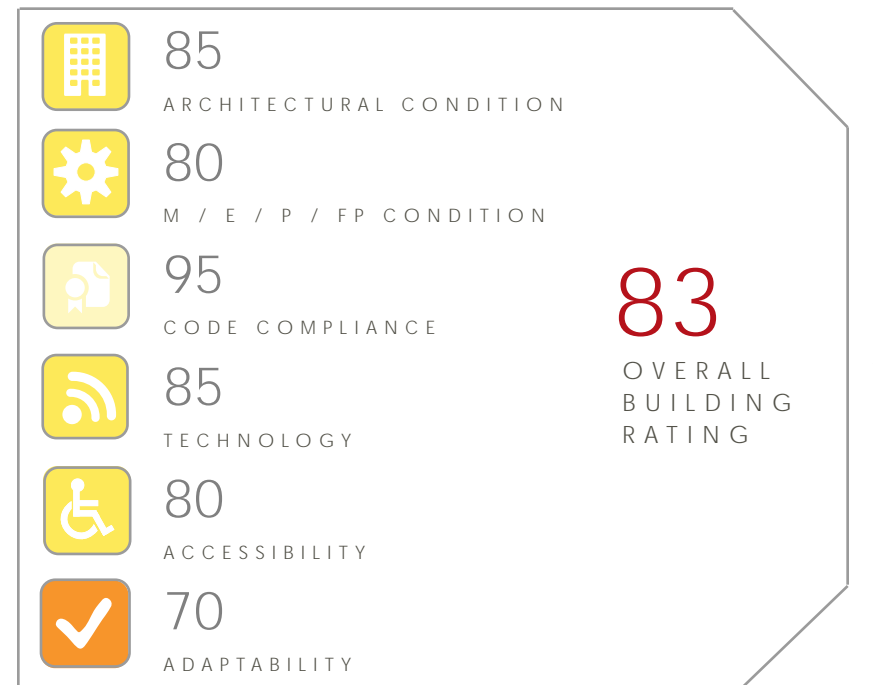
**BUILDING SUMMARY** The maintenance facility services the entire campus and contains offices, storage, and repair shops for the various building trades. Maintenance is also the central campus receiving for over-sized shipments. The facility is ideal for its current use.

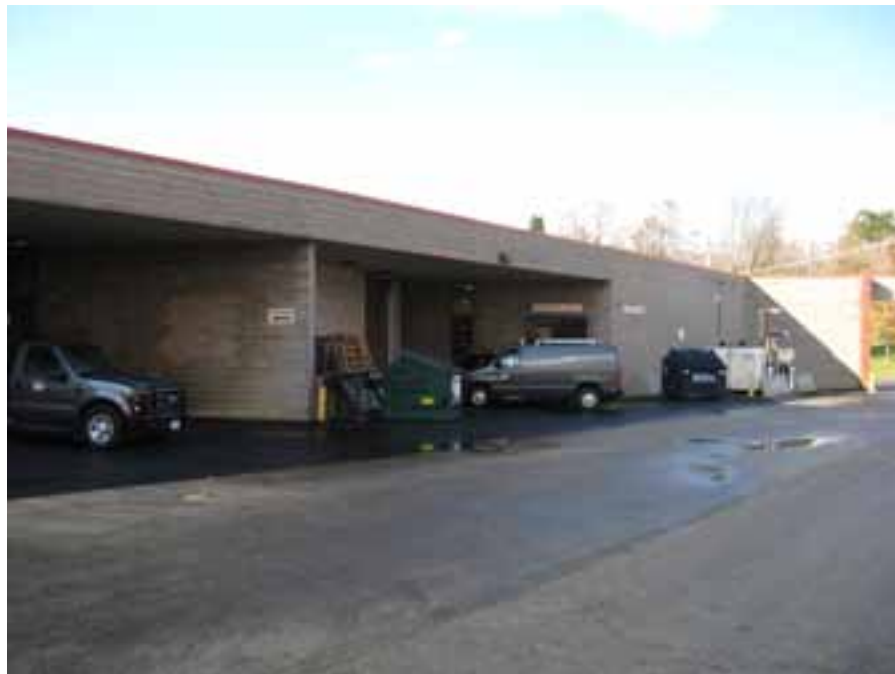
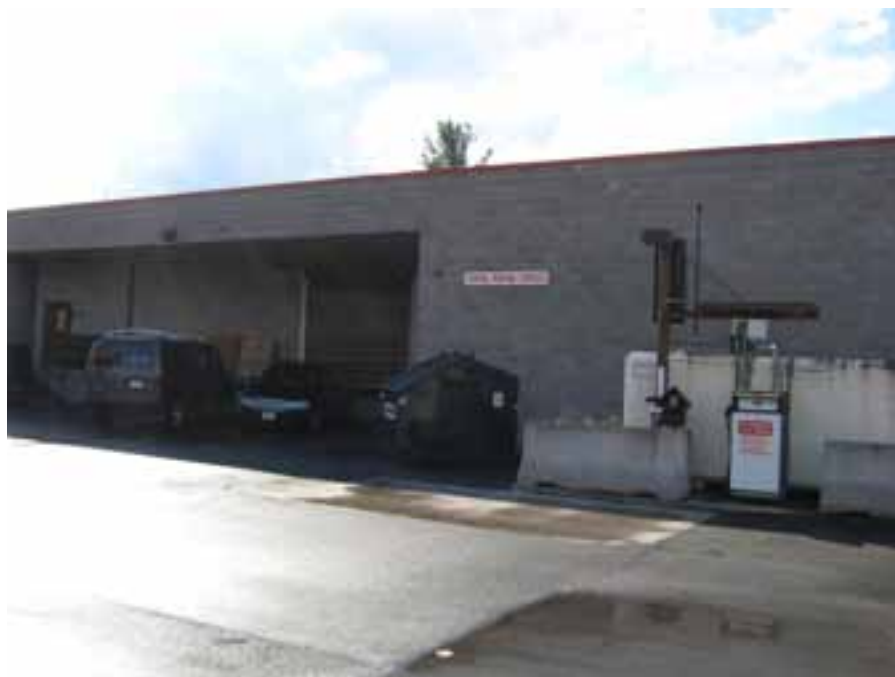
Roof drains need cleaning. Vent stacks are too short.

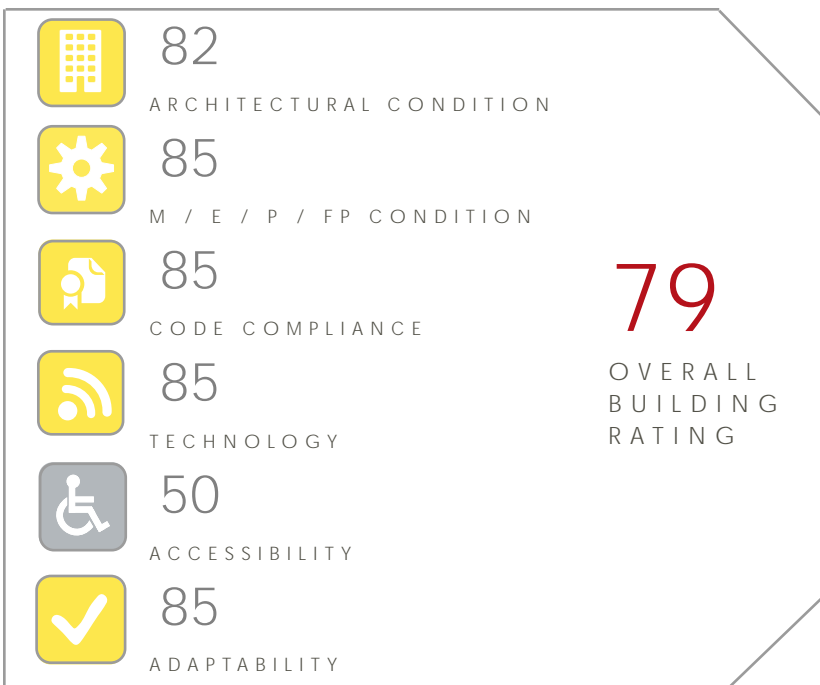
**BUILDING SUMMARY** The Central Printing facility, constructed in 1966, houses the central printing shop for the campus on the northern side, as well as maintenance shops, storage, and offices. The building was built within the Physical Plant complex walls at the northern end of the campus. The central printing department moved into the space after the facility was operational. Central Printing currently provides printing services for both SUNY Potsdam and SUNY Canton.

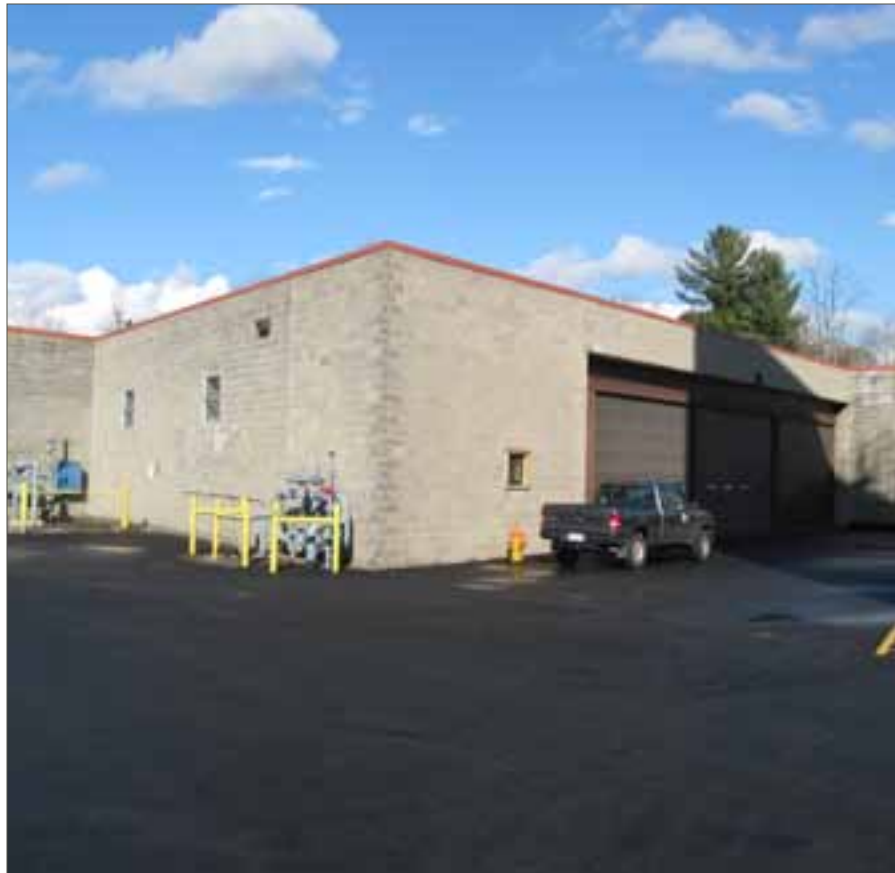
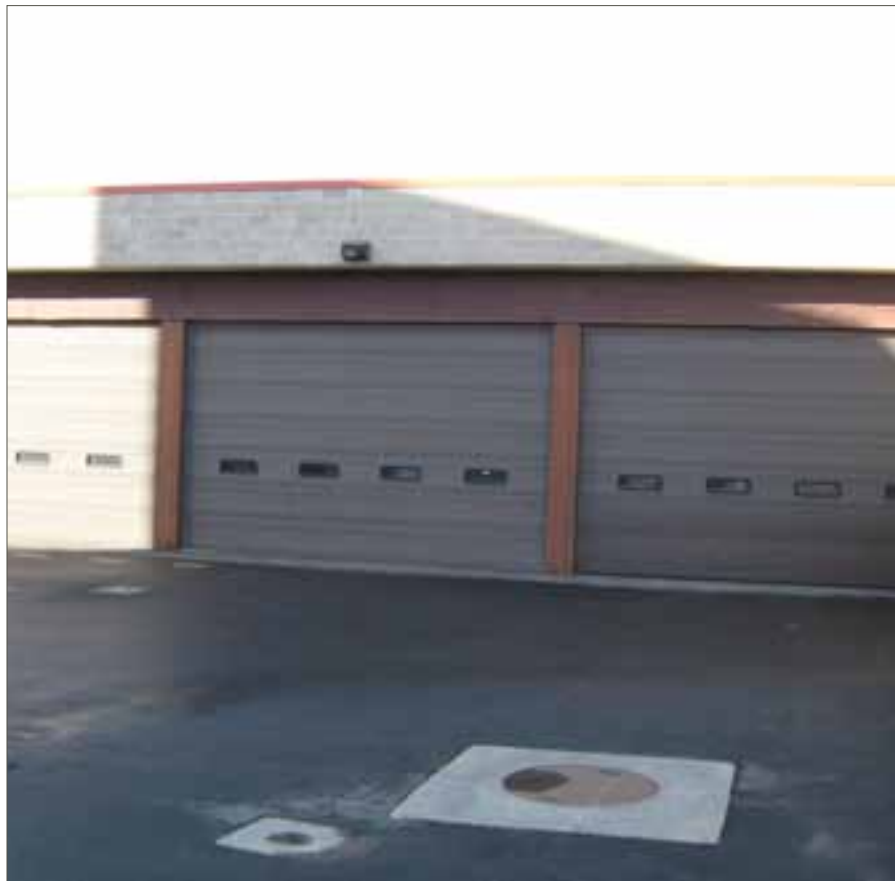
# VEHICLE REPAIR GARAGE

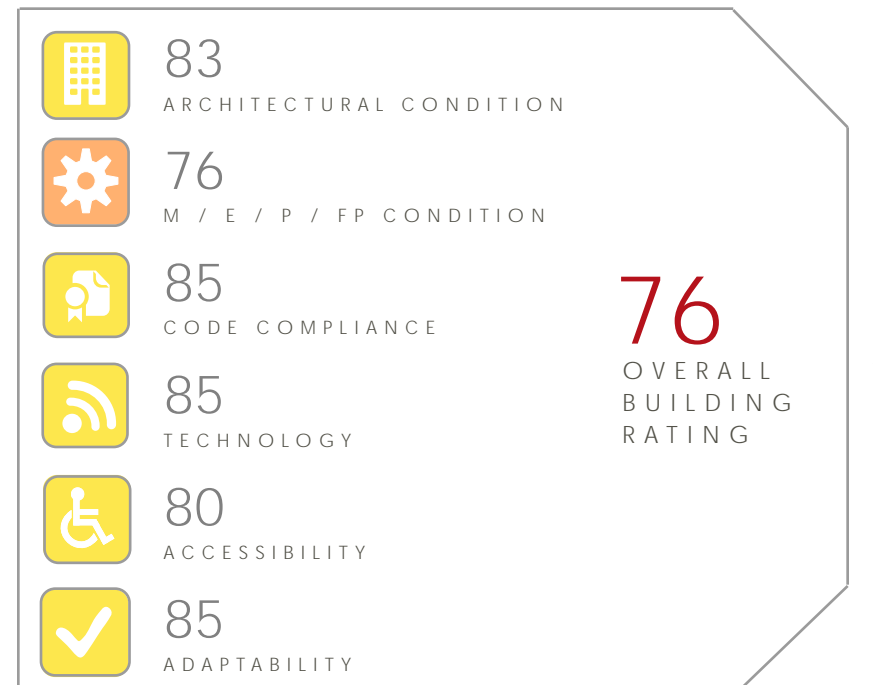
**BUILDING SUMMARY** The Vehicle Repair Garage, constructed in 1966, is used by the facilities employees. The building is used for automobile repairs and maintenance, and appears generally well suited for this purpose. The garage is located at the northern most portion of campus within the walls of the physical plant complex. The campus steam tunnel can be accessed from this facility.

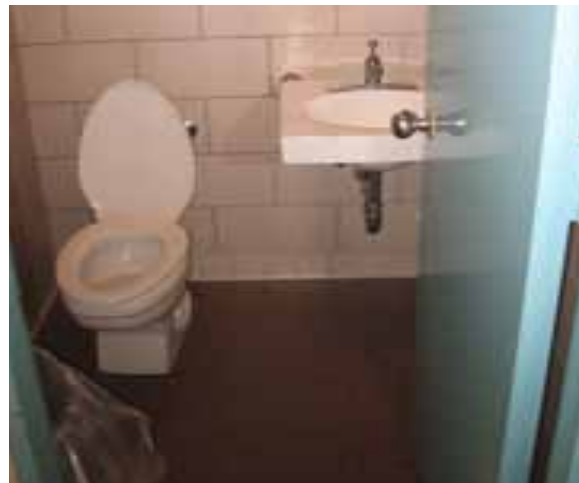
MAINTENANCE FACILITY NON-COMPLIANT TOILET

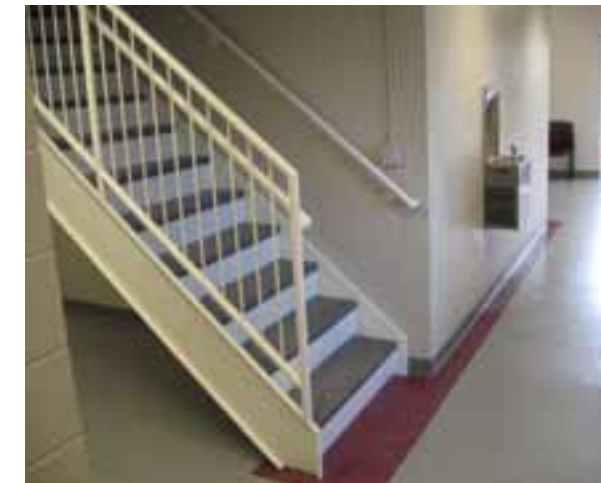
MAINTENANCE STAIRWELL MISSING HANDRAIL EXTENSIONS

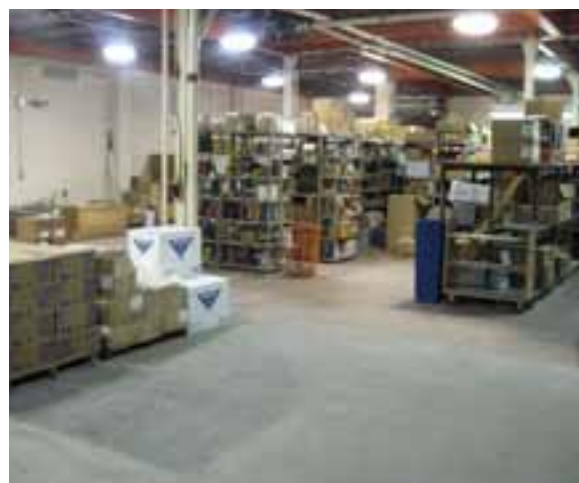
VIEW OF MAINTENANCE STORAGE

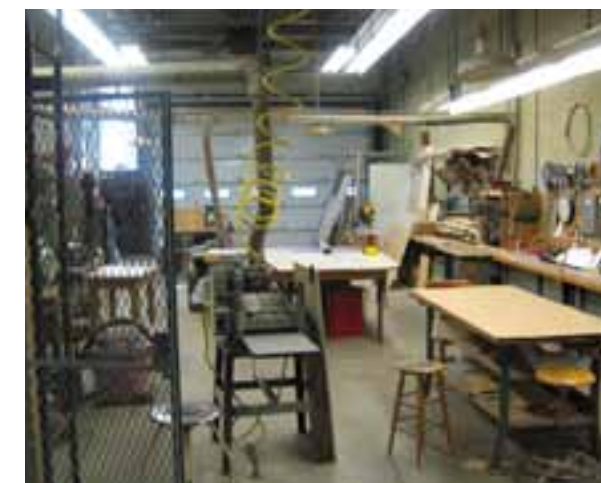
VIEW OF TRADES REPAIR SHOP

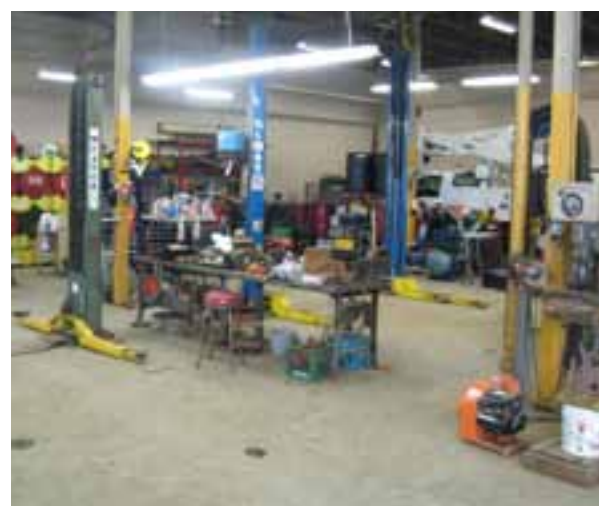
VIEW OF VEHICLE REPAIR SHOP

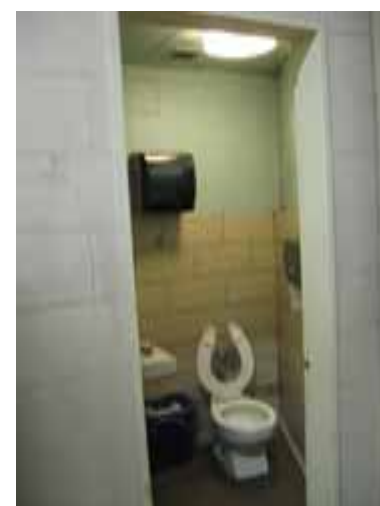
VEHICLE REPAIR SHOP TOILET

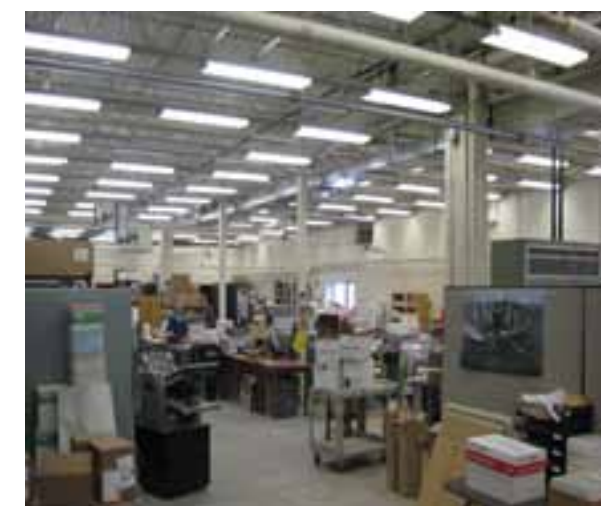
VIEW OF CENTRAL PRINTING

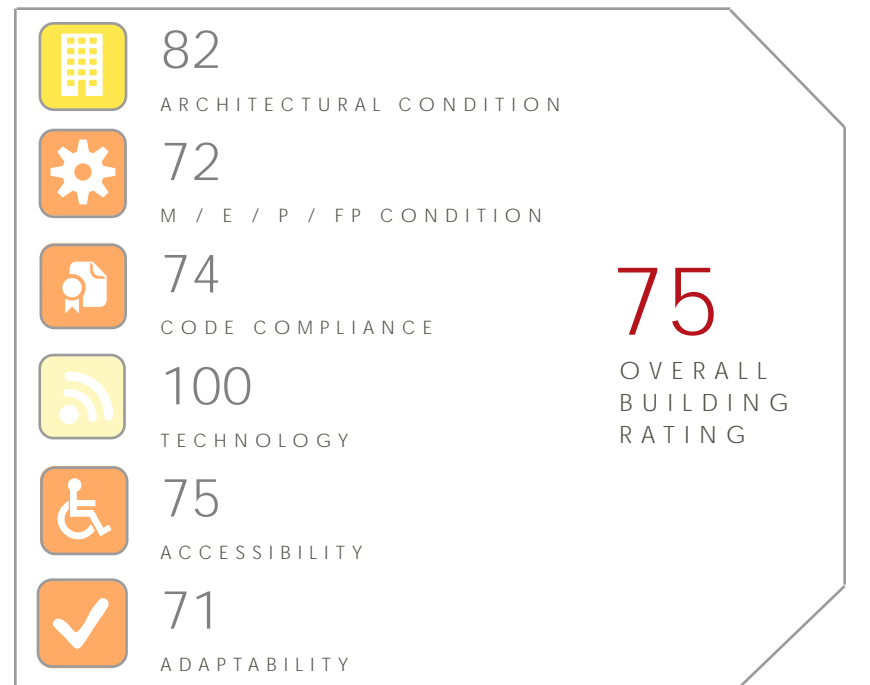
**BUILDING SUMMARY** Constructed in 1967, Kellas Hall contains large-tiered classrooms sought-after by most faculty on campus. The technology in all the classrooms is at optimal levels. Kellas also has an unusual building layout of an open main corridor running along the west side of the building, and a smaller, stacked corridor running along the east edge of the building. The building is located on the north side of campus adjacent to Merritt Hall, connected by an internal vestibule. The North Quad Gate connects the building to Stillman Computer Center at the northwest corner of the facility. The building does need some minor upgrades to accessibility to increase the utilization of the building by all students on campus.

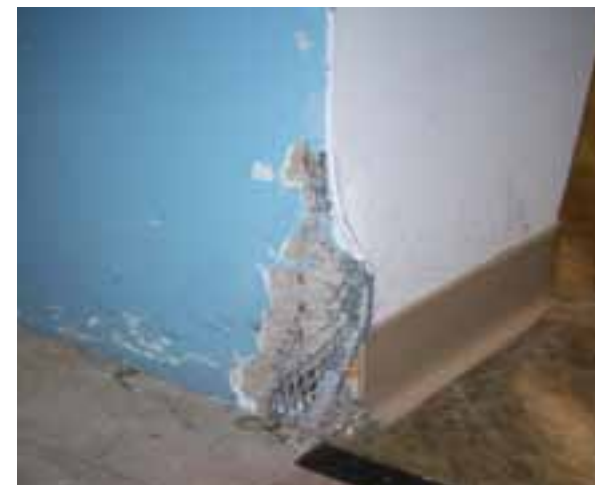
MINOR DAMAGE AND/OR DETERIORATION VISIBLE AT WALLS AT SOME LOCATIONS

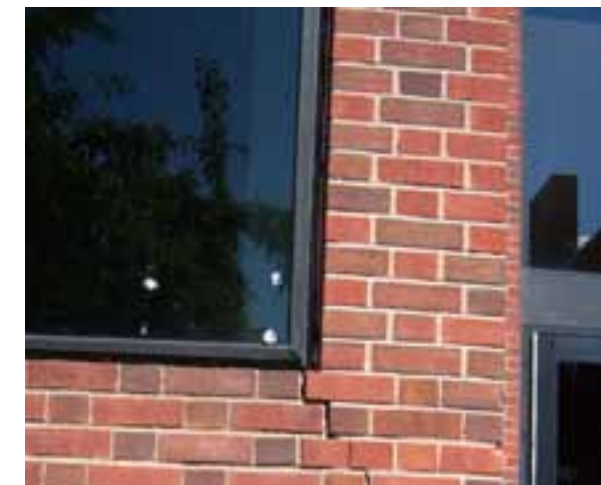
THERE ARE CRACKS IN THE MASONRY ALONG THE BAND OF WINDOWS.

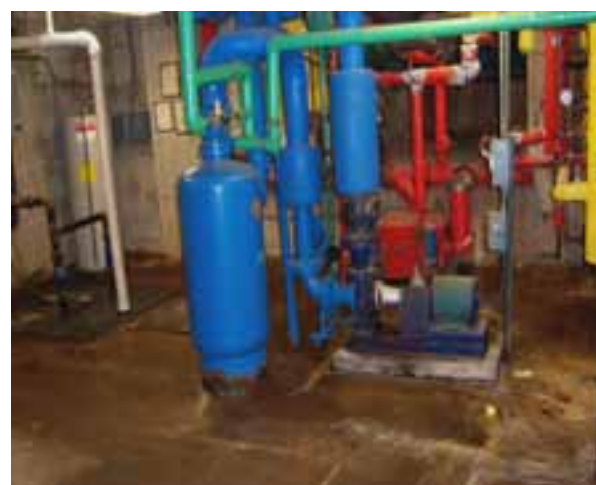
HEATING HOT WATER PIPING AND PUMPS

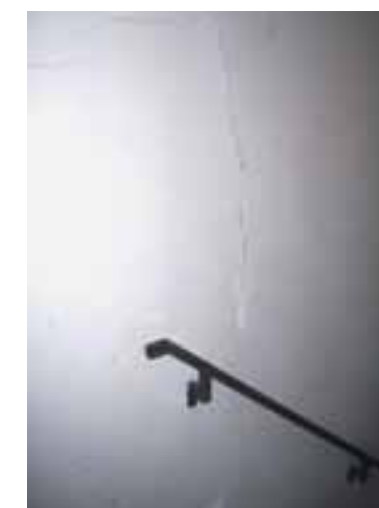
THE EGRESS STAIRWELLS ARE MISSING HANDRAIL EXTENSIONS.

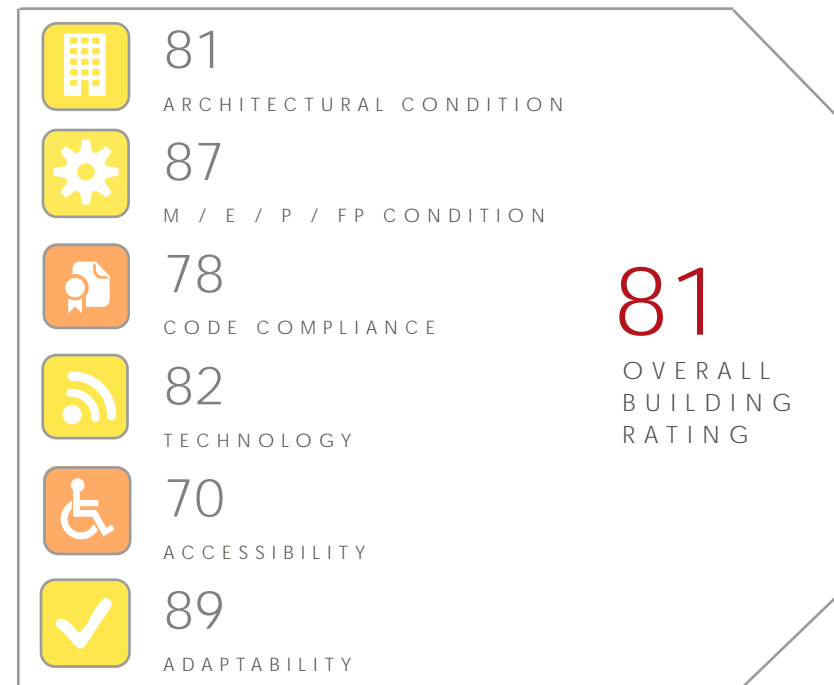
**BUILDING SUMMARY** Brainerd Hall, originally constructed in 1968 as the studio arts building. Brainerd also accommodates exhibition space, studios, faculty rooms, and miscellaneous building maintenance spaces. The tall, two-story art laboratories with abundant natural light from the ceiling are ideal for teaching art. Brainerd is an academic building for fine arts located in the central quadrangle of the campus.

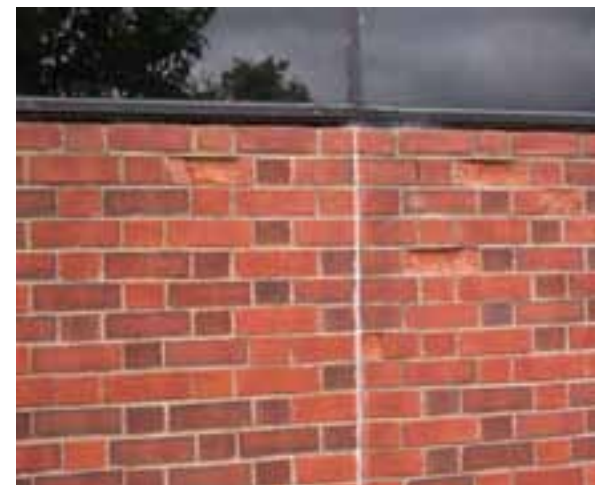
BRICK SPALLING AND DETERIORATED GROUT JOINTS ON THE EAST SIDE.

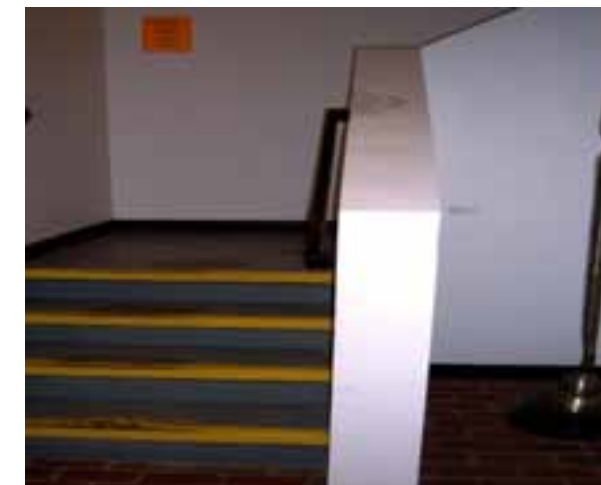
VIEW OF BUILDING WORN FINISHES

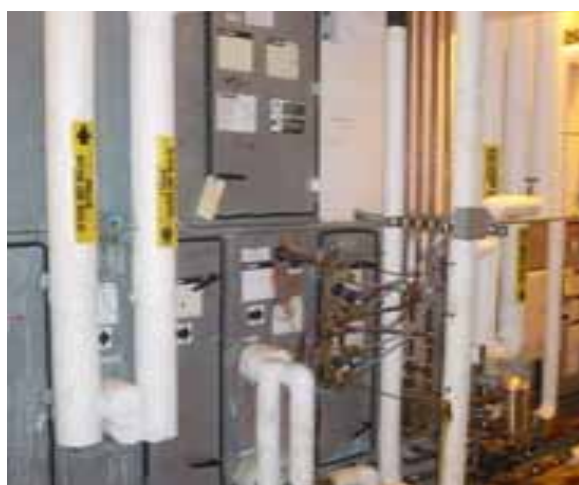
BUILDING AIR HANDLING UNIT

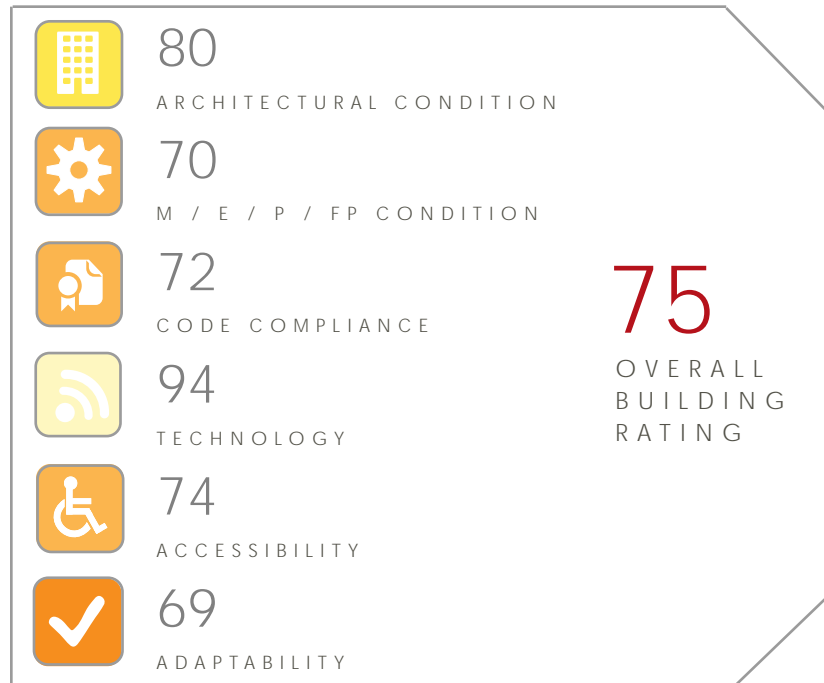
**BUILDING SUMMARY** Timerman Hall, constructed in 1968 as a classroom, laboratory, and faculty office building, is located at the southeast corner of the academic quad, connected to Stowell Hall at the basement level and to Merritt Hall. The connection to Merritt Hall is currently inaccessible. There is a daycare center located in Merritt that obstructs the internal connection between buildings. Timerman has a unique offset corridor configuration that makes any floor plate adaptation difficult for other academic functions. The narrow second floor loft footprint is not currently large enough to accommodate programming other than faculty offices. In general, the building appears to be well suited for its current purpose.

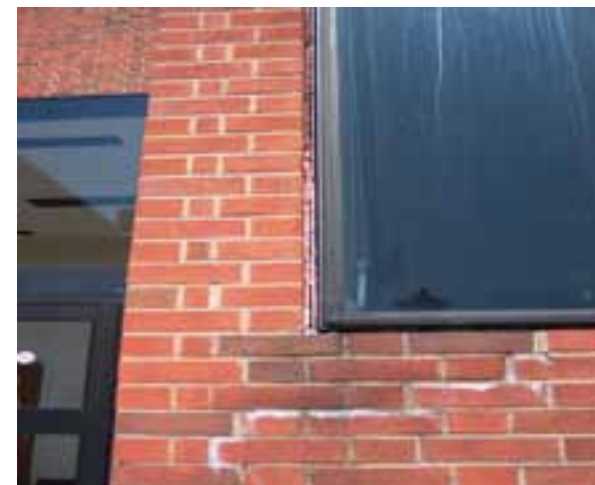
CRACKS IN THE MASONRY ALONG THE BAND OF WINDOWS ON THE WEST

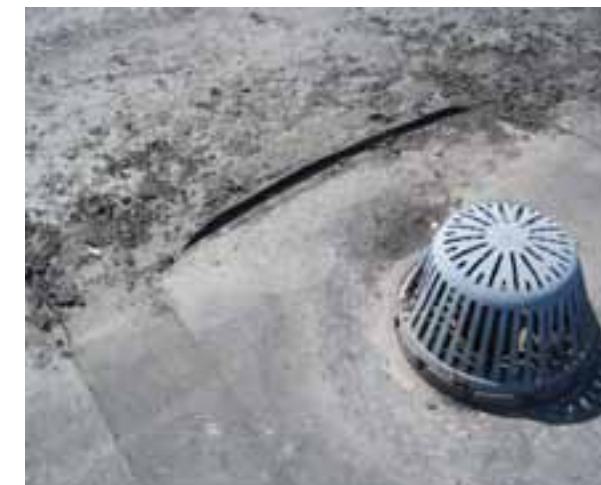
VIEW OF ROOF THAT ARE IN DETERIORATED CONDITION WITH DELAMINATED SEAMS

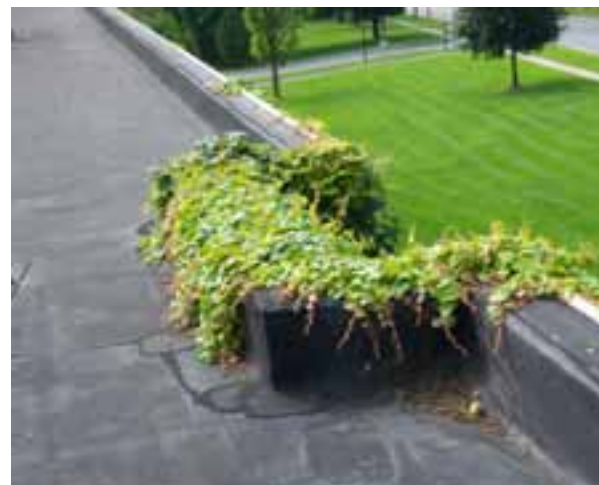
THERE IS SOME VEGETATION GROWTH ON THE ROOFS AND DEBRIS AT THE DRAINS;

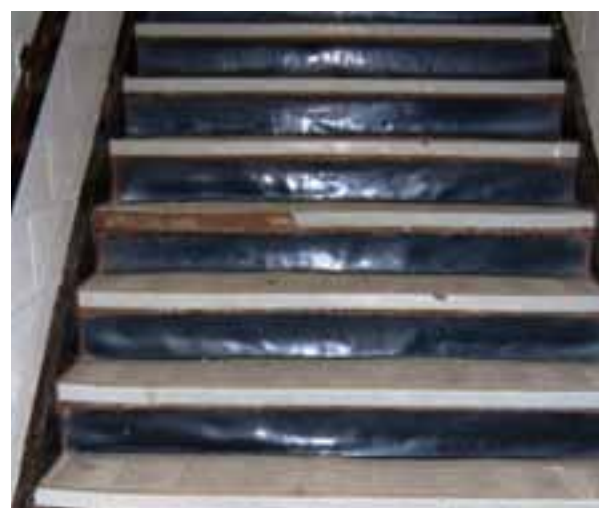
DEFICIENT FINISHES OF SOME OF THE INTERIOR ELEMENTS.

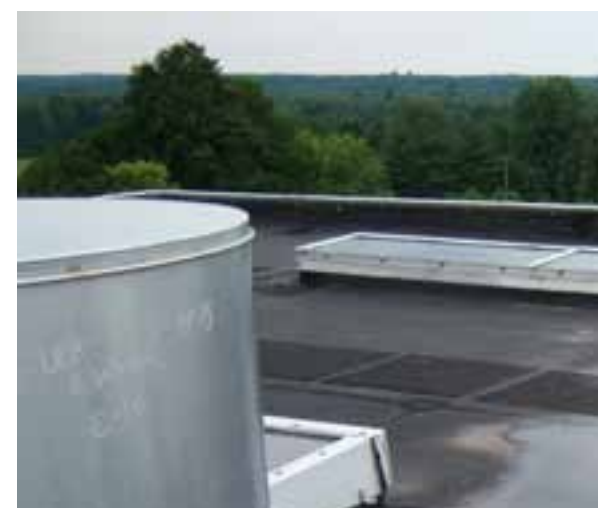
PONDING ON HIGHRISE ROOF

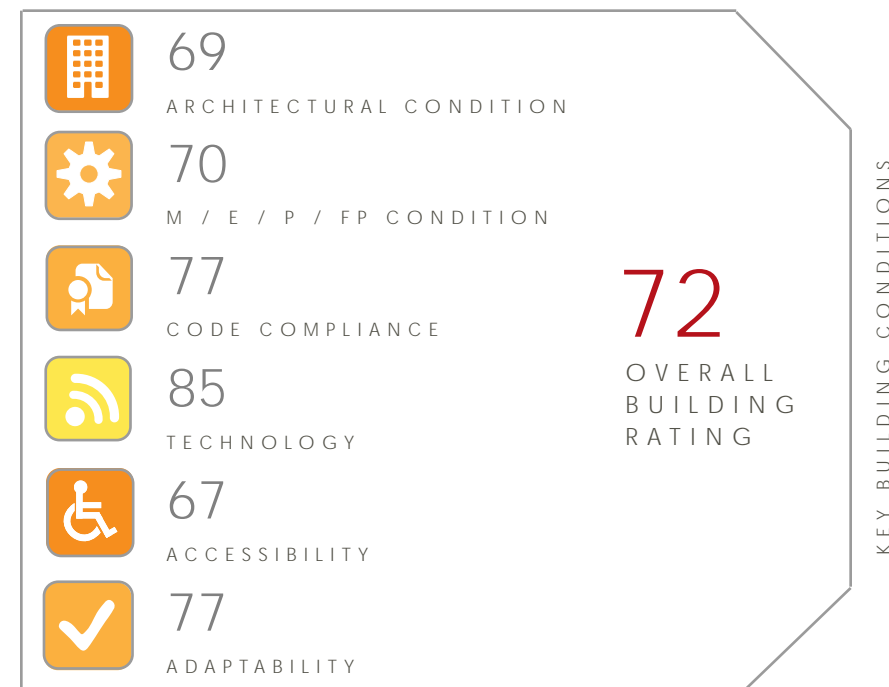
**DEPARTMENTS:** COLLEGE STORE, OFFICE OF STUDENT CONDUCT & COMMUNITY STANDARDS, PHYSICAL PLANT, CAMPUS MAIL SERVICES, STUDENTS AFFAIRS, STUDENT GOVERNMENT ASSOCIATION

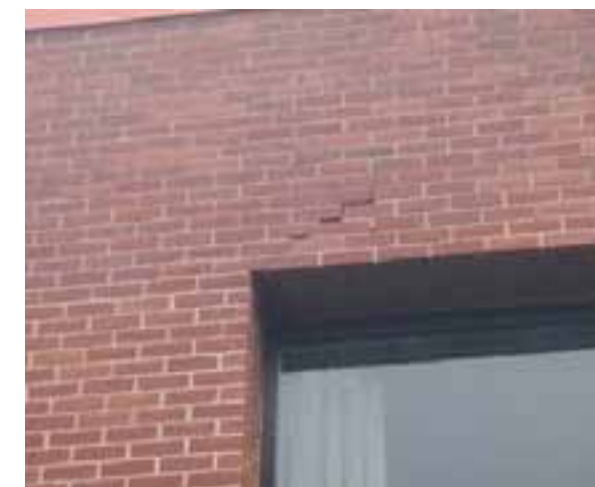
LARGE DIAGONAL CRACKS IN THE MASONRY AT THE LINTELS DUE TO MASONRY MOVEMENT AND EXPANSION.

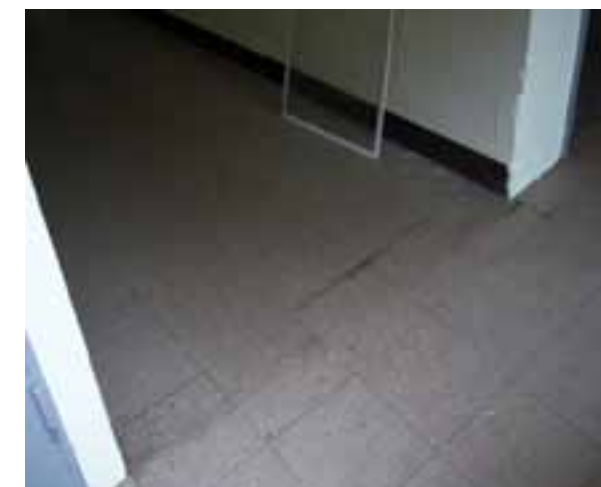
THE INTERIOR FINISHES ARE GENERALLY IN GOOD CONDITION.

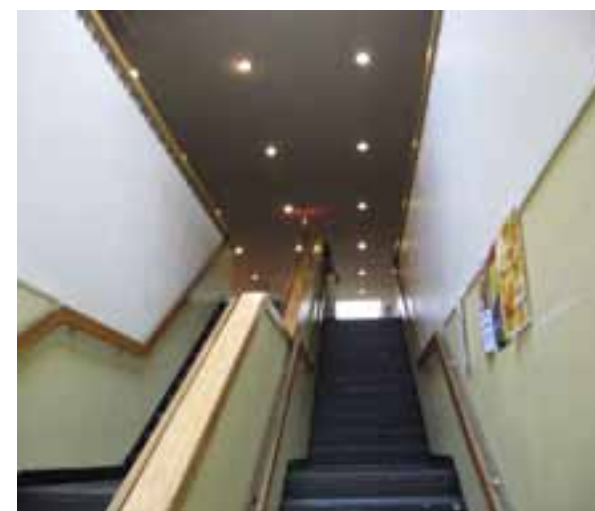
THE COMMUNICATING STAIRWELLS ARE MISSING HANDRAIL EXTENSIONS.

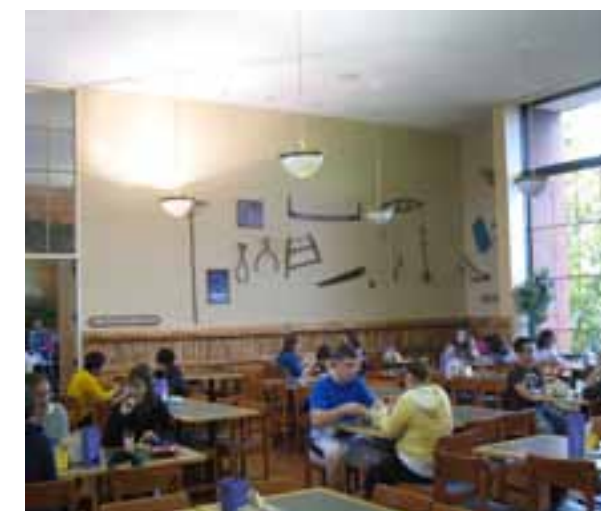
VIEW OF ONE-OF-THREE THEMED DINING AREAS.

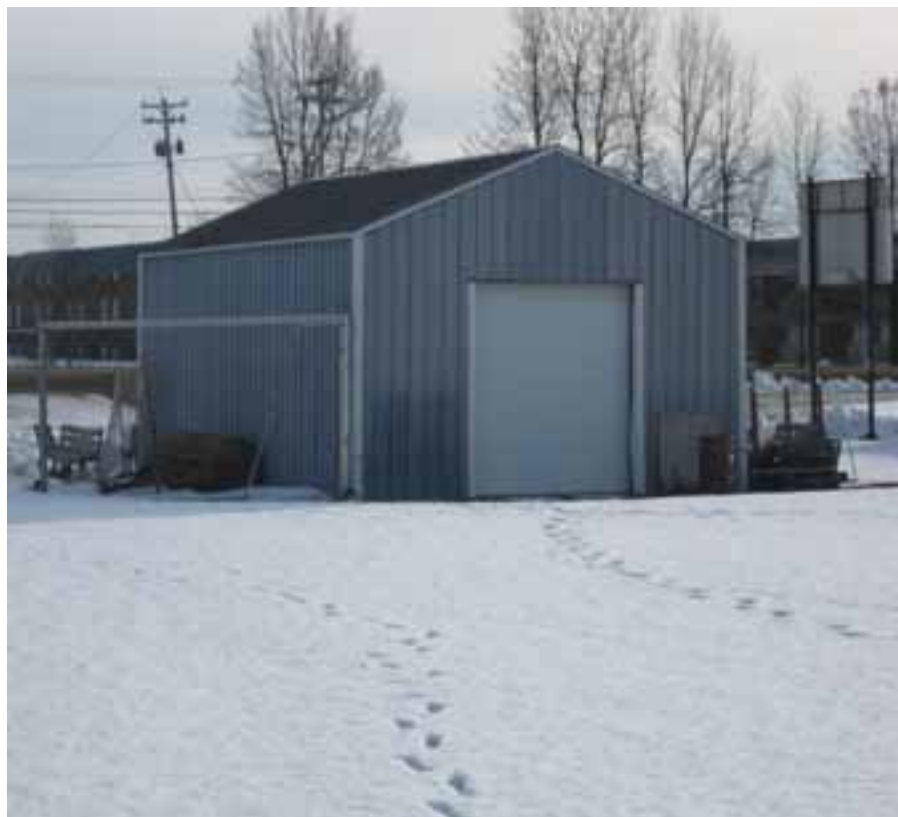
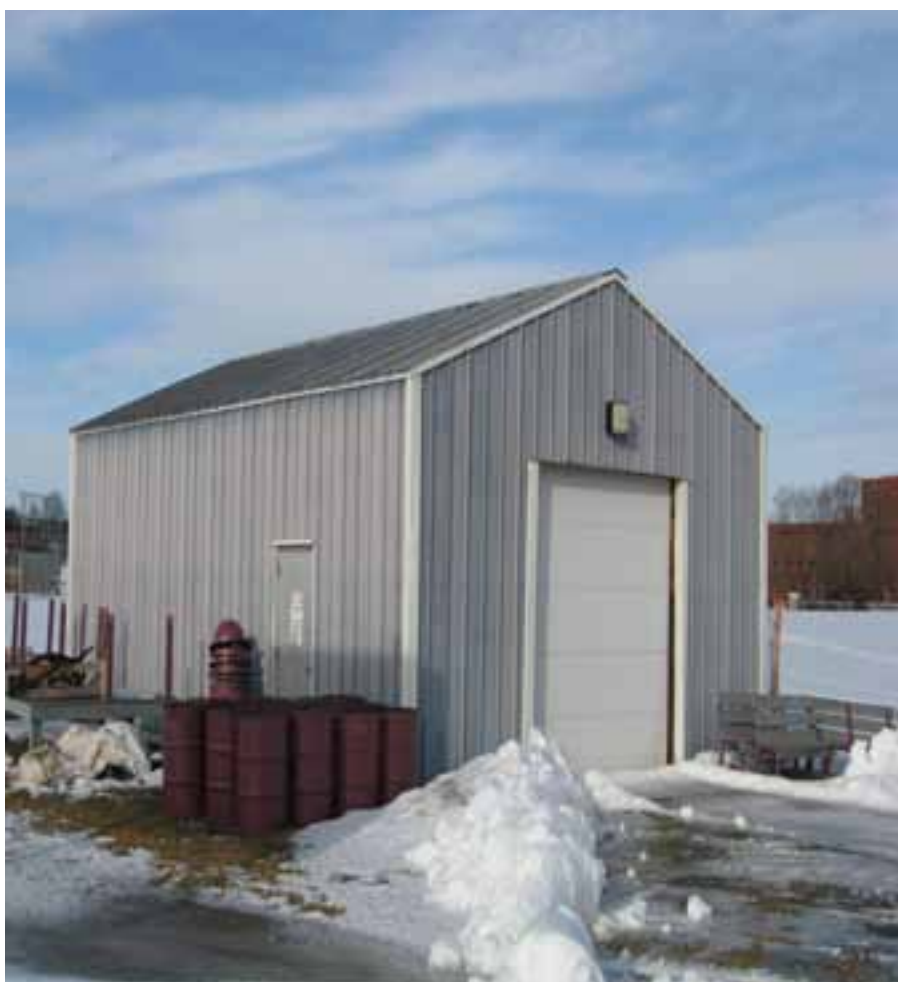
**BUILDING SUMMARY** This is a prefabricated enclosure to house the electrical substation for the campus.

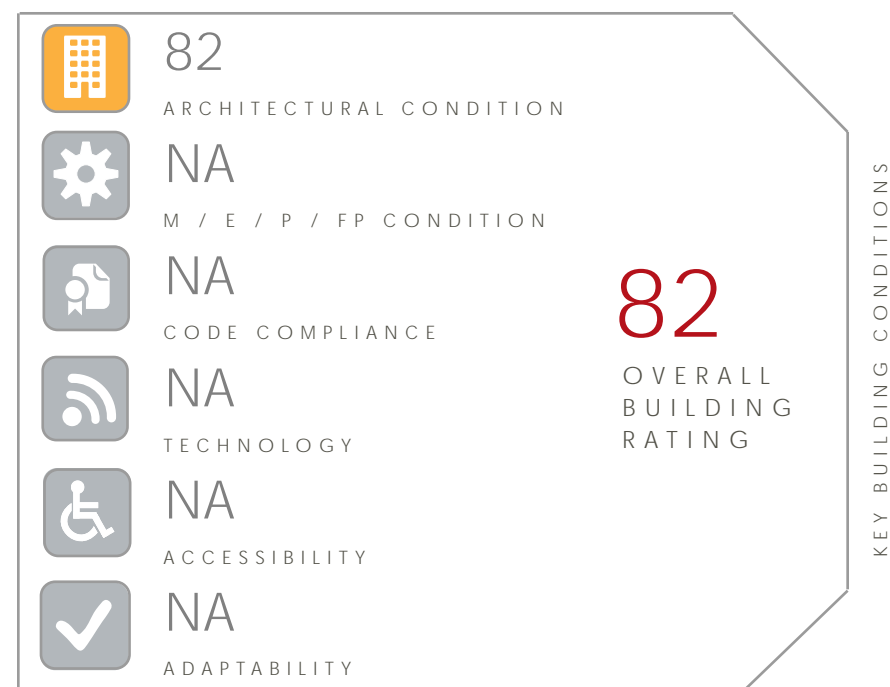
**BUILDING SUMMARY** The structure adequately serves the storage needs of the Athletic Department. It is ideally located for access to the athletic fields.

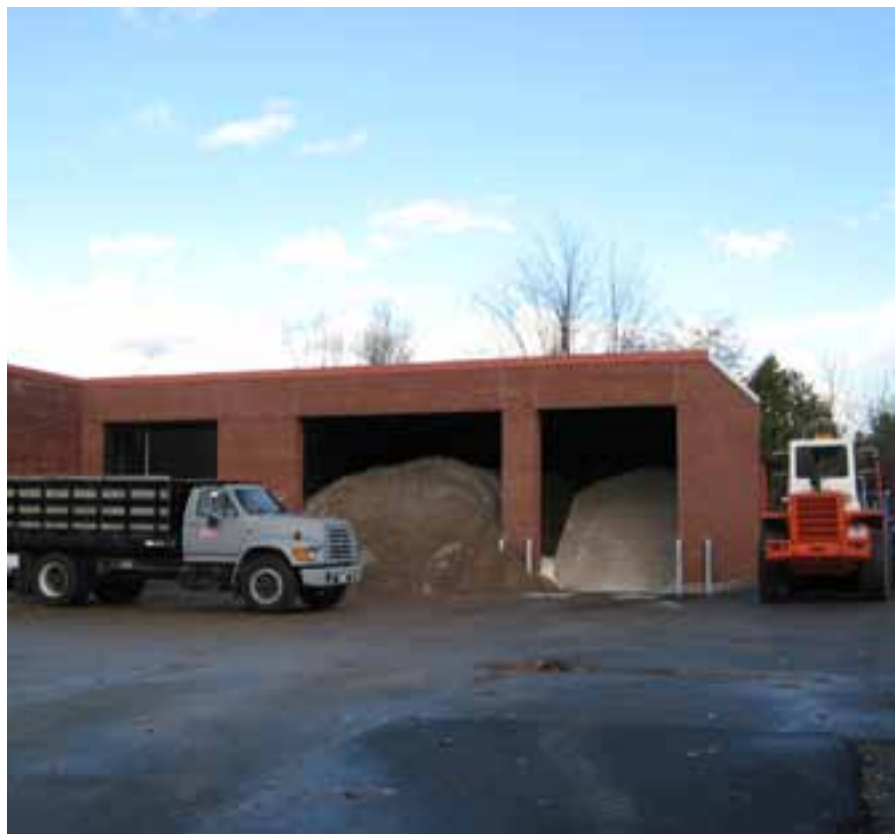
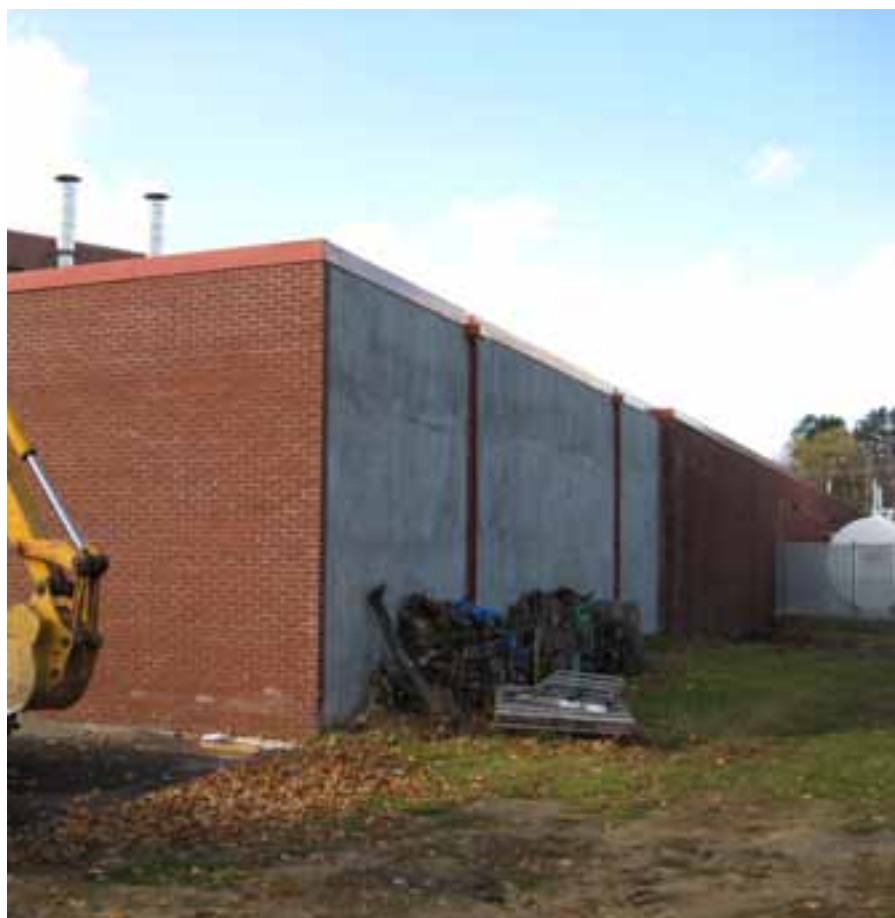
# SAND / SALT BUILDING

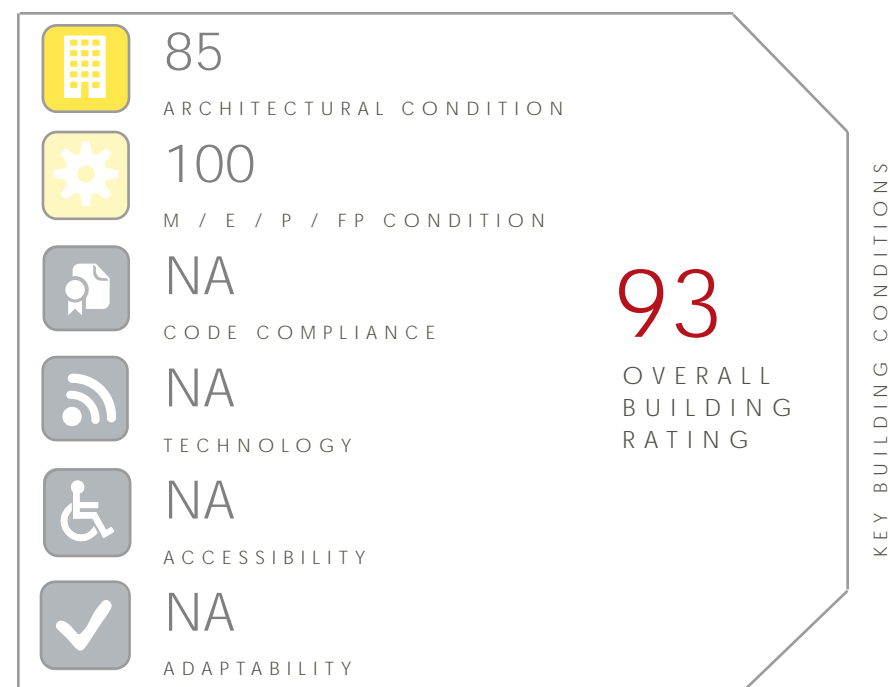
**BUILDING SUMMARY** The Sand / Salt Storage Building was constructed in 2006 for storing sand and/or salt used on the campus during bad winter conditions. The building is located adjacent to the Physical Plant facilities and is well suited for its function.

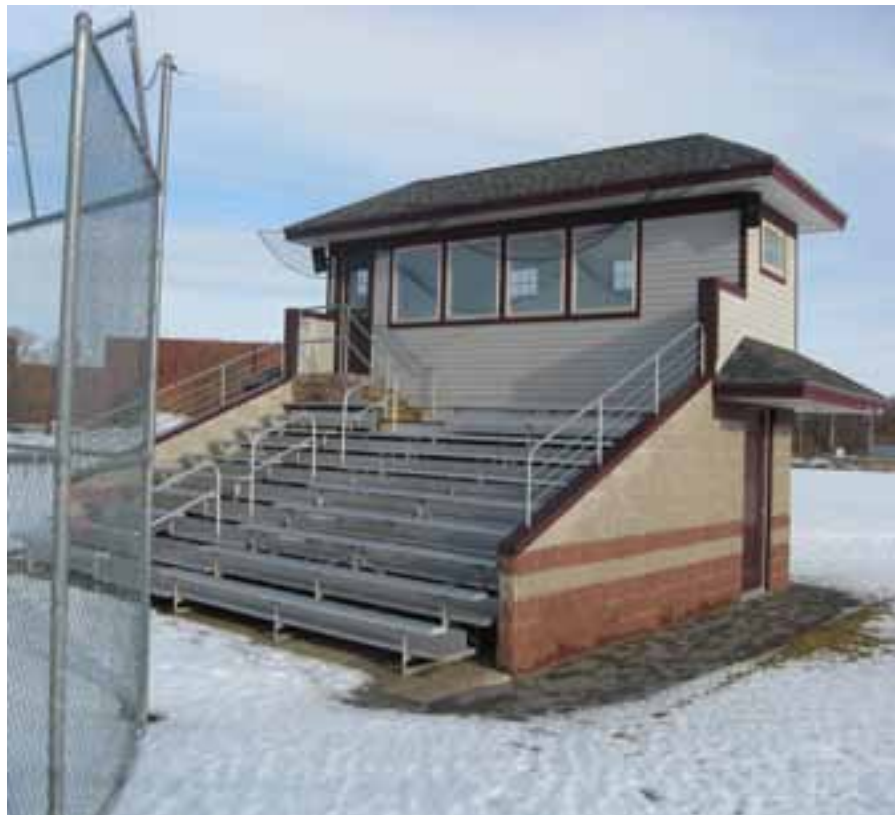
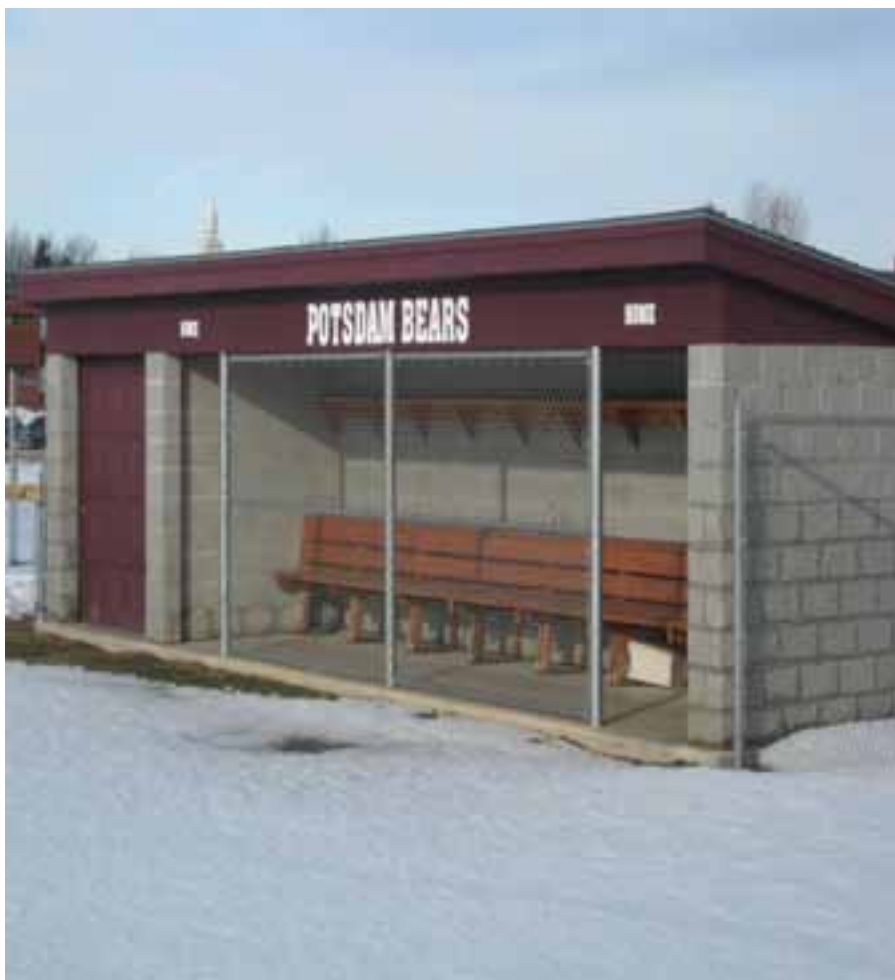
**BUILDING SUMMARY** This facility is located on the campus athletic fields adjacent to the synthetic lacrosse / soccer field. Recently constructed, the press box is ideally suited for its intended function.
